**RE: Periodic Structural Stability Assessment
 East Ash Disposal Area
 EPA CCR Rule
 TVA Allen Fossil Plant
 Memphis, Tennessee**

INITIAL STRUCTURAL STABILITY ASSESSMENT

Initial Structural Stability Assessment

TENNESSEE VALLEY AUTHORITY (TVA)
ALLEN FOSSIL PLANT – EAST ASH DISPOSAL AREA
PIPE INSPECTION REPORT

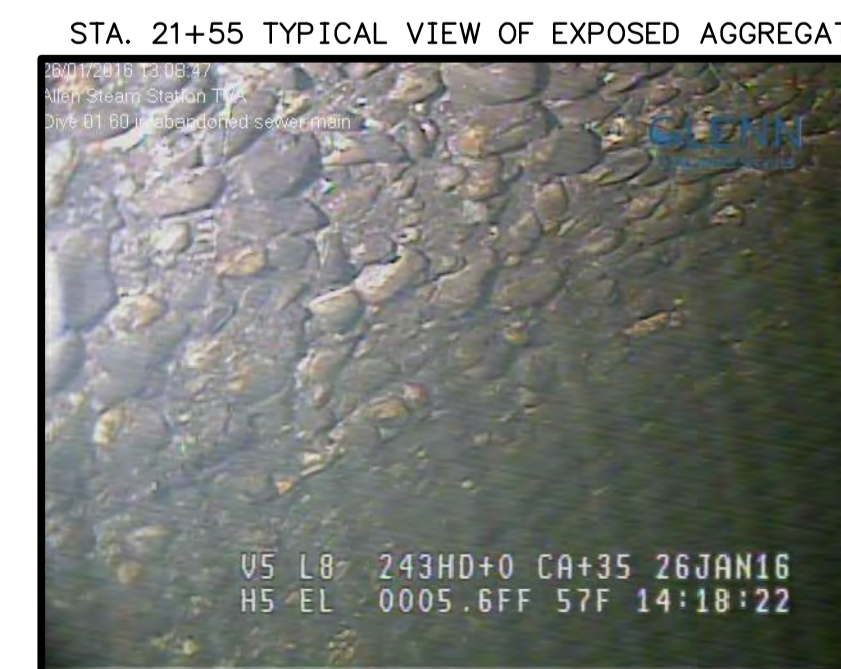
STA. 21+55 TYPICAL VIEW OF EXPOSED AGGREGATE

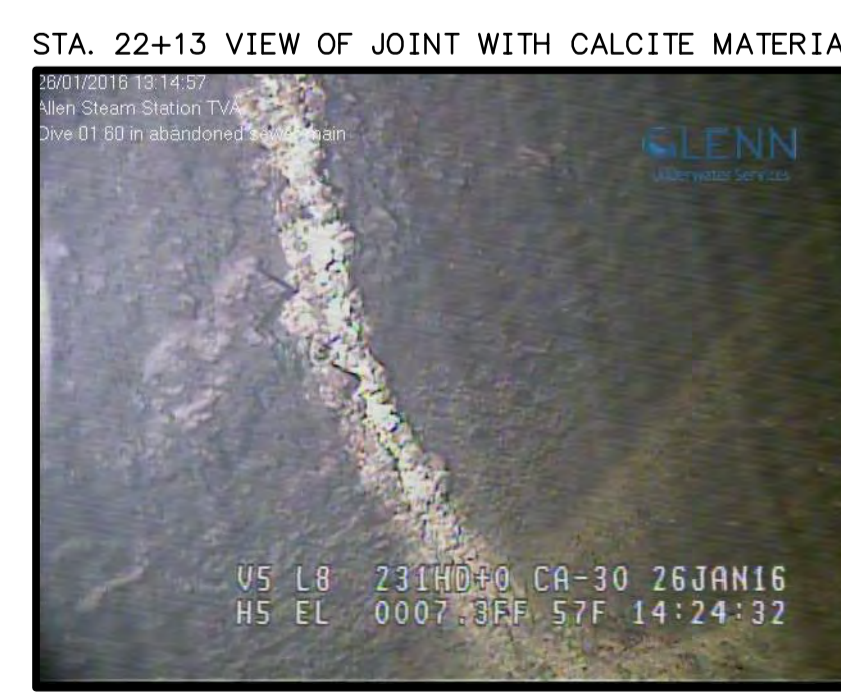
STA. 22+13 VIEW OF JOINT WITH CALCITE MATERIAL

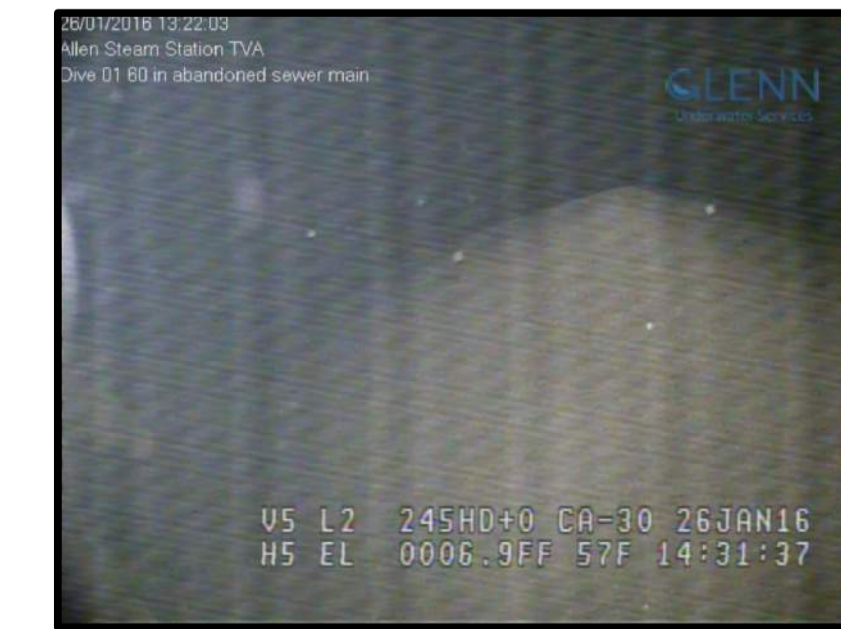
STA. 22+95 SEDIMENT DEPOSIT IN A CONE SHAPE AT INVERT OF RADIAL JOINT

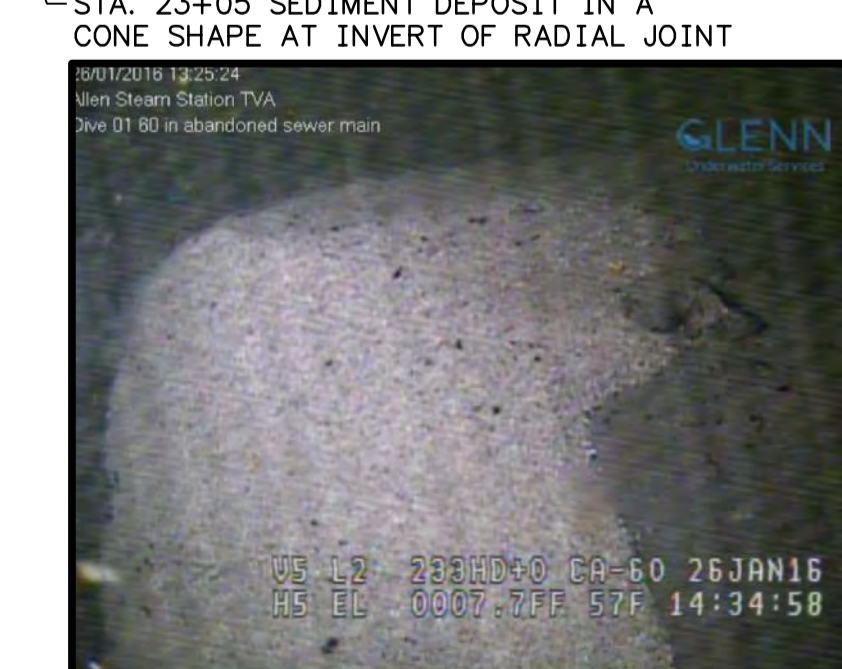
STA. 23+05 SEDIMENT DEPOSIT IN A CONE SHAPE AT INVERT OF RADIAL JOINT

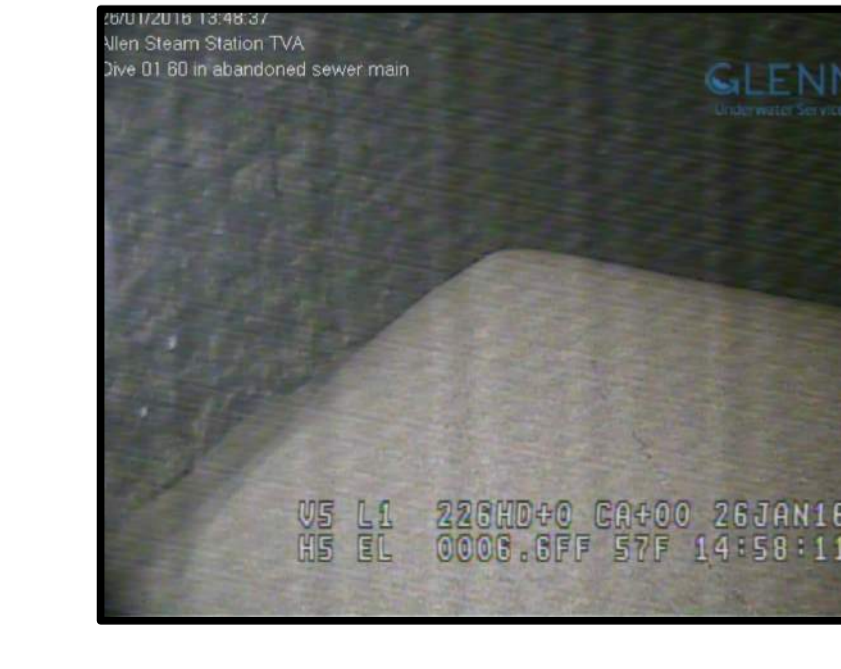
STA. 28+10 SEDIMENT DEPOSIT IN A CONE SHAPE AT INVERT OF RADIAL JOINT

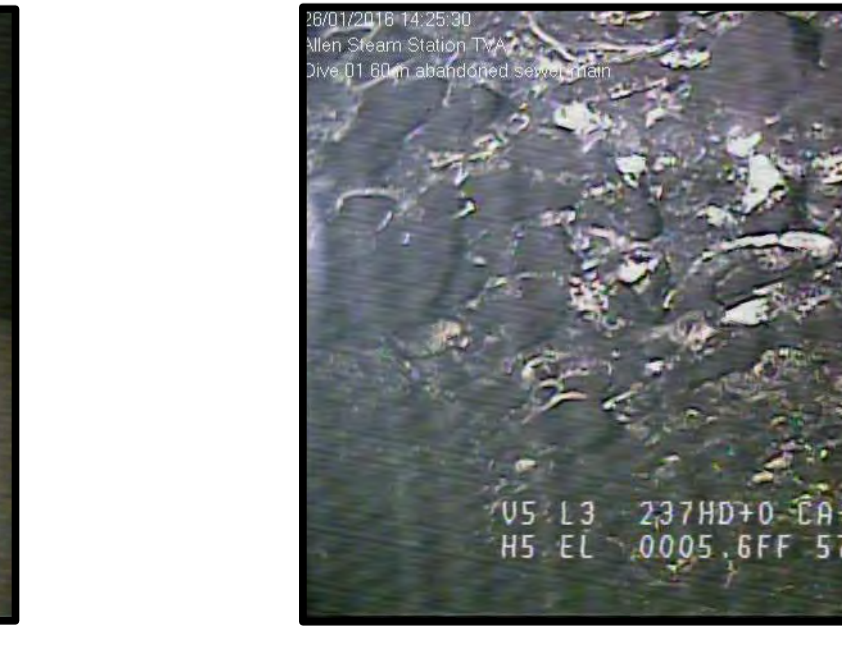
STA. 33+90 TYPICAL VIEW OF EXPOSED AGGREGATE

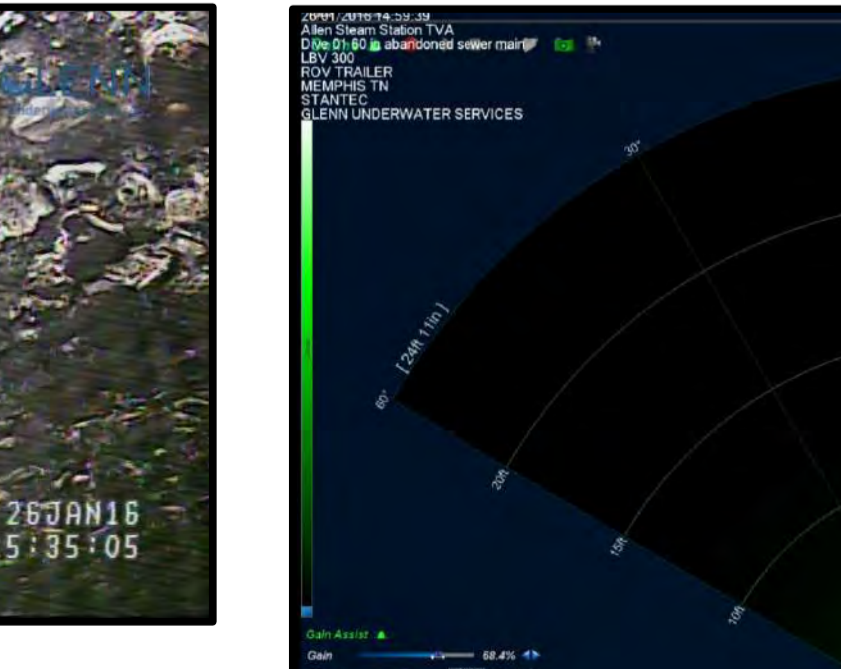
STA. 37+30 DEBRIS IN PIPE UNPASSABLE; INSPECTION ENDED

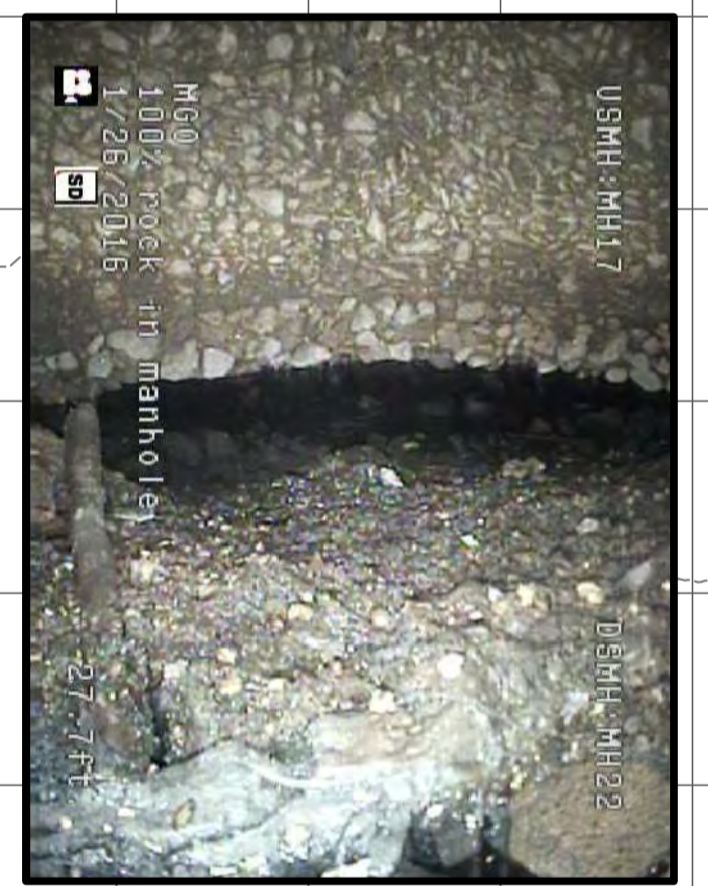
INVERT OF MH 22 CONTAINS APPROX. 95% SEDIMENT

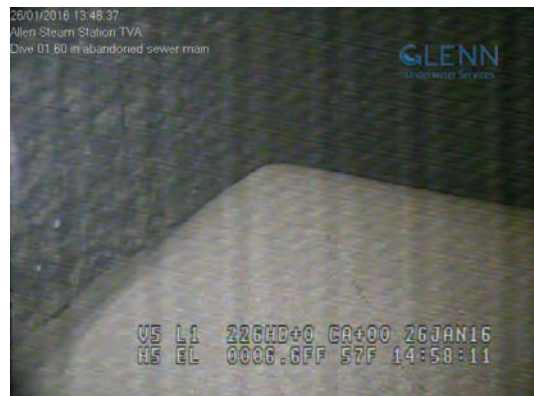
The debris at the invert of the pipe is approximately 6" in depth from Manhole No. 17 to Sta. 17+29'. At Sta. 17+29' the debris in the invert increased rapidly and prevented the ROV from performing the pipeline inspection. At this location, the debris was approximately 42" in depth. The sonar image could see further into the pipe. The images can be found in Appendix B.

Figure 1 – 810' from manhole No. 17. Fine sand deposit at invert of pipe.

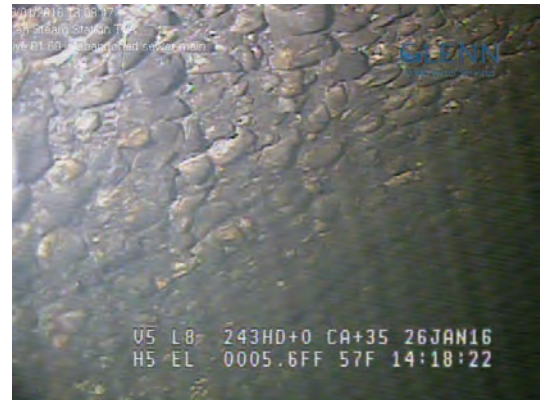
Uniform exposed aggregate with weak cement paste was identified throughout the pipeline, with the heaviest concentration being at the crown of the pipeline between the 10 o'clock to 2 o'clock positions. The ROV, while traveling along the crown of the pipeline, was able to easily dislodge aggregate and delaminated concrete. In fact, the ROV struggled because of the amount of dislodged aggregate that was trapped into the vehicle's thrusters and other components (See Figures 2 & 3). It appears that the material transferred in this pipe may have contributed to the concrete deterioration.

Figure 2 – 155' downstream from manhole No. 17. Example of exposed aggregate.

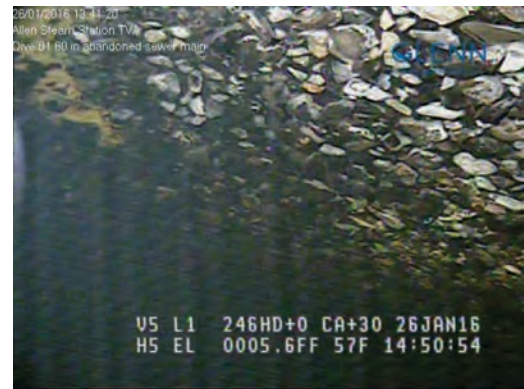
Silt layers on the pipe's surface did mask some of the concrete delamination but could be visually confirmed by the ROV hitting the concrete surface of the pipe. At Sta. 1+85' and 2+13' there were radial joints that exhibited a calcite leaching from the joint opening. This appears to be similar to what is found in autogenous (self) healing of concrete cracking (See Figure 4).

Figure 3 – 800' downstream from manhole No. 17. Example of exposed aggregate with loose cement paste.

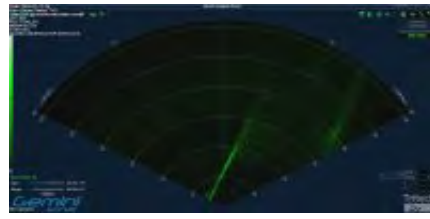
Time:	2016-01-26 13:13:07.4	Video Time:	00:07:43
Log Event:	Photo [C1,C2]: 185 ft from manway 17 note debris along wall on oppostie side		
Log Session:	185 ft from manway 17 note debris along wall on oppostie side_C1.jpg		
Structure:			
Sub-Structure:			
Anomaly ID:

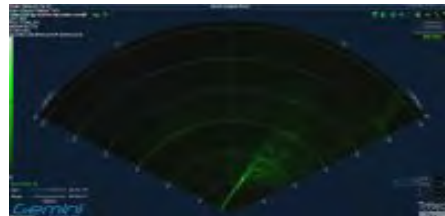
Time:	2016-01-26 13:14:57.8	Video Time:	00:09:34
Log Event:	Photo [C1,C2]: 213 ft from manway 17 view of joint with material		
Log Session:	213 ft from manway 17 view of joint with material_C1.jpg		
Structure:			
Sub-Structure:			
Anomaly ID:

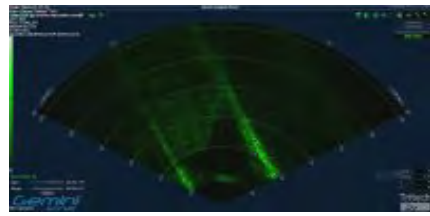
Time:	2016-01-26 13:22:03.2	Video Time:	00:16:39
Log Event:	Photo [C1,C2]: 295 ft from manway 17. Sand deposit at invert of pipe. below joint.		
Log Session:	295 ft from manway 17. Sand deposit at invert of pipe. below joint._C1.jpg		
Structure:			
Sub-Structure:			
Anomaly ID:

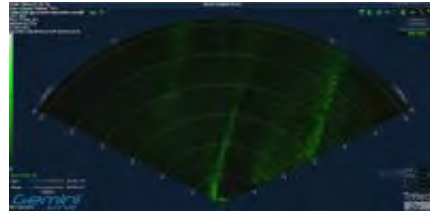
305 ft from manway 17 sand deposit ontop of silt.

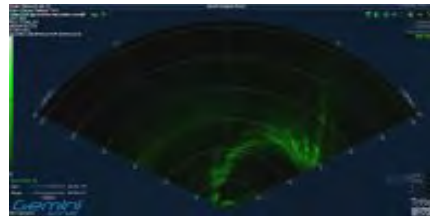
810 ft from manway 17 large amount of debris at invert of pipe

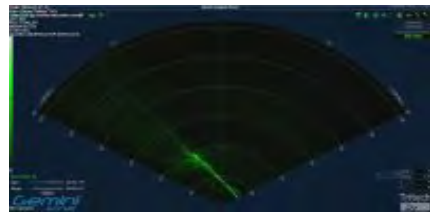
820 ft rov at second manhole view of ladder

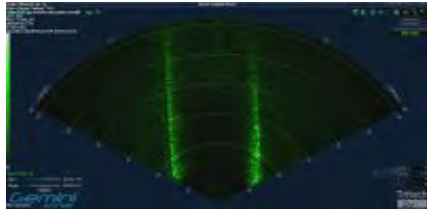
Time:	2016-01-26 13:54:15.4	Video Time:	00:18:51
Log Event:	Photo [C1,C2]: 825 ft from manway 17 debris hanging from crown of pipe		
Log Session:	825 ft from manway 17 debris hanging from crown of pipe_C1.jpg		
Structure:			
Sub-Structure:			
Anomaly ID:

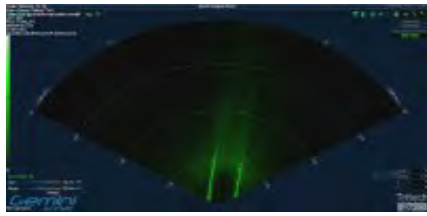
Time:	2016-01-26 14:25:30.7	Video Time:	00:20:07
Log Event:	Photo [C1,C2]: 1390 ft from manway 17 exposed aggregate at crown of pipe		
Log Session:	1390 ft from manway 17 exposed aggregate at crown of pipe_C1.jpg		
Structure:			
Sub-Structure:			
Anomaly ID:

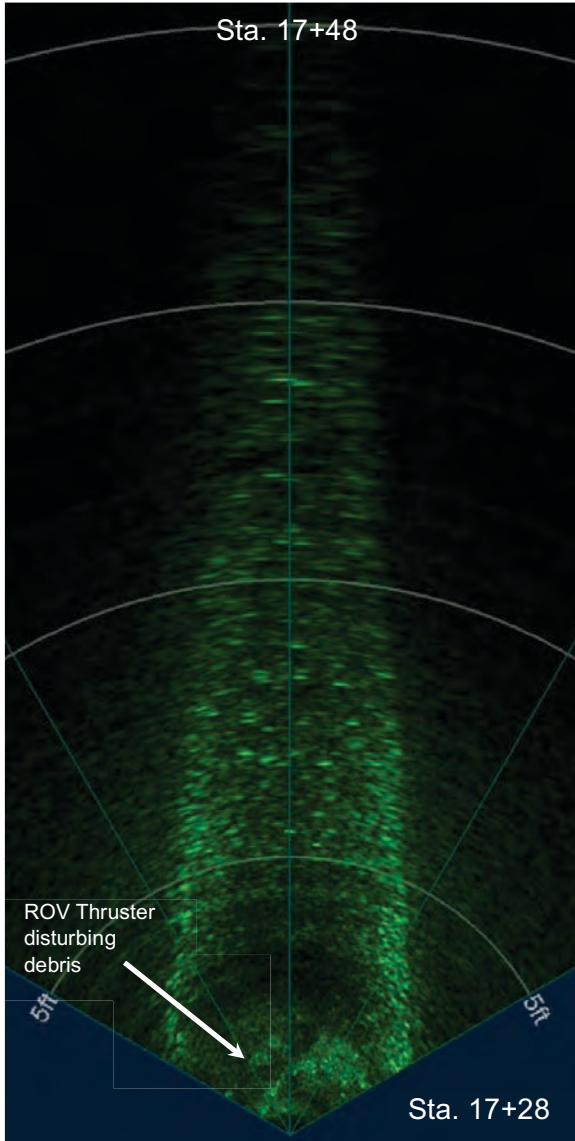
Image 1 - This sonar image shows the approximate location of the closure in the pipe from debris or other materials. It appears the blockage is at approximately Sta. 17+48'. The top of the ROV was positioned against the crown of the pipe and the sonar which is connect to the bottom of the ROV was in the debris. The vehicle could not move any further downstream in the pipeline.
