**RE: Initial Structural Stability Assessment
Active Ash Pond 2
EPA Final Coal Combustion Residuals (CCR) Rule
TVA Johnsonville Fossil Plant
New Johnsonville, Tennessee**

Initial Structural Stability Assessment

Johnsonville Fossil Plant – Active
Ash Pond 2
New Johnsonville, Tennessee

October 12, 2016
Revision 0

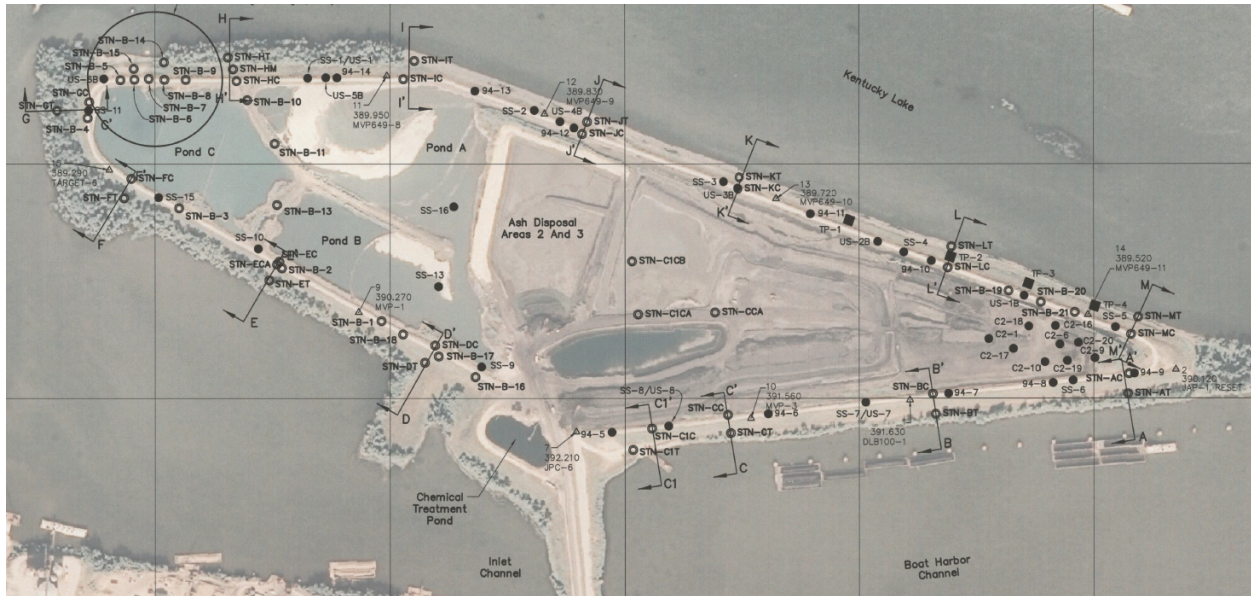
**Figure 2 JOF Active Ash Pond 2 – Plan View of Cross Sections
(Stantec, 2010a)**

From Stantec (2010a) and Stantec and URS (2014), the baseline condition produced the lowest factors of safety in sections C1-C1', J-J', K-K', and M-M'. However, Stantec and URS (2014) used straight-line approximations of the piezometric line instead of using seepage analyses. Stantec (2010a) compared the field piezometer measurements and calibrated seepage models to determine a reasonable prediction of the phreatic surface as opposed to a straight-line piezometric assumption. The seepage models were therefore incorporated into this analysis.

Preliminary slope stability analyses were performed on existing conditions for sections C1'-C1', J-J', K-K', and M-M'. The current geometry was used for the four sections, including the sediment accumulation shown in topographic information (Tuck Mapping Solutions, 2015) at the toes of sections J-J', K-K', and M-M'. A seepage analysis was performed to determine the pore water pressures for the steady state, long-term normal pool elevations for Active Ash Pond 2 and Kentucky Lake discussed in Section 8.1.2.3. These analyses indicate that section K-K' is the critical cross section.

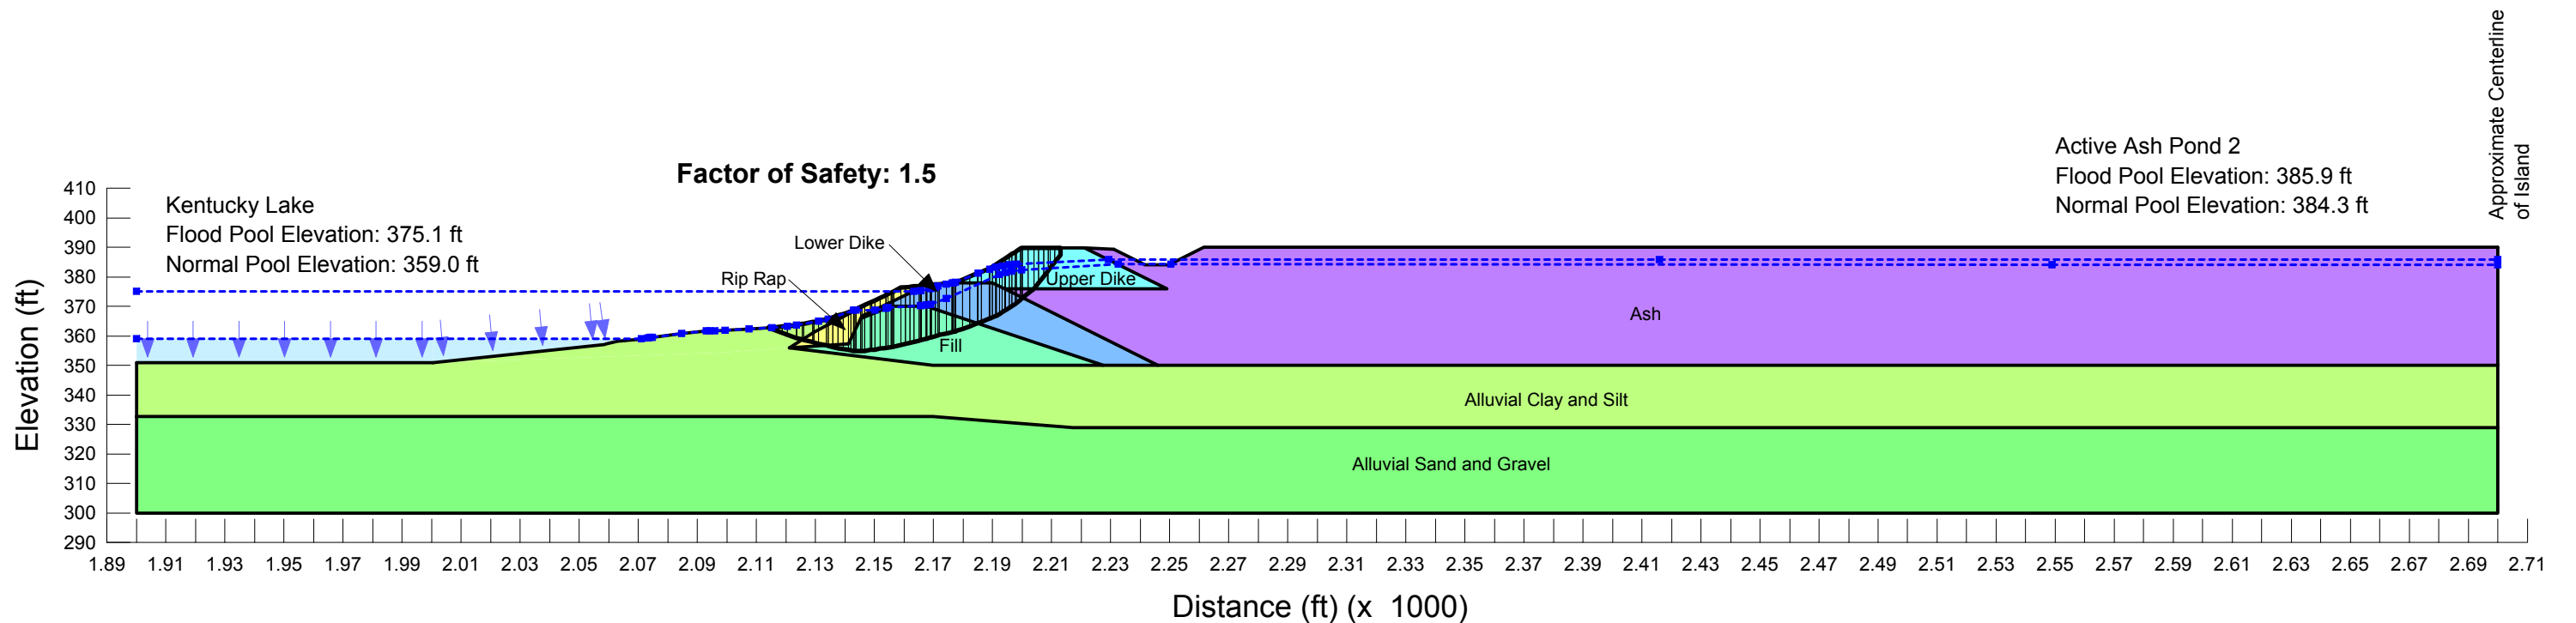
Tennessee Valley Authority
Johnsonville Fossil Plant - Active Ash Pond 2
New Johnsonville, Tennessee
Section K-K'

Plant	Facility	Critical Cross Section	EPA Criteria	Recommended Factor of Safety Criteria	Calculated Factor of Safety
JOF	Active Ash Pond 2	K-K'	Sudden Drawdown	1.1	1.5
