**RE: Periodic Structural Stability Assessment
 Stilling Pond
 EPA CCR Rule
 TVA Kingston Fossil Plant
 Kingston, Tennessee**

**RE: Initial Structural Stability Assessment
Stilling Pond
EPA Final Coal Combustion Residuals (CCR) Rule
TVA Kingston Fossil Plant
Roane County, Tennessee**

Initial Structural Stability Assessment

Kingston Fossil Plant – Stilling Pond
Roane County, Tennessee

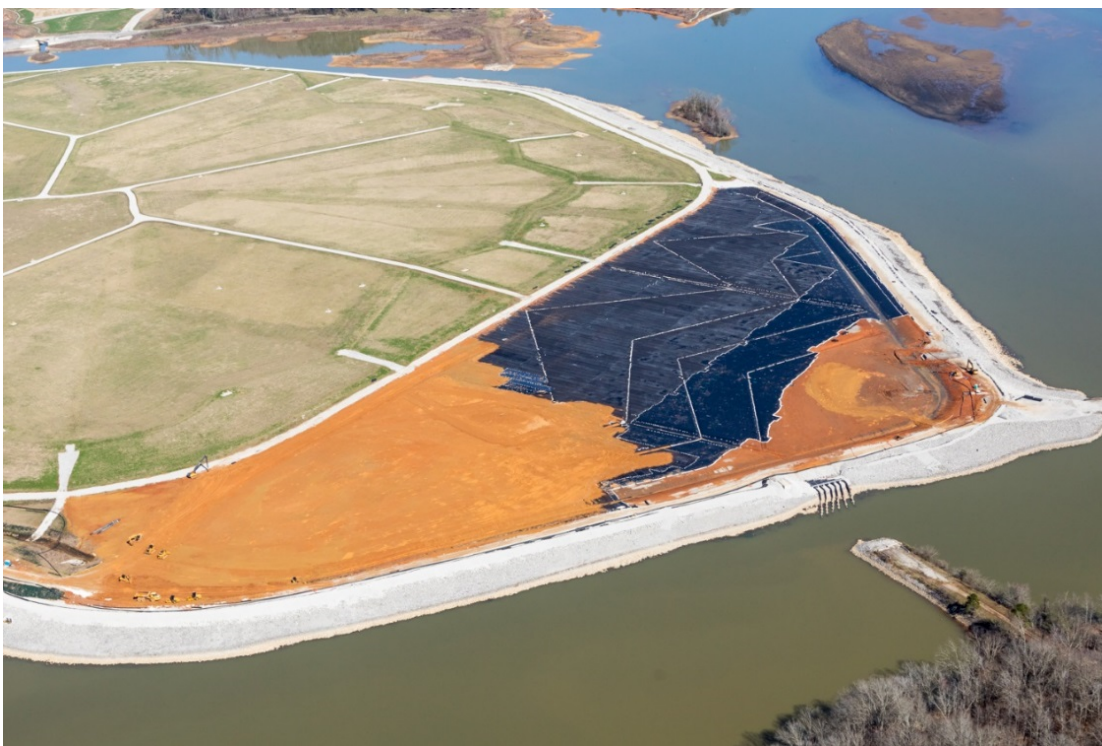
Figure 1 Aerial Photograph of KIF Stilling Pond Closure (February 27, 2018)

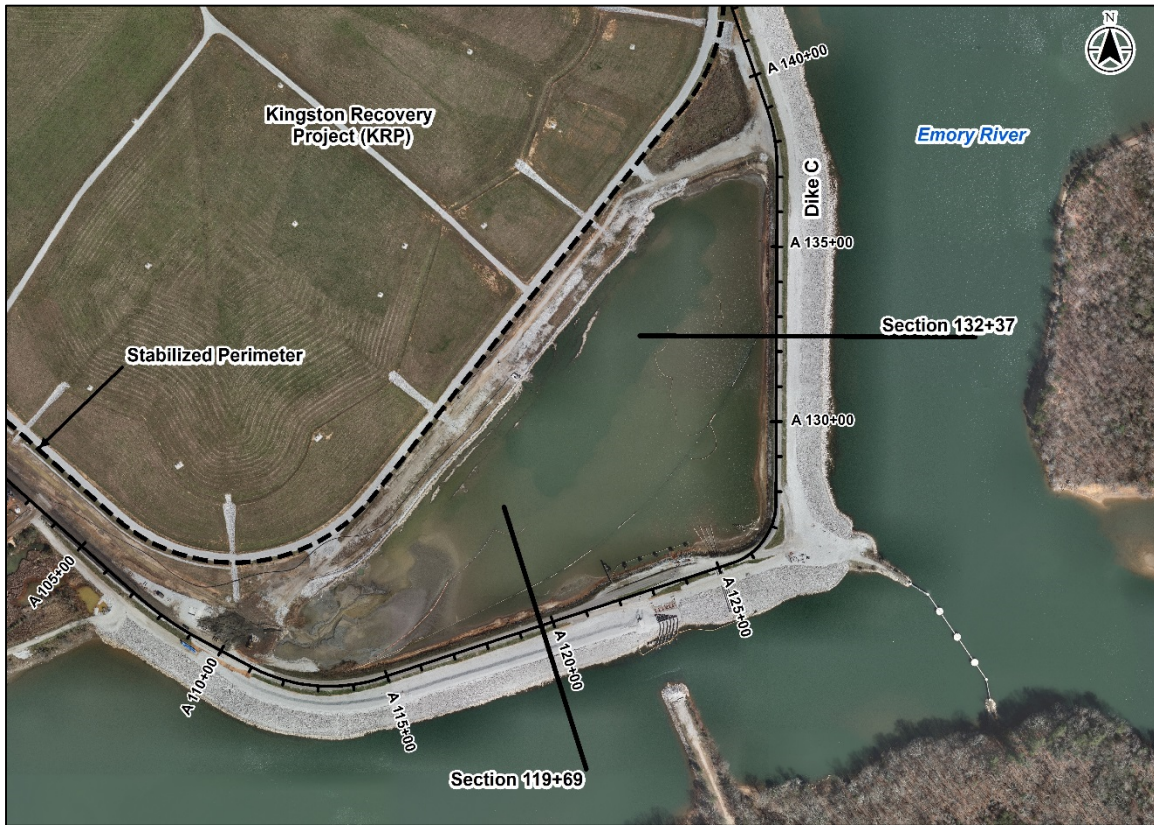
Slope stability analyses for the closed system geometry were developed as a part of the calculation package for Closure (Stantec, 2017d). Two cross-sections along the Stilling Pond perimeter alignment (Figure 3), Stations 119+69 and 132+37, were used as the critical profile geometries for modeling conditions of Dike C.

Figure 3 Aerial Photograph of KIF Stilling Pond Prior to Closure
