October 12, 2021
File: rpt_043_let_175568465
Revision 0

**RE: Periodic Structural Stability Assessment
Peabody Ash Pond
EPA CCR Rule
TVA Paradise Fossil Plant
Drakesboro, Kentucky**

**TENNESSEE VALLEY AUTHORITY - PEABODY ASH POND
TVA PARADISE FOSSIL PLANT
DRAKESBORO, KENTUCKY**

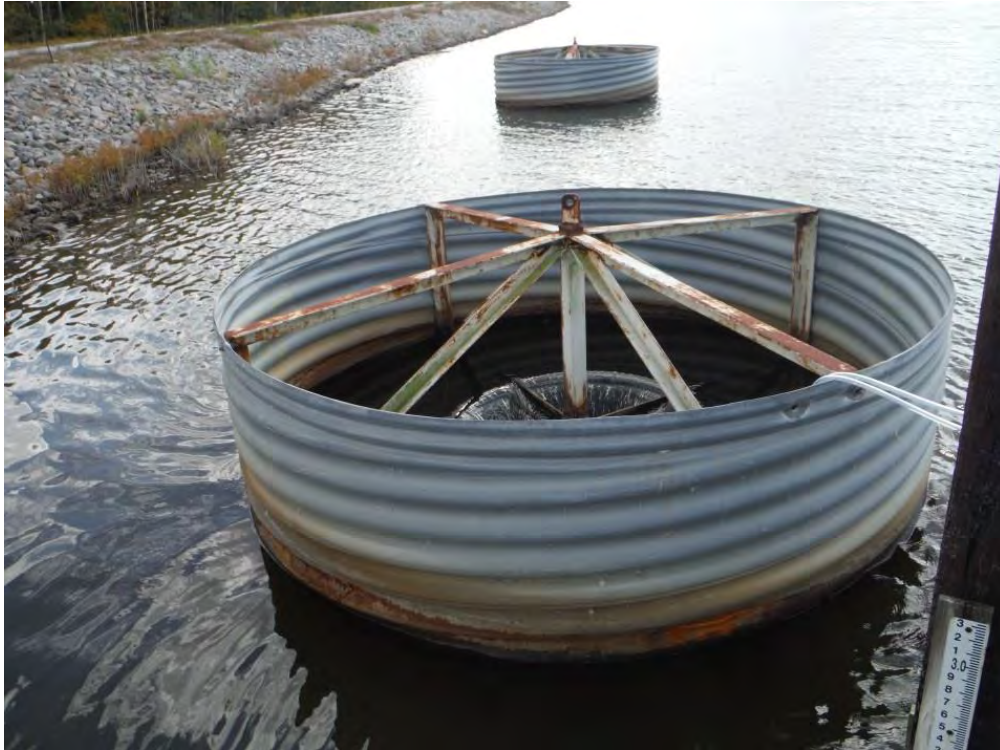
Photo 11 – Spillway skimmer, middle and south

On October 8th 2015, AECOM conducted a site inspection to evaluate the condition of the three risers at Peabody Stilling Pond and the outlet of the concrete pipes at Jacob's Creek. Conditions for all three spillways were in similar condition. The skimmer devices are open at the top, and they exhibit minor surface rust on the corrugated metal pipe and associated steel bracings. The visible portions of the outer concrete risers are in good condition. Cracking, deterioration or spalling was not detected. There are no apparent deteriorations or obstructions to water flow from the top of the riser. The water level was measured in at roughly 3" above the top of the riser #2 (nearest to walkway). In-depth inspection was restricted due to the present water level and the risers' distance to the edge of the pond. Using a probing rod, the corrugated metal pipe skimmer was checked for deterioration at the base. None was detected. See **Photos 11 & 12** for typical condition of the risers.

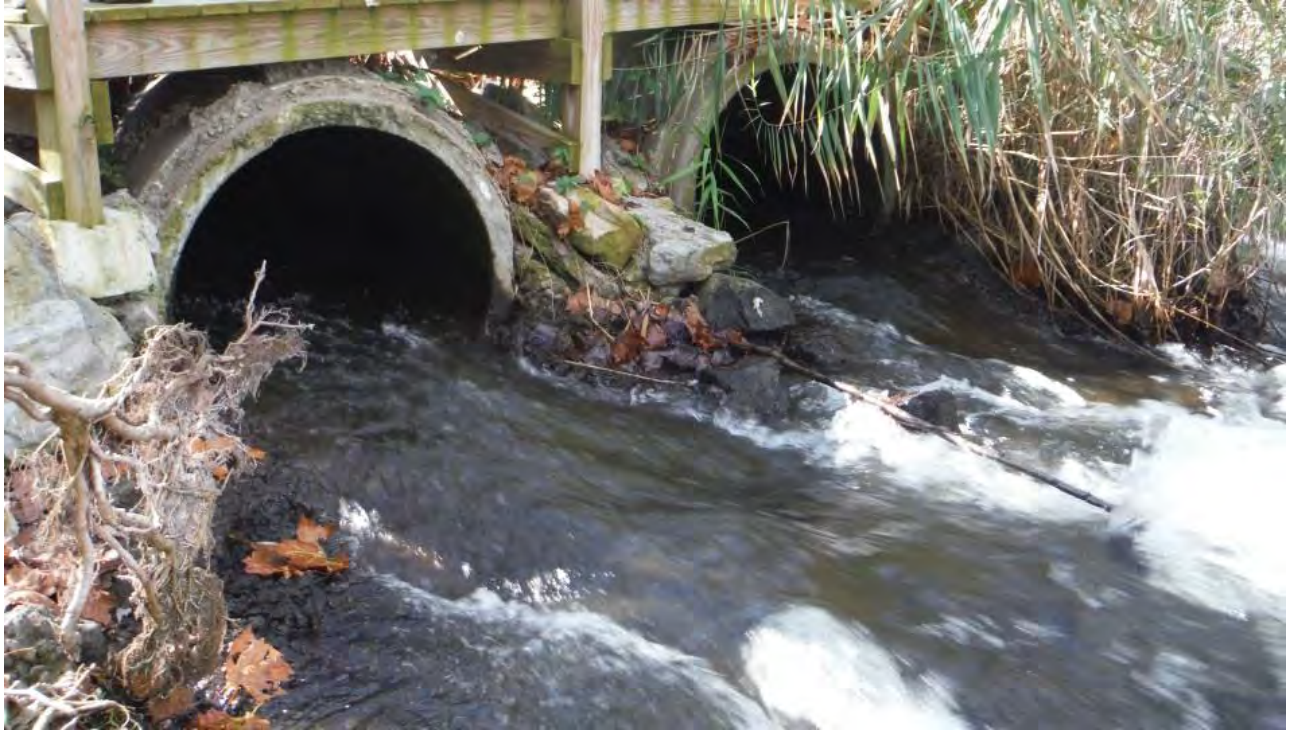
Photo 13 – 36” Pipe spillway outlets (east)

The spillway outlet concrete pipes are in good condition with minor spalls at the outer circumference. The access panels to the 36" pipes reveal exposed rebar from the cut-out, however the surrounding concrete is still in good condition. The water level is low inside the pipes and flow is steady without any obstructions. See **Photos 13, 15, and 16** for the typical condition of the 36" concrete pipes.

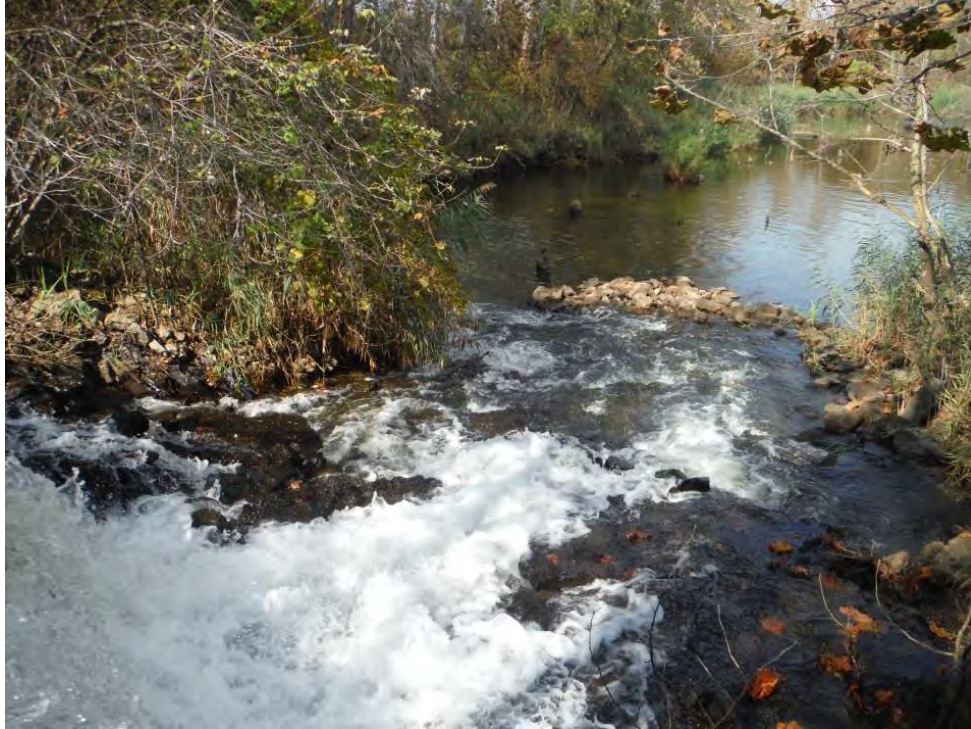
Photo 14 – Outlet flow into Jacob’s Creek

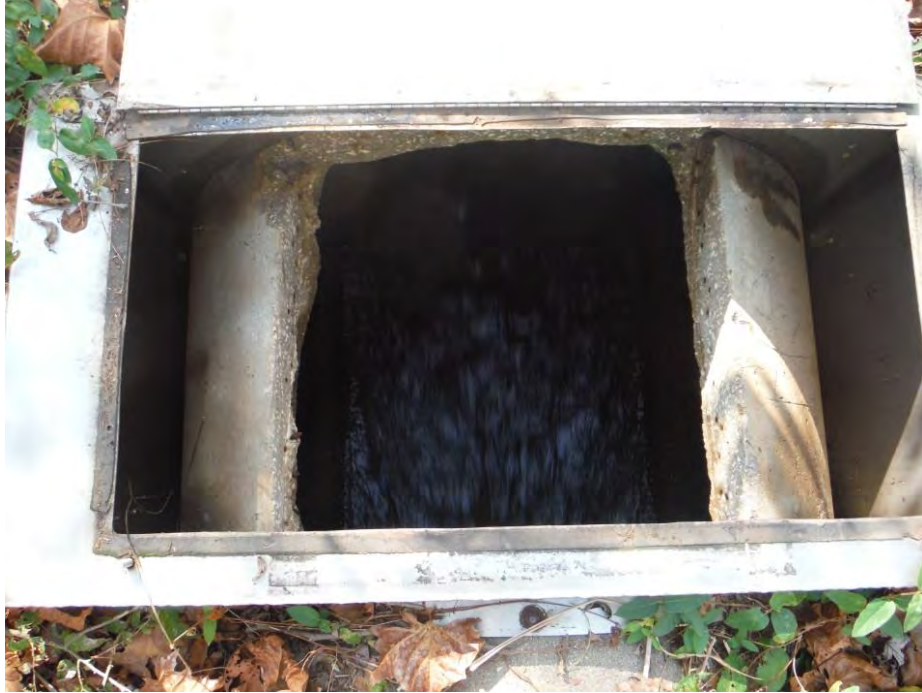
Photo 15 – Access location near outlet end of 36” concrete pipes (Typ.)

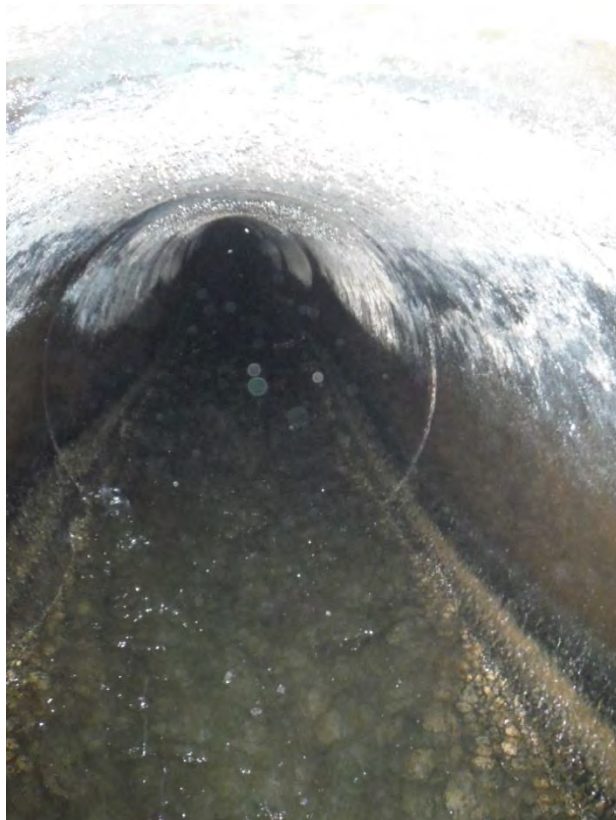
Evaluation of historical video inspection recordings performed in 2014 showed a clear pathway for the water flow without any obstruction or debris present inside the spillways. The interior of the pipes are in acceptable condition. **Photo 16** was from the available videos and represents the conditions described above.

Photo 16 – Flow inside 36” concrete pipe (Typ.)
