**Initial Structural Stability Assessment  
Peabody Ash Pond  
EPA Final CCR Rule  
TVA Paradise Fossil Plant  
Drakesboro, Kentucky**

**TENNESSEE VALLEY AUTHORITY - PEABODY ASH POND  
TVA PARADISE FOSSIL PLANT  
DRAKESBORO, KENTUCKY**

**INITIAL STRUCTURAL STABILITY ASSESSMENT  
(40 CFR §257.73(d)(1))  
FOR COAL COMBUSTION RESIDUALS (CCR)  
EXISTING SURFACE IMPOUNDMENT**

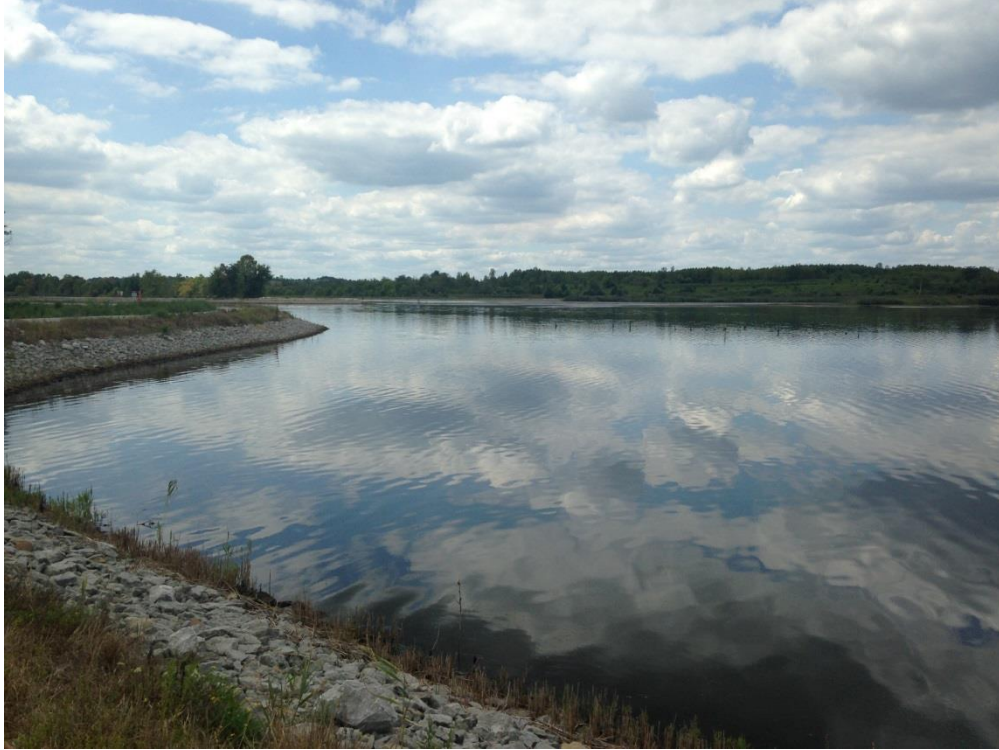
**Photo 1 – Southeast dike condition**

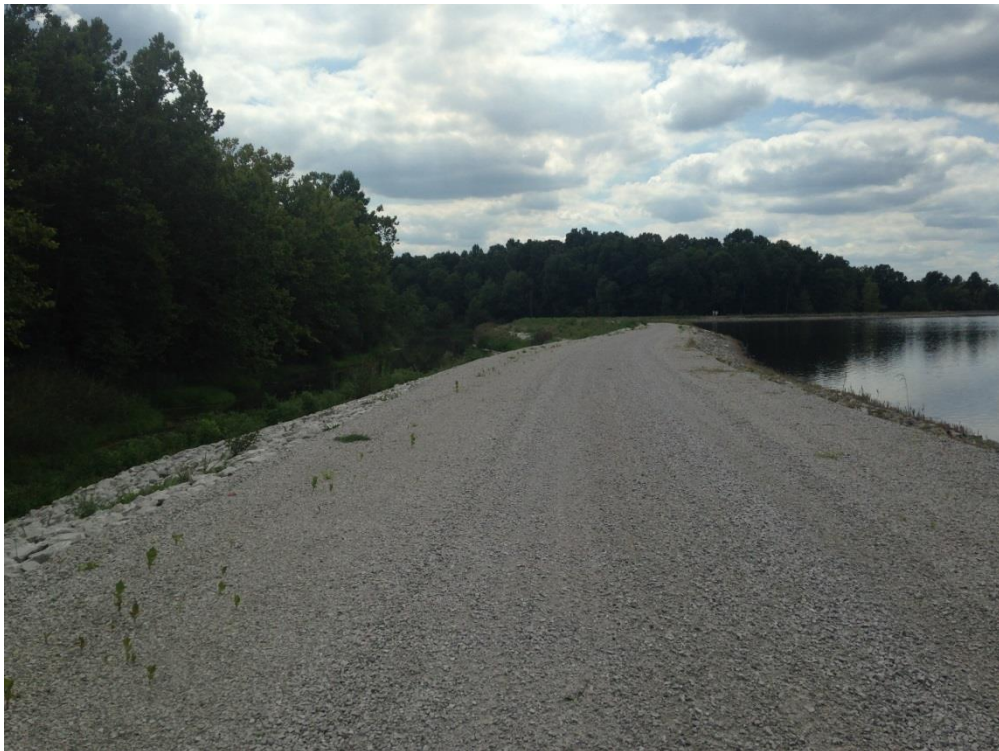
**Photo 2 – Southeast dike condition**

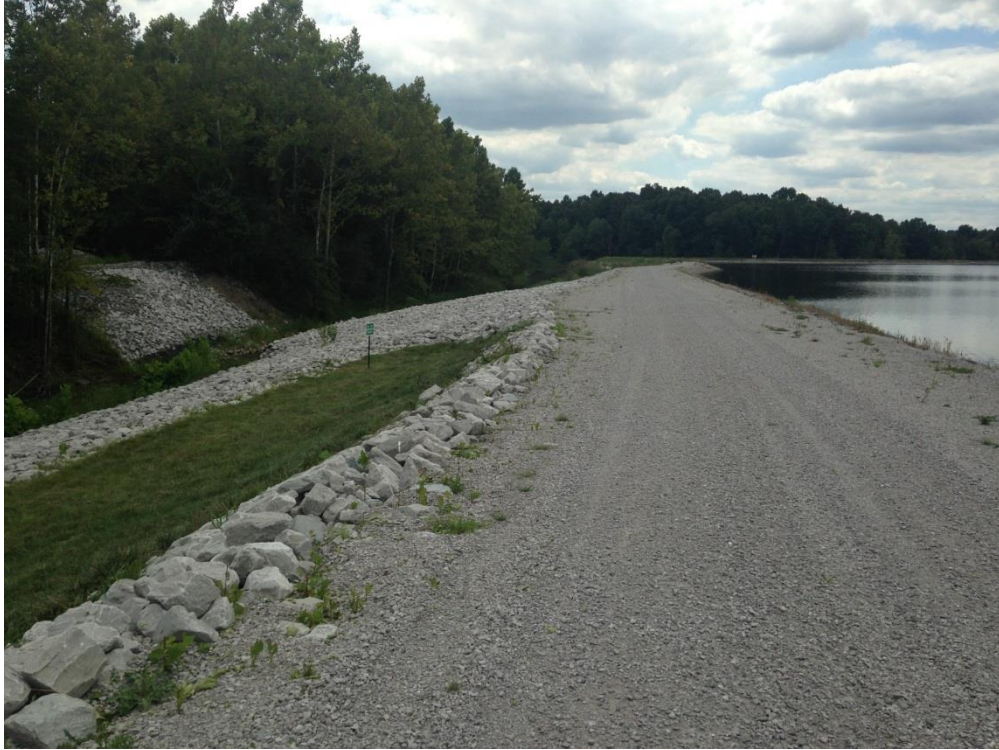
**Photo 3 – East dike condition**

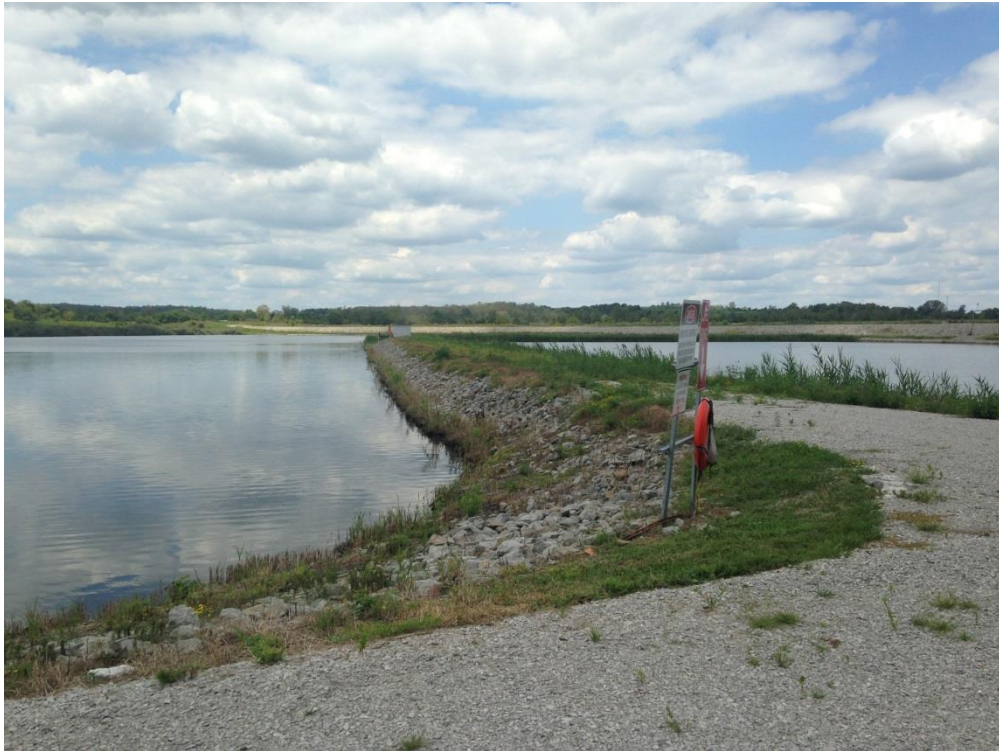
**Photo 4 – Stilling Pond dike condition**

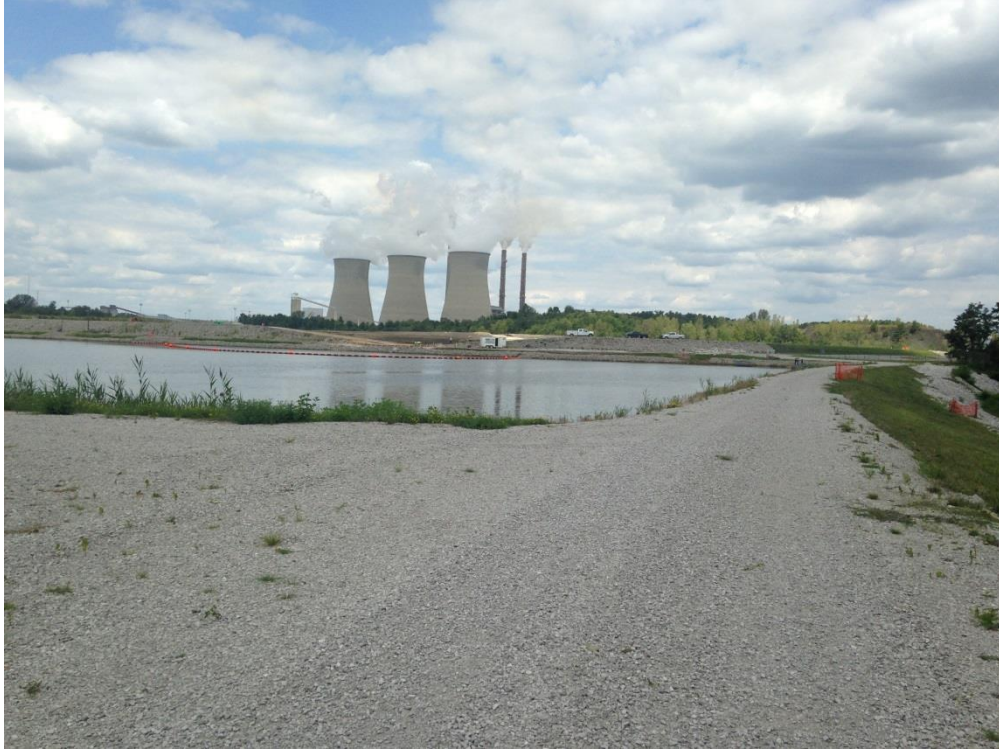
**Photo 5 – East dike condition**

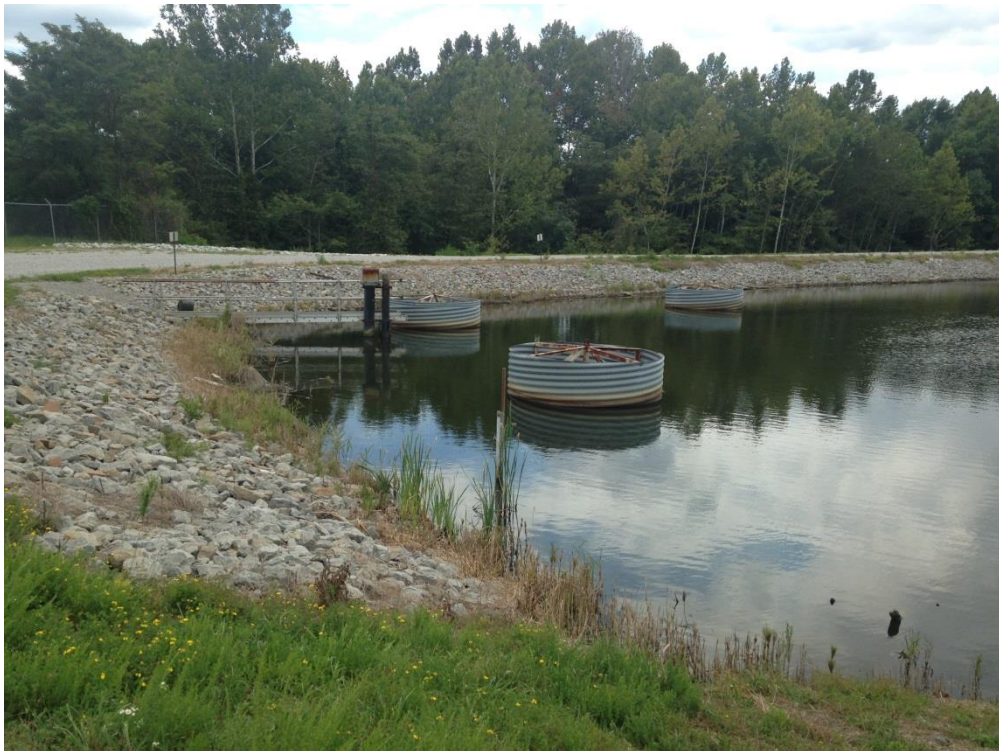
**Photo 6 – Northeast dike condition**

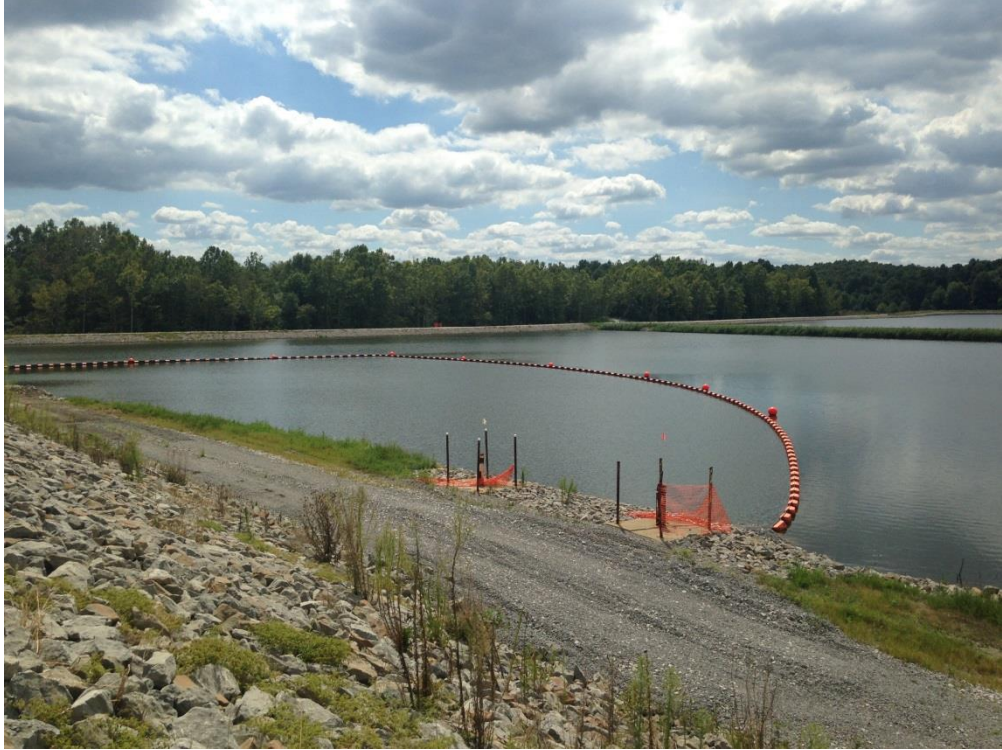
**Photo 7 – North dike condition**

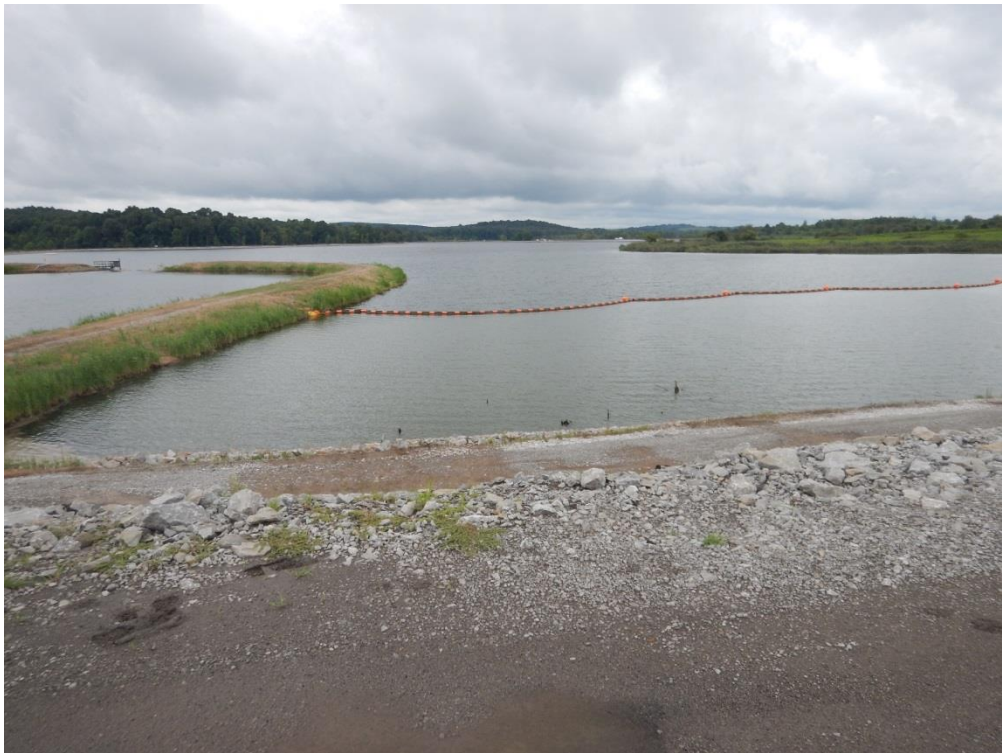
**Photo 8 – North dike condition**

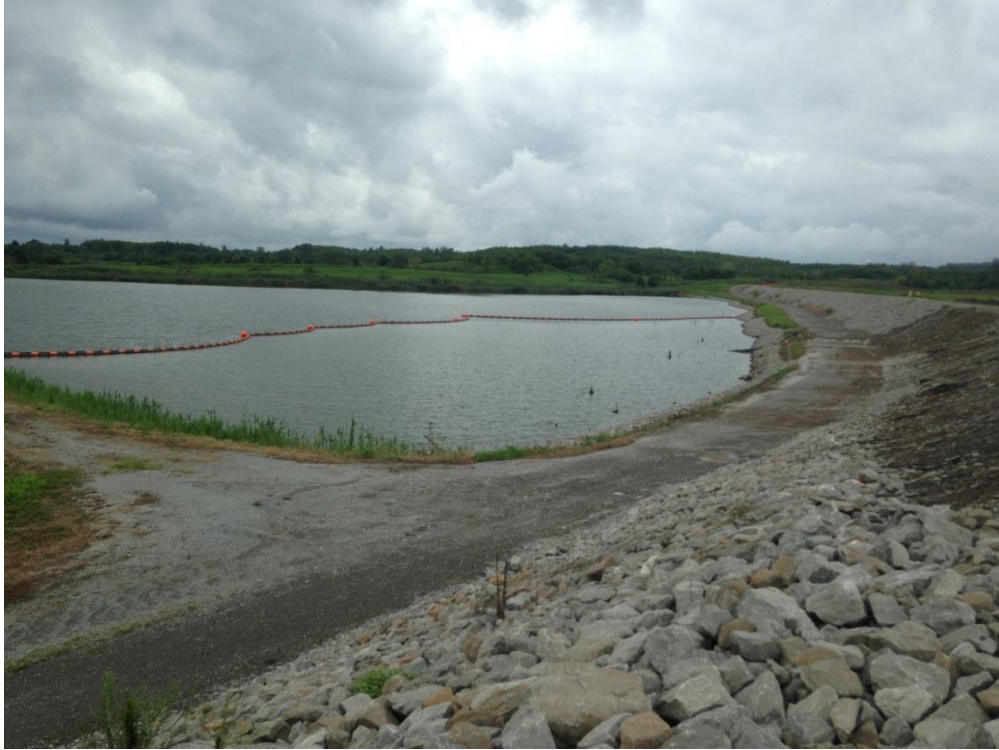
**Photo 9 – North dike condition**

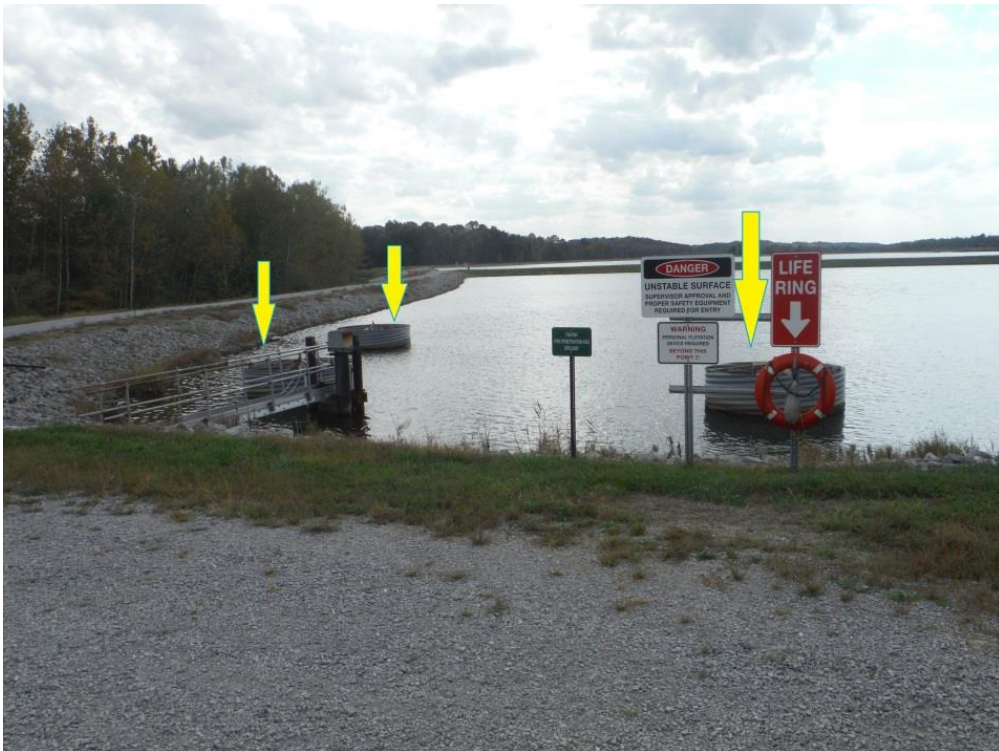
**Photo 10 – General view of risers**

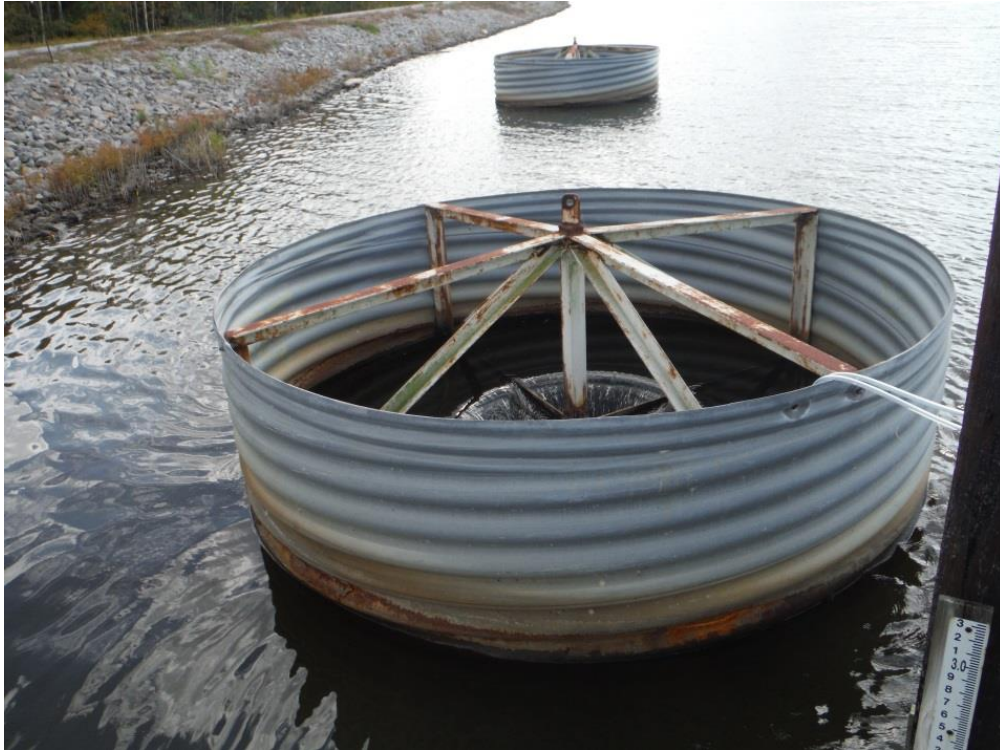
On October 8th 2015, AECOM conducted a site inspection to evaluate the condition of the three risers at Peabody Stilling Pond and the outlet of the concrete pipes at Jacob's Creek. Conditions for all three spillways were in similar condition. The skimmer devices are open at the top, and they exhibit minor surface rust on the corrugated metal pipe and associated steel bracings. The visible portions of the outer concrete risers are in good condition. Cracking, deterioration or spalling was not detected. There are no apparent deteriorations or obstructions to water flow from the top of the riser. The water level was measured in at roughly 3" above the top of the riser #2 (nearest to walkway). In-depth inspection was restricted due to the present water level and the risers' distance to the edge of the pond. Using a probing rod, the corrugated metal pipe skimmer was checked for deterioration at the base. None was detected. See **Photos 11 & 12** for typical condition of the risers.

**Photo 11 – Spillway skimmer, middle and south**

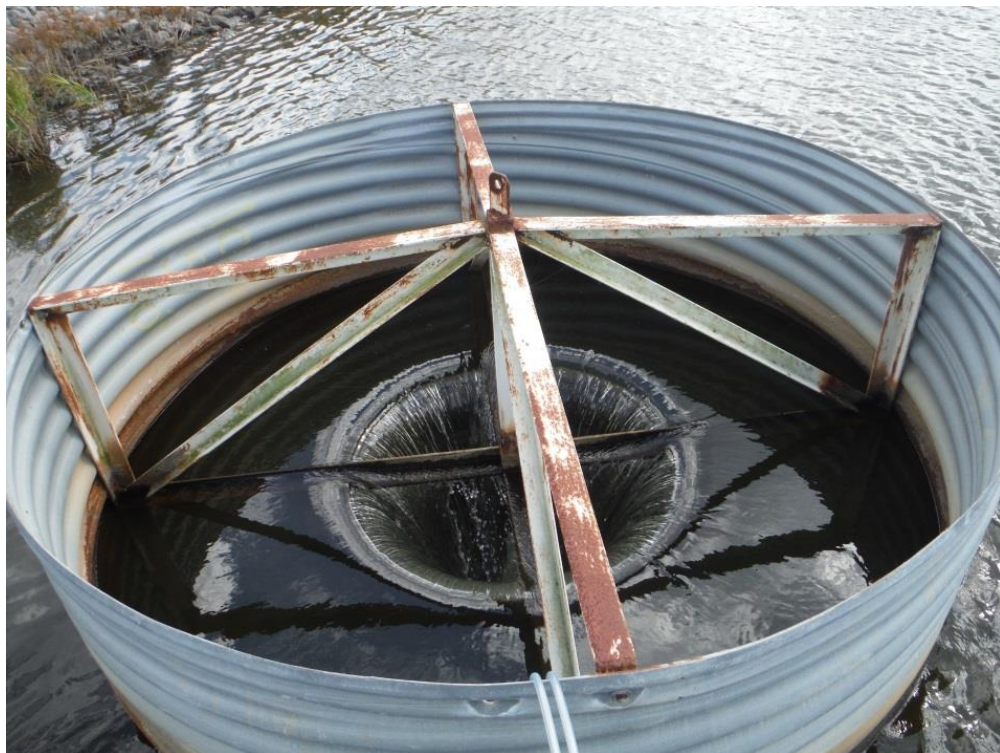
**Photo 12 – Spillway skimmer, middle (Typ.)**

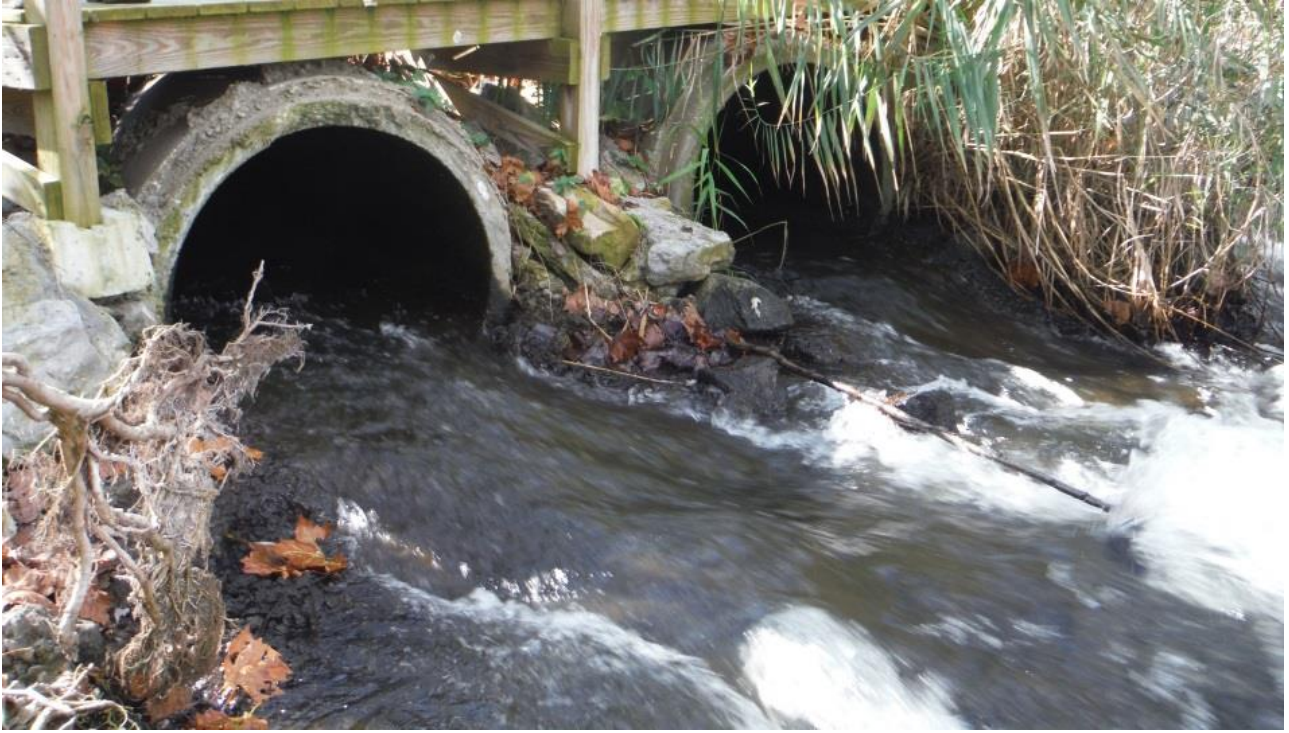
The spillway outlet concrete pipes are in good condition with minor spalls at the outer circumference. The access panels to the 36" pipes reveal exposed rebar from the cut-out, however the surrounding concrete is still in good condition. The water level is low inside the pipes and flow is steady without any obstructions. See **Photos 13, 15, and 16** for the typical condition of the 36" concrete pipes.

**Photo 13 – 36” Pipe spillway outlets (east)**

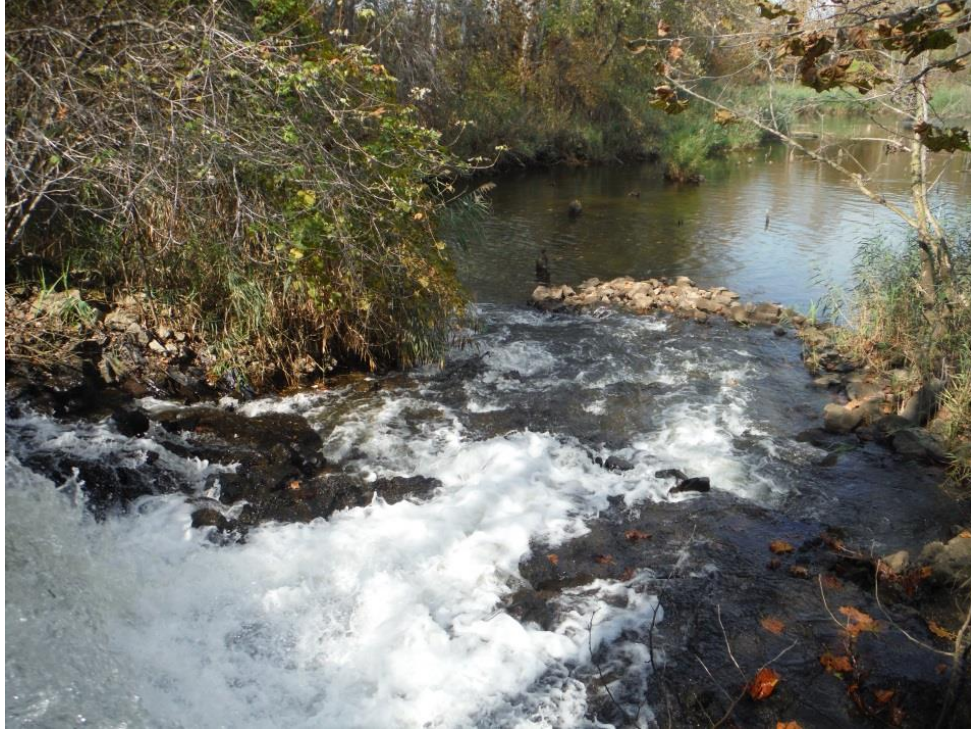
**Photo 14 – Outlet flow into Jacob’s Creek**

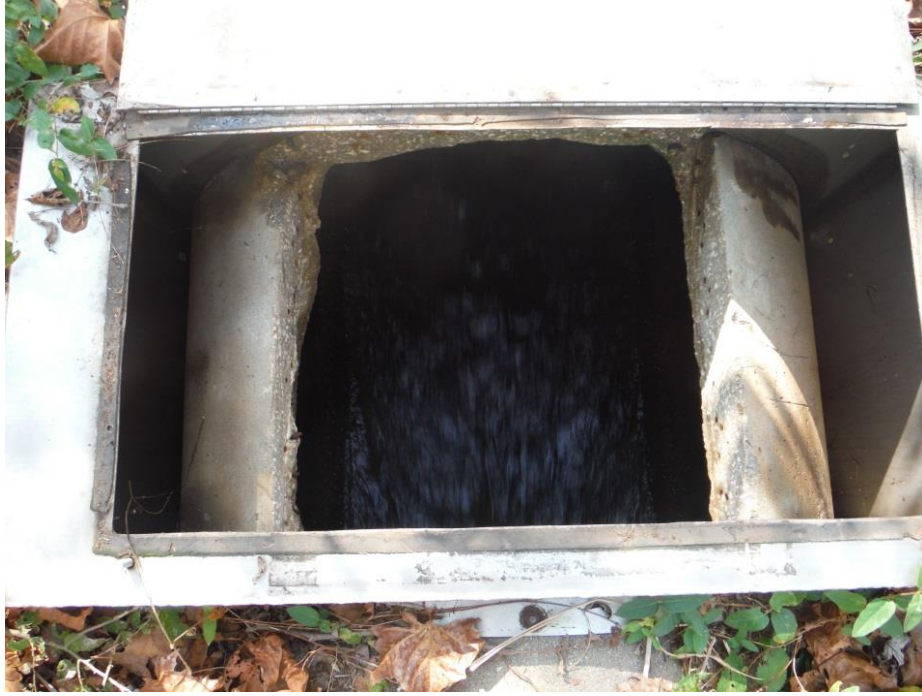
**Photo 15 – Access location near outlet end of 36” concrete pipes (Typ.)**

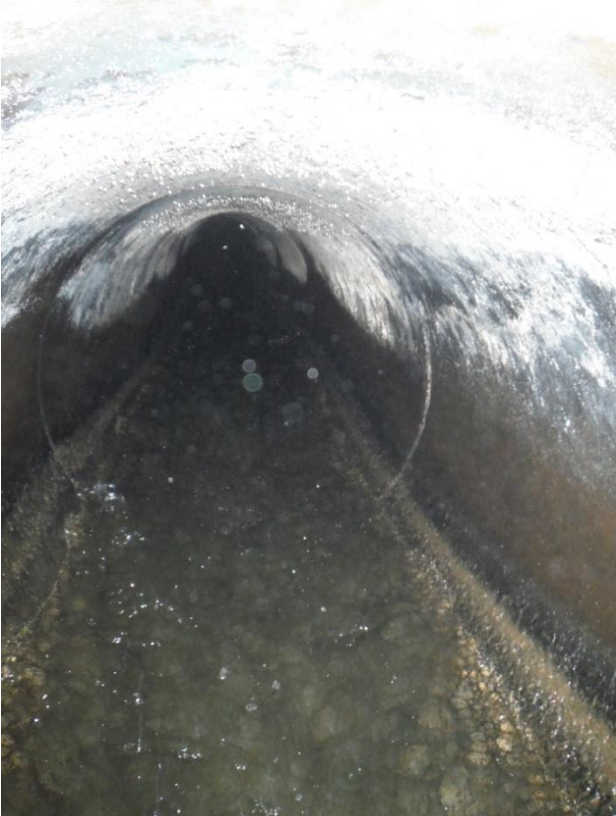
Evaluation of historical video inspection recordings performed in 2014 showed a clear pathway for the water flow without any obstruction or debris present inside the spillways. The interior of the pipes are in acceptable condition. **Photo 16** was from the available videos and represents the conditions described above.

**Photo 16 – Flow inside 36” concrete pipe (Typ.)**
