October 12, 2016

**Initial Structural Stability Assessment
Slag Ponds 2A and 2B, Slag Stilling Pond 2C
EPA Final CCR Rule
TVA Paradise Fossil Plant
Drakesboro, Kentucky**

**TENNESSEE VALLEY AUTHORITY – SLAG PONDS 2A AND 2B,
AND SLAG STILLING POND 2C
TVA PARADISE FOSSIL PLANT
DRAKESBORO, KENTUCKY**

**INITIAL STRUCTURAL STABILITY ASSESSMENT
(40 CFR §257.73 (d)(1))
FOR COAL COMBUSTION RESIDUALS (CCR)
EXISTING CCR SURFACE IMPOUNDMENTS**

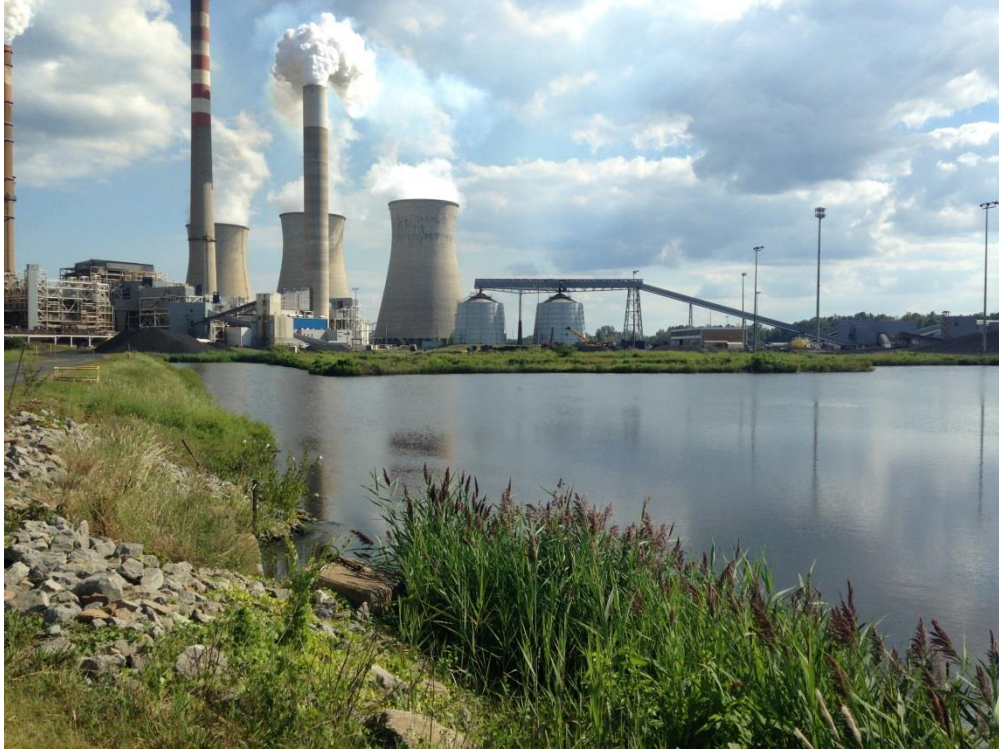
Photo 1 – Slag Pond 2A & 2B splitter dike condition, west side

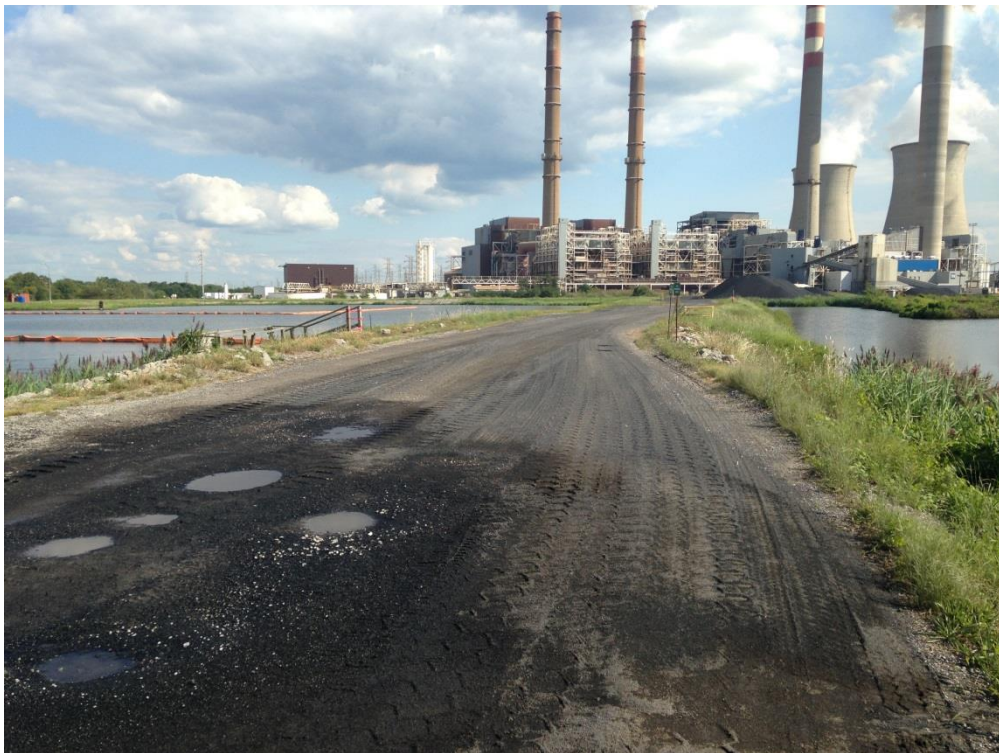
Photo 2 – Slag Pond 2A & 2B splitter dike condition, top

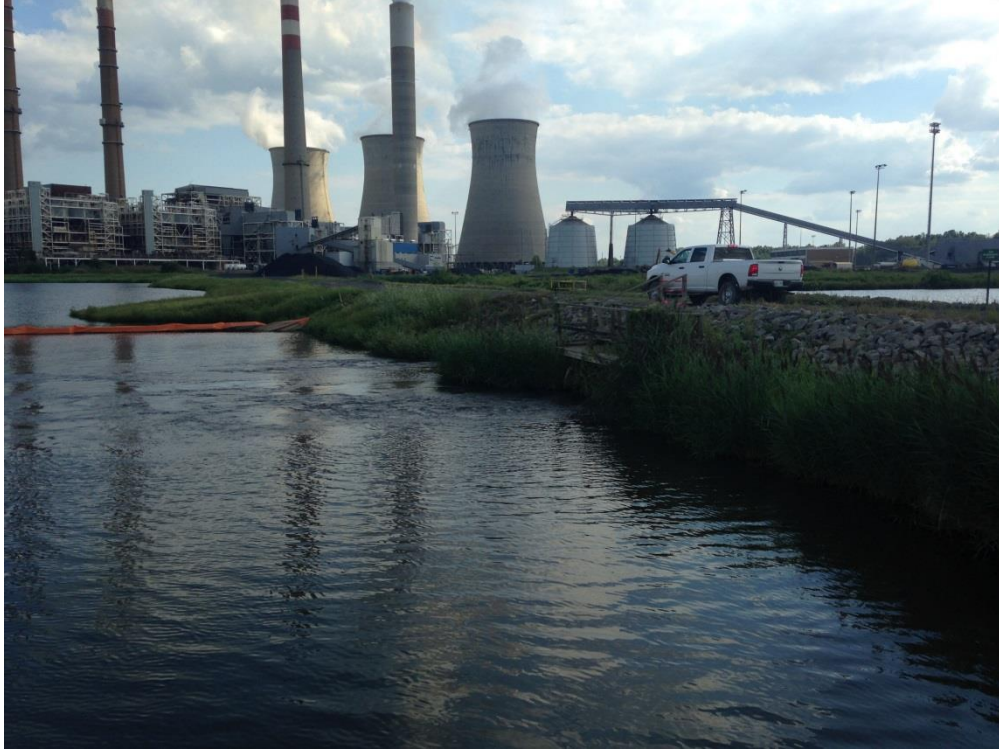
Photo 3 –Slag Pond 2A & 2B splitter dike condition, east side

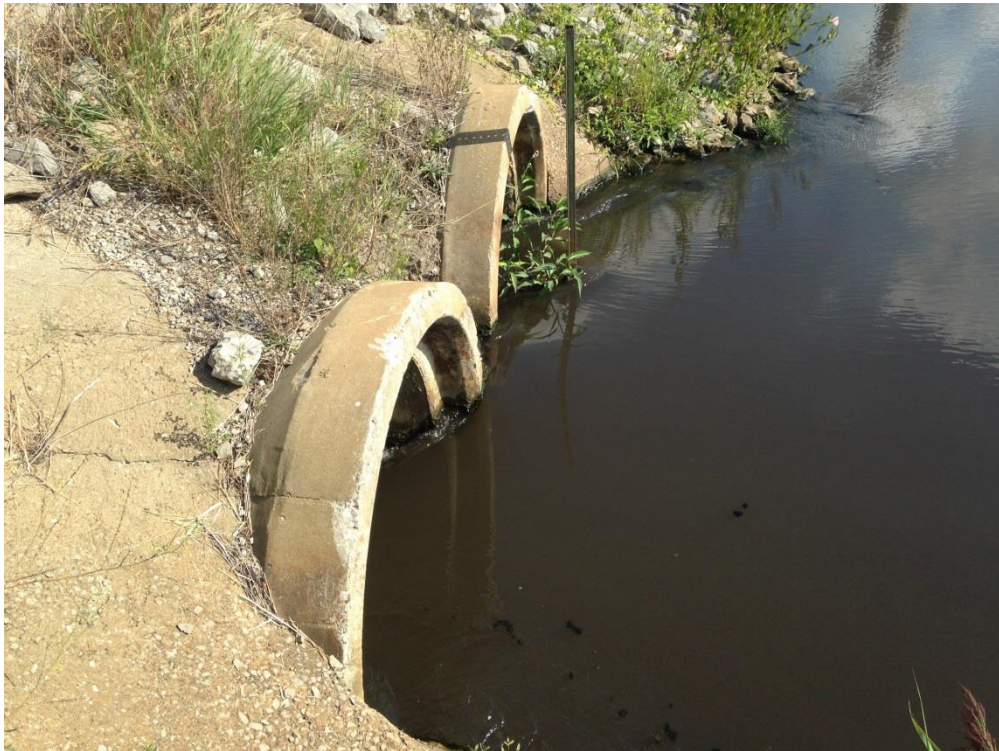
Photo 4 – Slag Pond 2A 48” spillway inlets

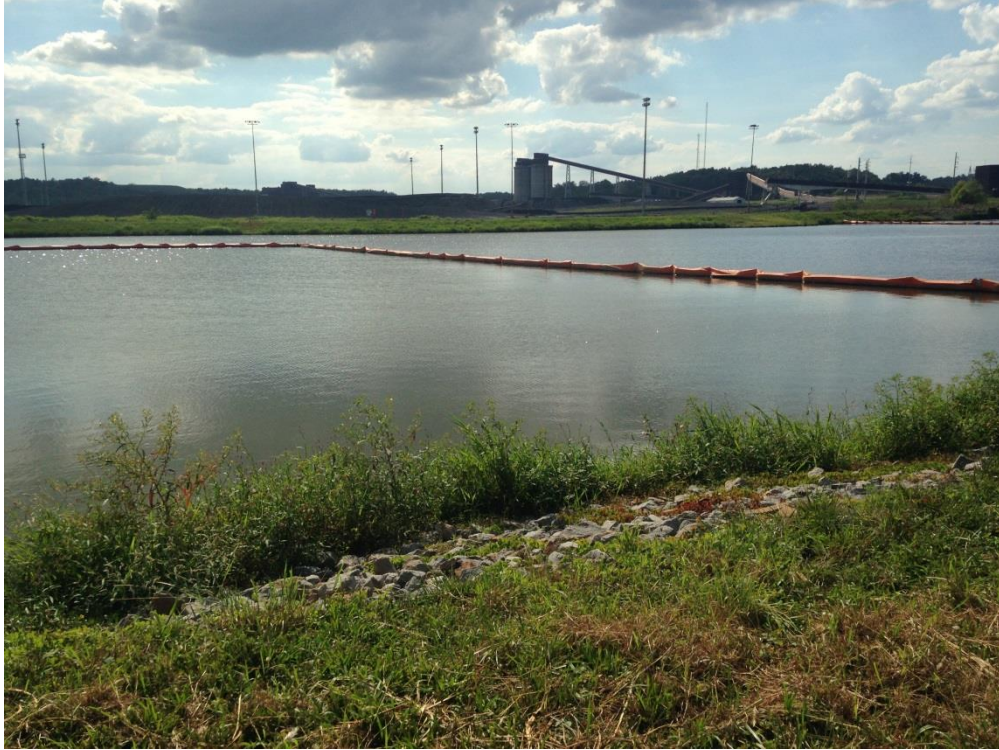
Photo 5 –Slag Pond 2B dike east dike condition

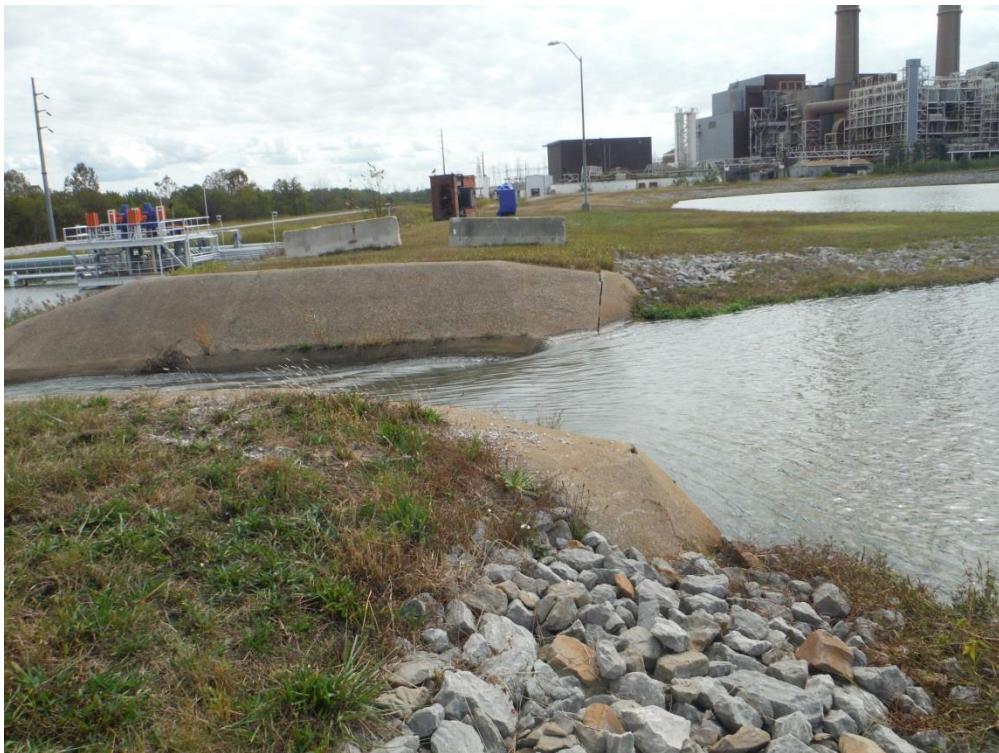
Photo 6 – Slag Pond 2B flume spillway inlet

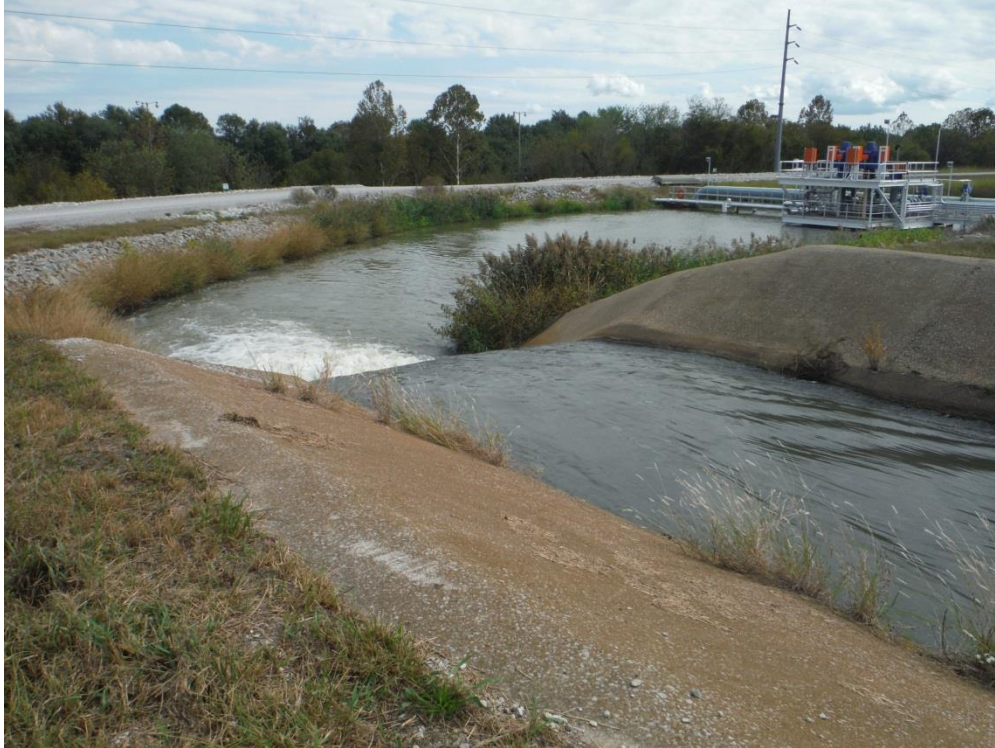
Photo 7 – Slag Pond 2B and Slag Stilling Pond 2C flume spillway

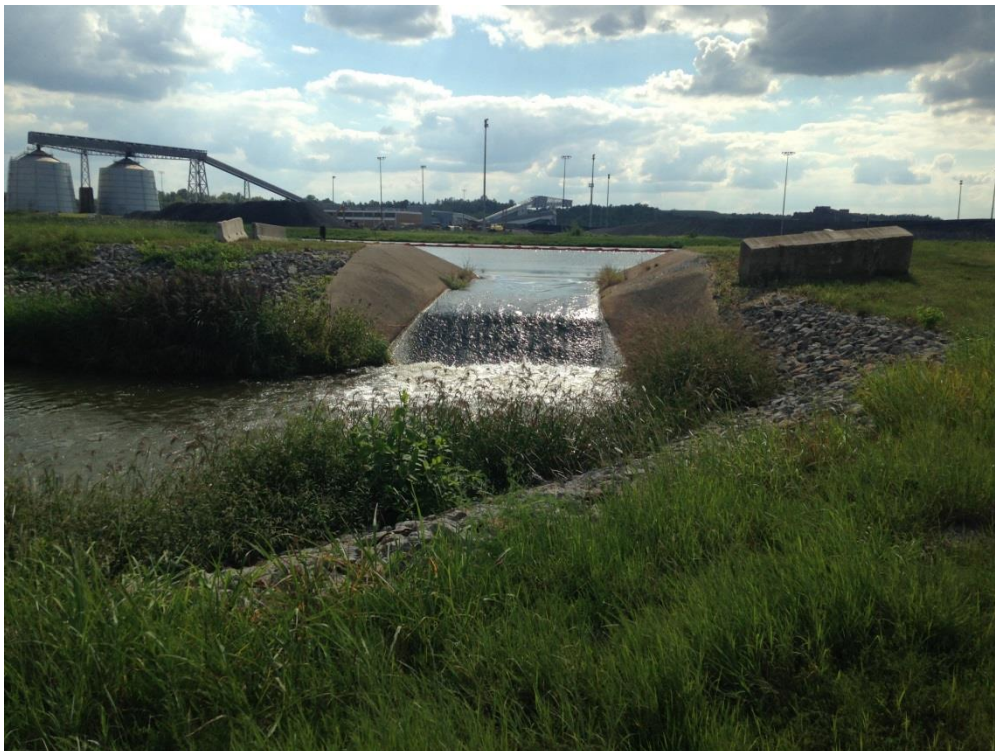
Photo 8 – Slag Stilling Pond 2C flume spillway outlet

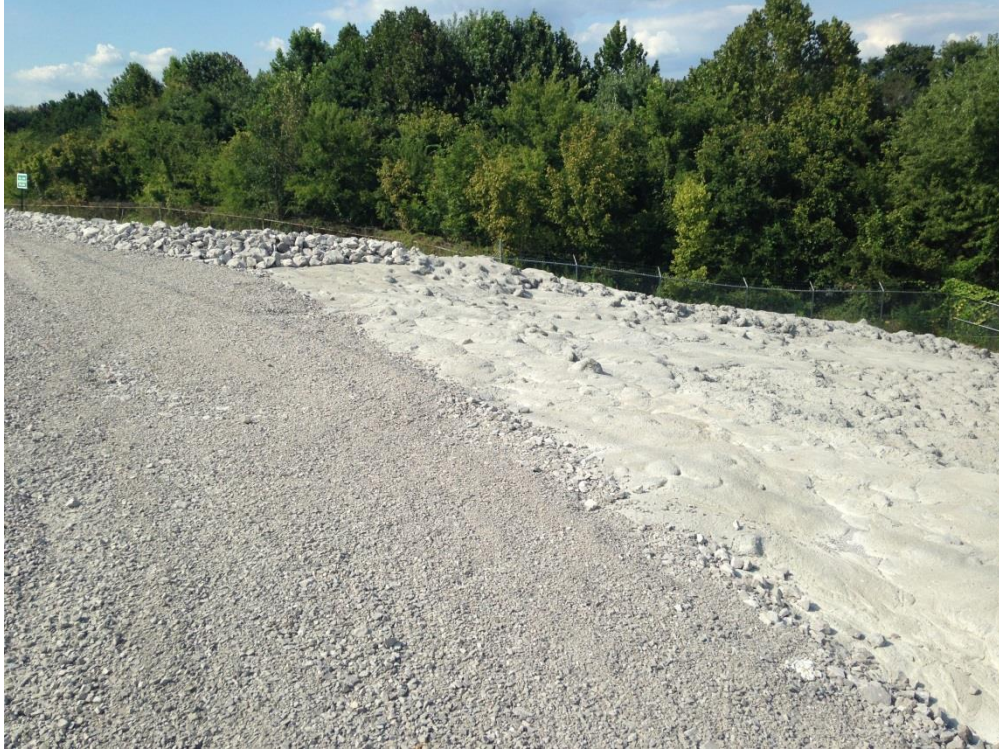
Photo 9 – Slag Stilling Pond 2C Emergency Spillway

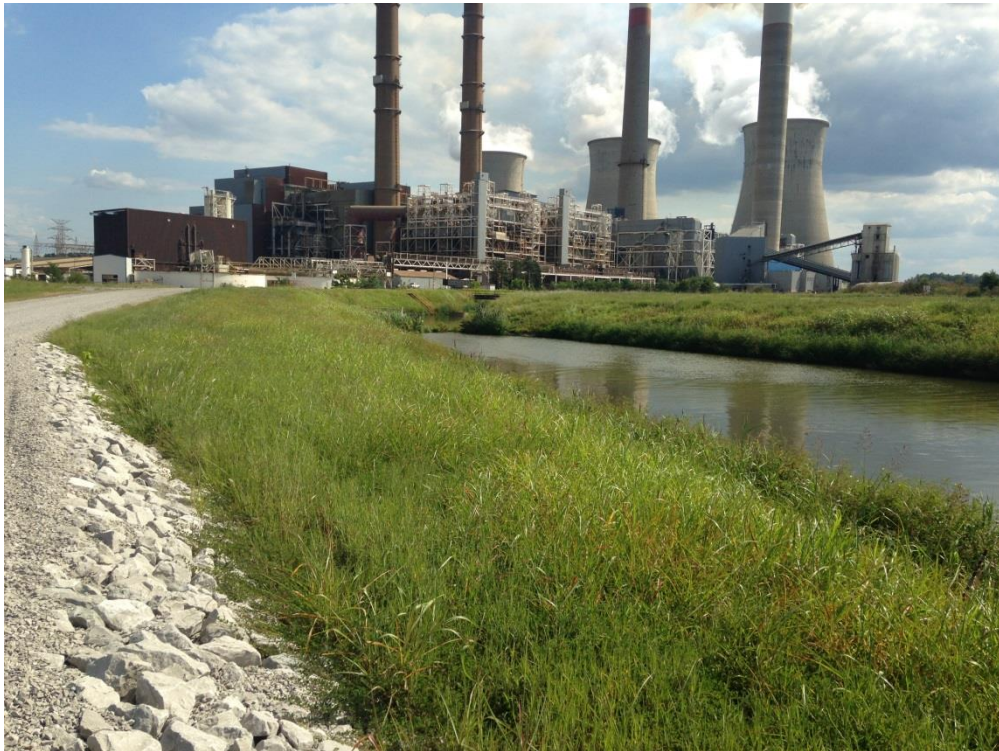
Photo 10 – Slag Stilling Pond 2C dike conditions

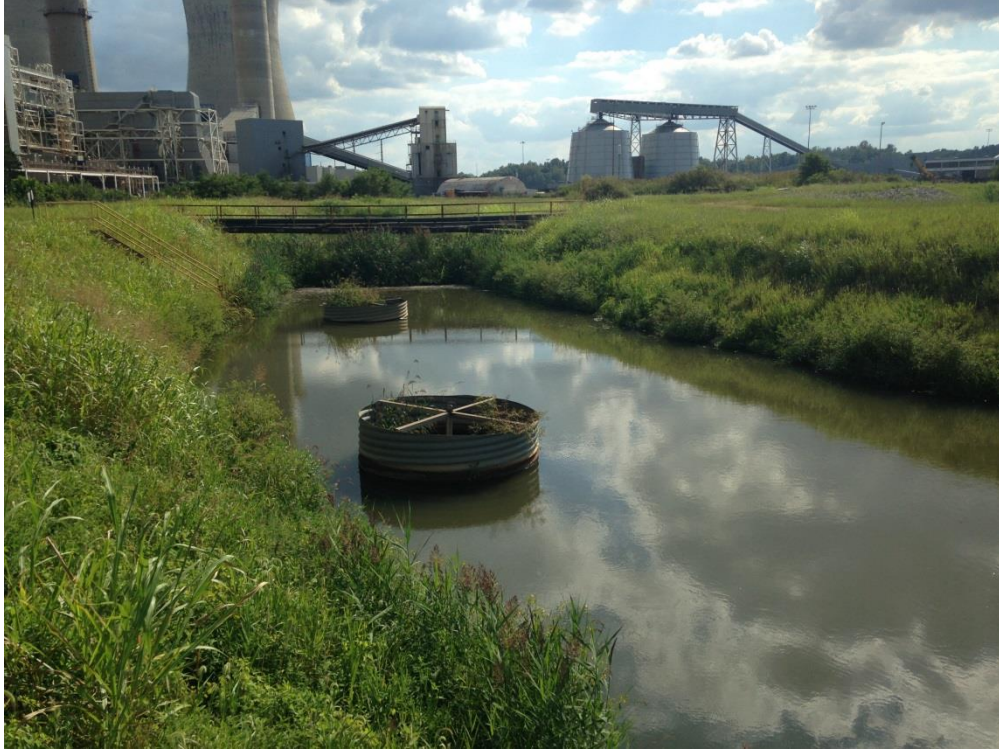
Photo 11 –Slag Stilling Pond 2C dike conditions

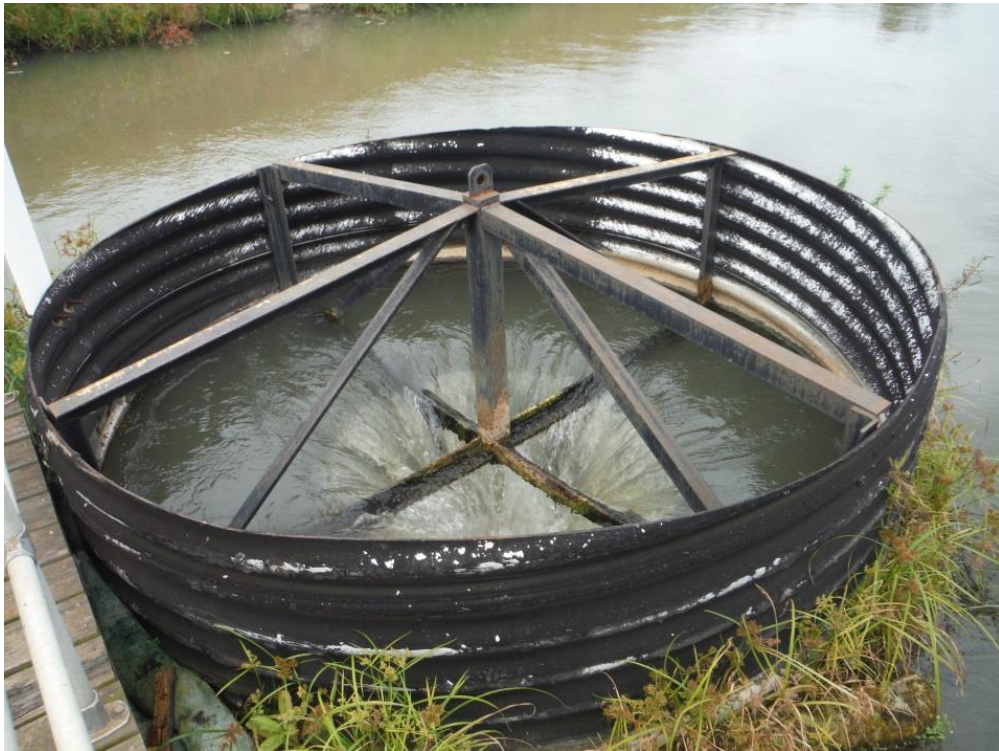
Photo 12 – Slag Stilling Pond 2C spillway skimmer, north

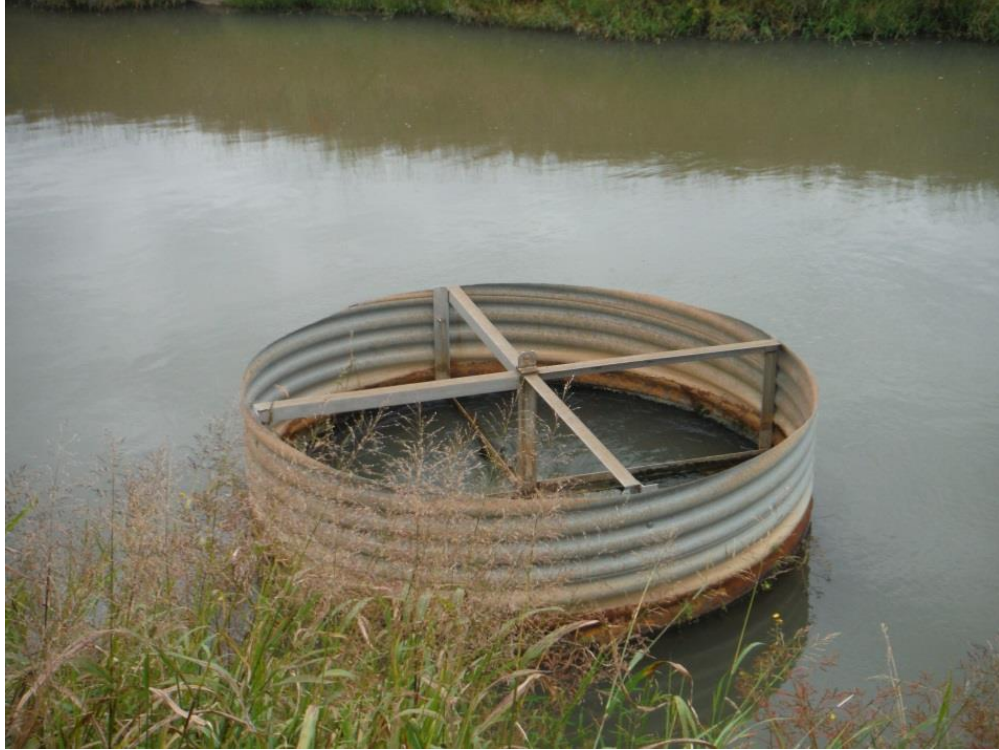
Photo 13 – Slag Stilling Pond 2C spillway skimmer, middle

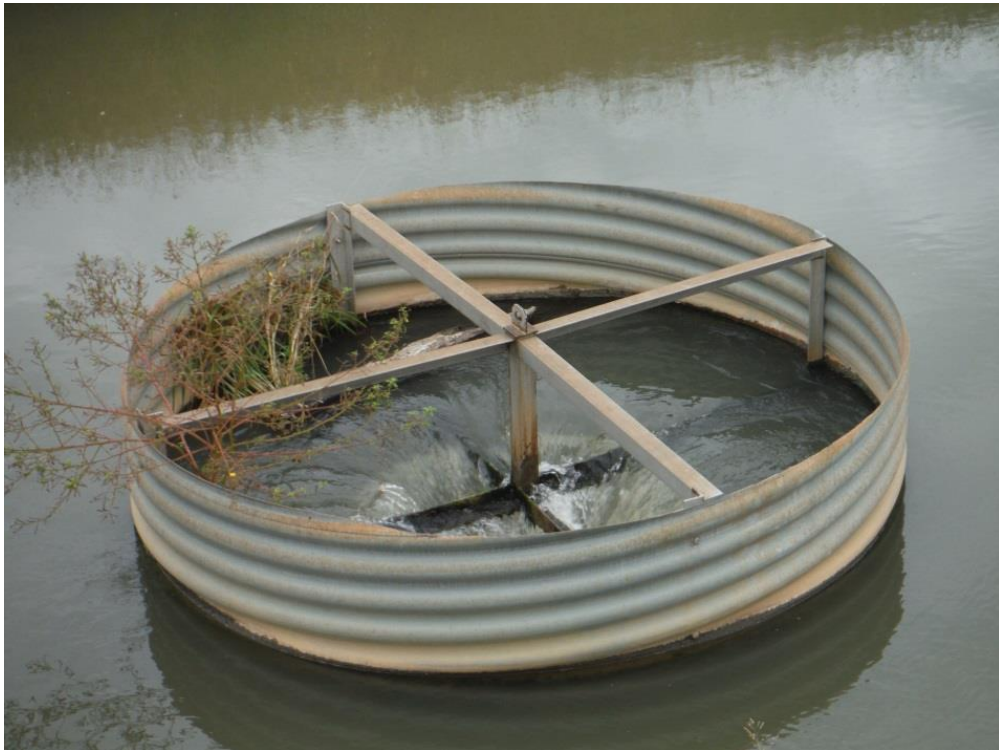
Photo 14 – Slag Stilling Pond 2C spillway skimmer, south

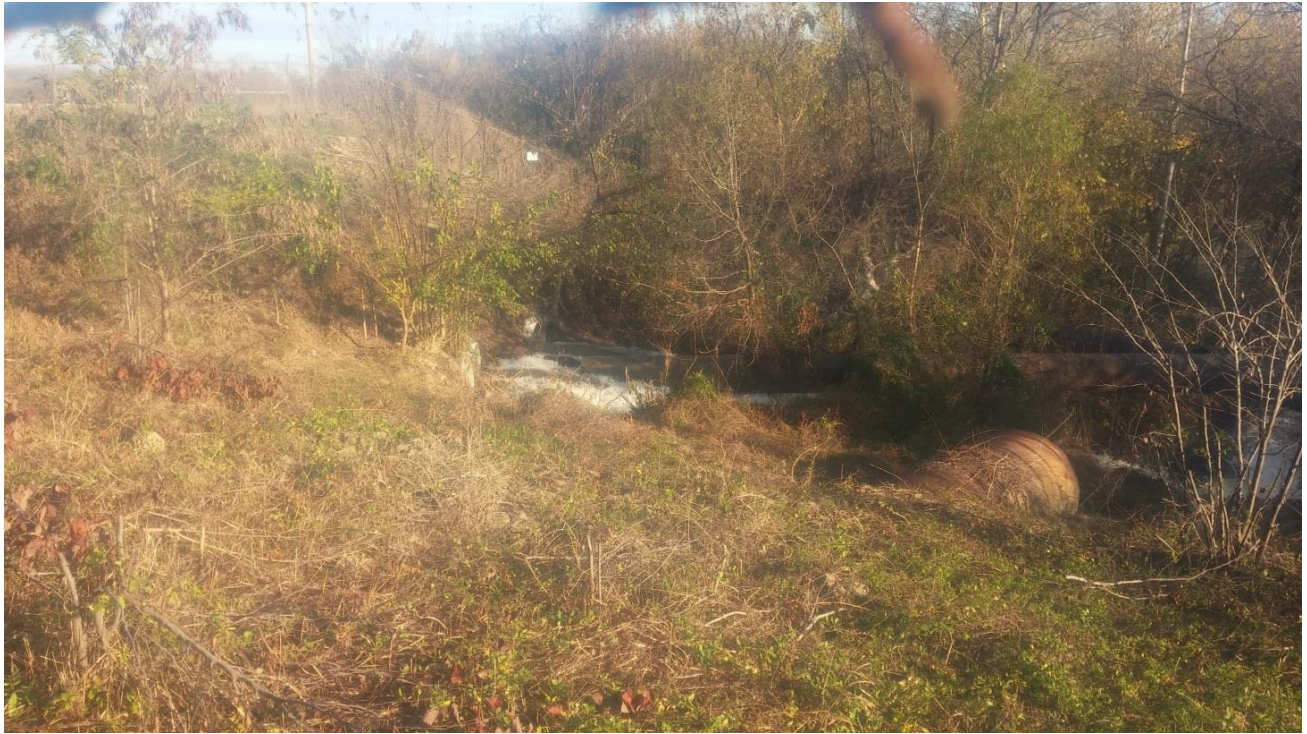
Photo 15 – Slag Stilling Pond 2C spillway outlets

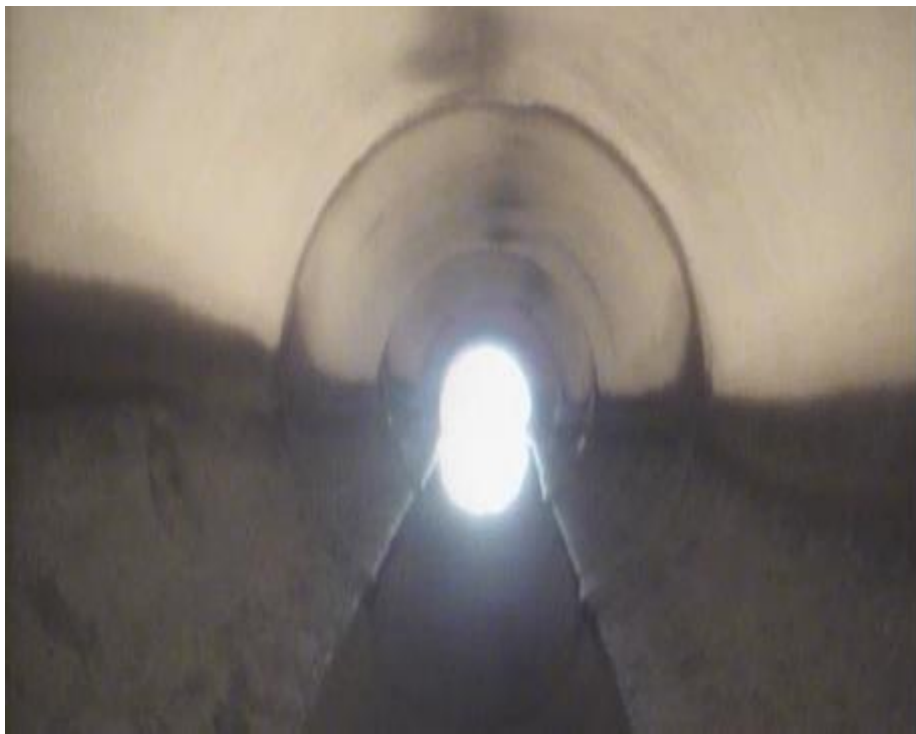
Due to the fenced area, the outer surface of the outlet pipes couldn't be evaluated. Videos of the pipes' interior were available and evaluated in the next section. **Photo 16** depicts the typical inside condition at the outlet.

Photo 16 – Flow inside 36" concrete pipe (Typ.)
