**RE: Periodic Structural Stability Assessment
 Ash Pond 2
 EPA CCR Rule
 TVA Shawnee Fossil Plant
 West Paducah, Kentucky**

**RE: Initial Structural Stability Assessment
Ash Pond 2
EPA Final Coal Combustion Residuals (CCR) Rule
TVA Shawnee Fossil Plant
West Paducah, Kentucky**

Initial Structural Stability Assessment

Shawnee Fossil Plant – Ash Pond 2
McCracken County, Kentucky

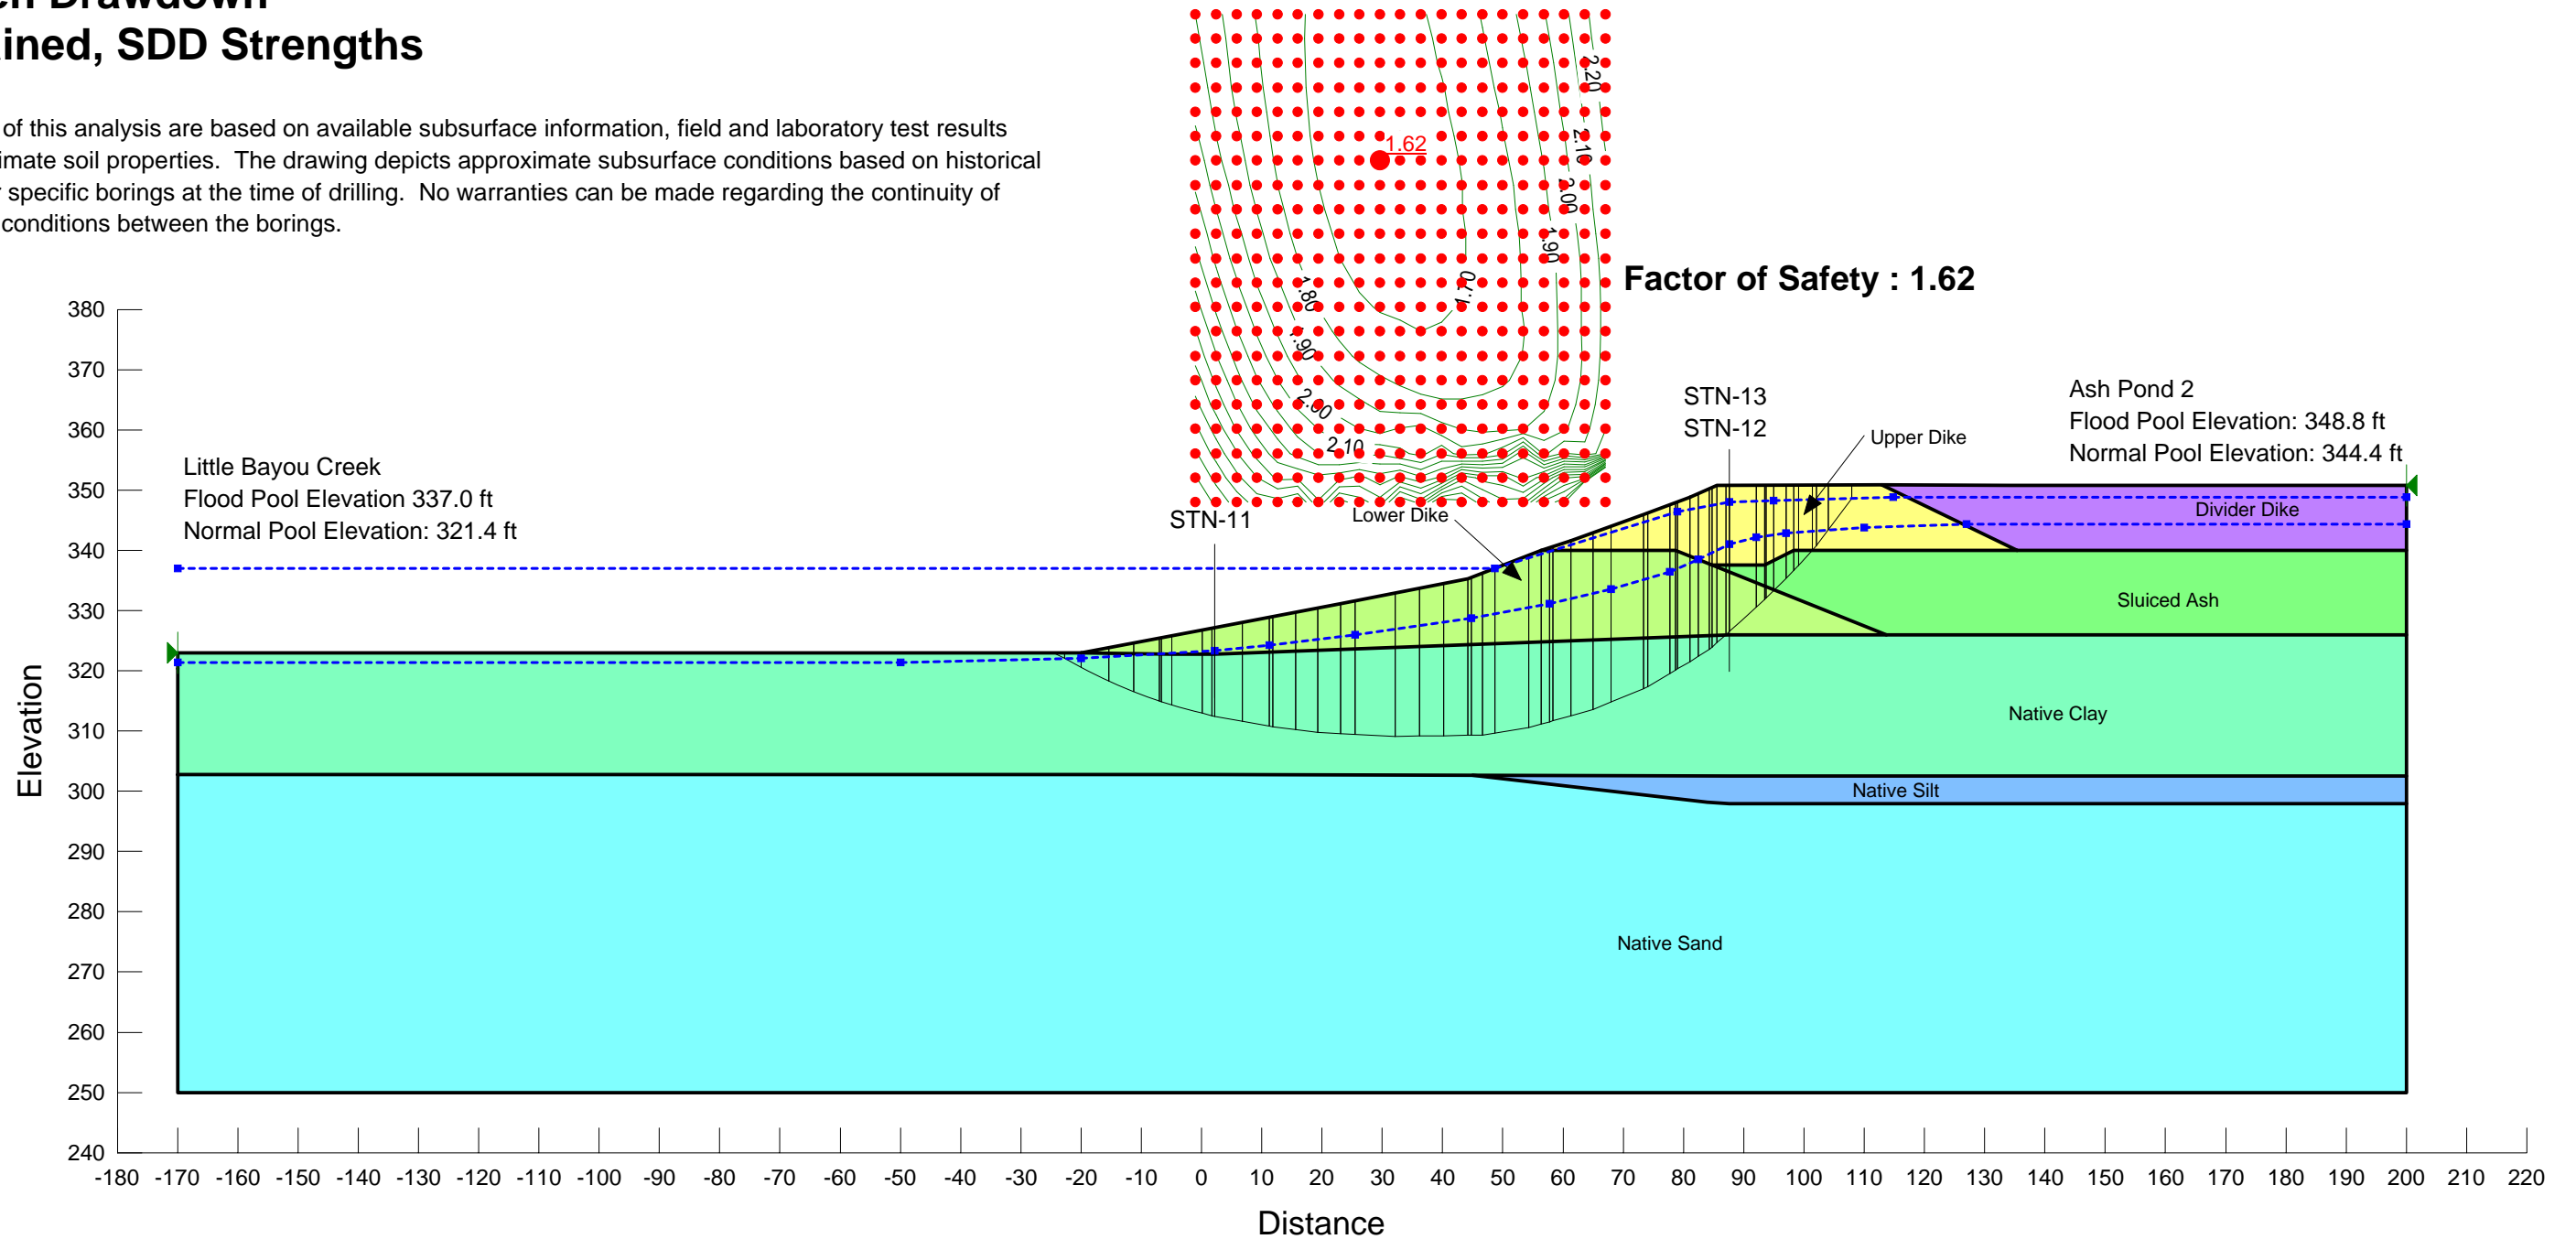
**Tennessee Valley Authority
Shawnee Fossil Plant Ash Pond 2
Paducah, Kentucky
Section E-E'**

Plant	Facility	Critical Cross Section	EPA Criteria	Recommended Factor of Safety Criteria	Calculated Factor of Safety
SHF	Ash Pond 2	E-E'	Sudden Drawdown	1.1	1.6
SHF	Ash Pond 2	N-N'	Sudden Drawdown	1.1	1.9
