**RE: Initial Structural Stability Assessment
Ash Pond 2
EPA Final Coal Combustion Residuals (CCR) Rule
TVA Shawnee Fossil Plant
West Paducah, Kentucky**

Initial Structural Stability Assessment

Shawnee Fossil Plant – Ash Pond 2
McCracken County, Kentucky

October 12, 2016
Revision 0

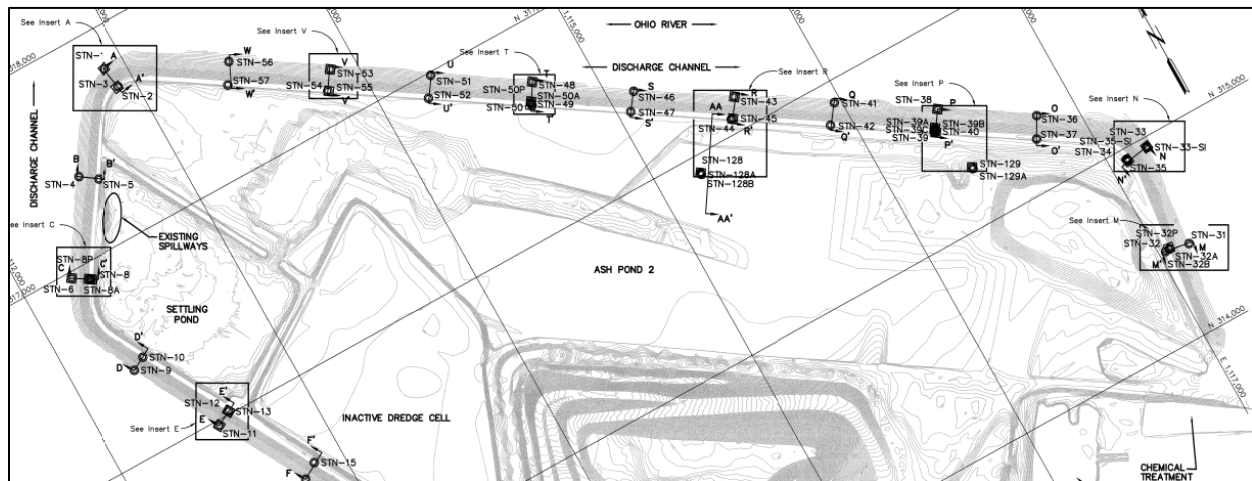
**Figure 2 SHF Ash Pond 1 – Plan View of Cross Sections
(Stantec, 2010b)**

Slope stability analyses were available from Stantec (2010b) and Stantec and URS (2014). Seven primary cross sections were analyzed under steady state and sudden drawdown conditions. The seven sections that were analyzed were A-A', C-C', E-E', N-N', P-P', R-R', and U-U' and are shown below in Figure 2. Two additional sections (F-F' and H-H') that were included in Ash Pond 2 from Stantec (2010b) are no longer considered a part of Ash Pond 2 because of landfill operations.

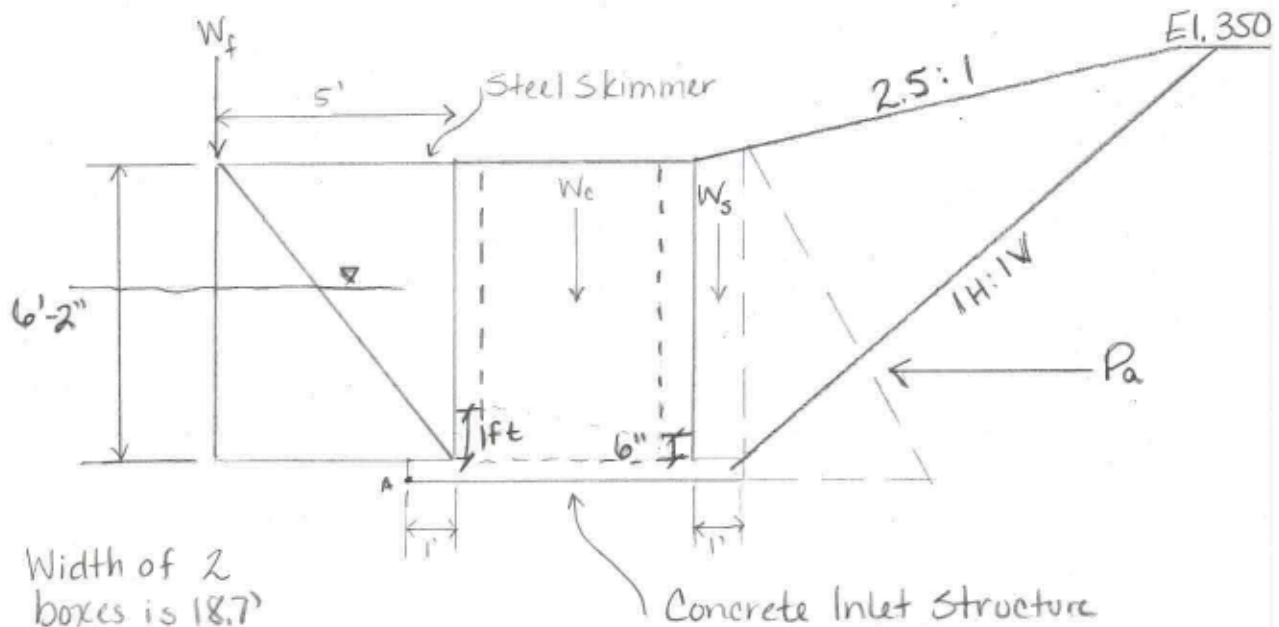
SHF Spillway Replacement Overturning, Eccentricity, + Sliding Check

In the SHF Spillway Replacement Design Calculations (in Appendix B4), it is demonstrated that the new spillway designs are adequate for stability. The structure was designed and constructed in 2011 to be sufficient for overturning, eccentricity, and sliding.

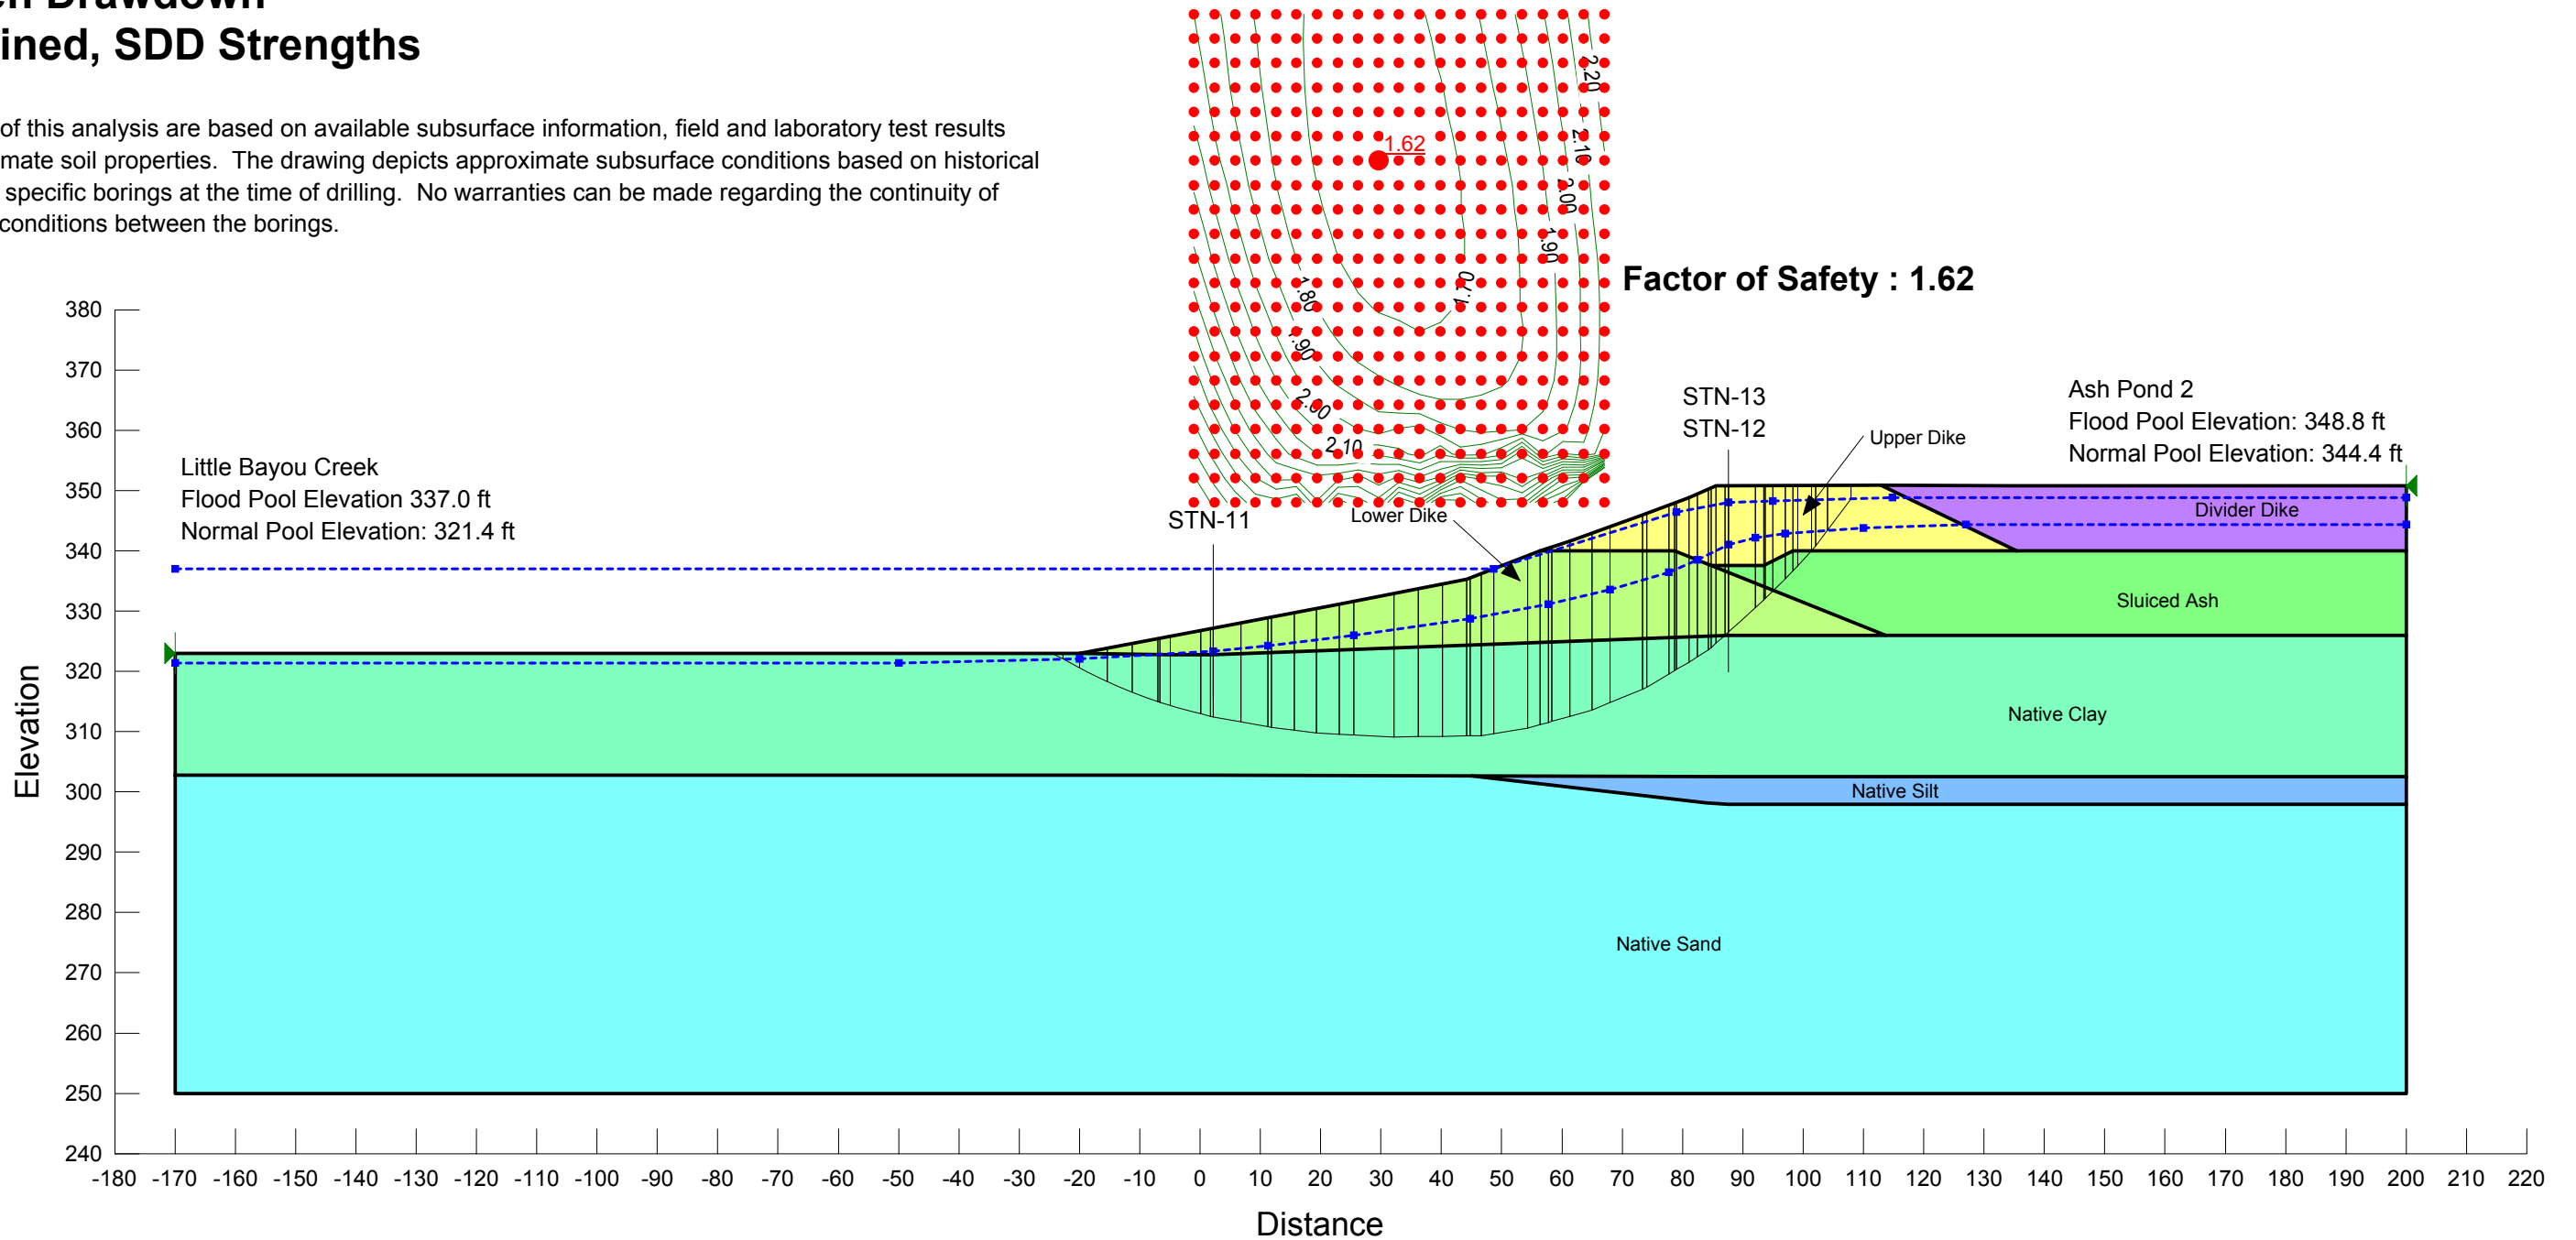
**Tennessee Valley Authority
Shawnee Fossil Plant Ash Pond 2
Paducah, Kentucky
Section E-E'**

Plant	Facility	Critical Cross Section	EPA Criteria	Recommended Factor of Safety Criteria	Calculated Factor of Safety
SHF	Ash Pond 2	E-E'	Sudden Drawdown	1.1	1.6
SHF	Ash Pond 2	N-N'	Sudden Drawdown	1.1	1.9

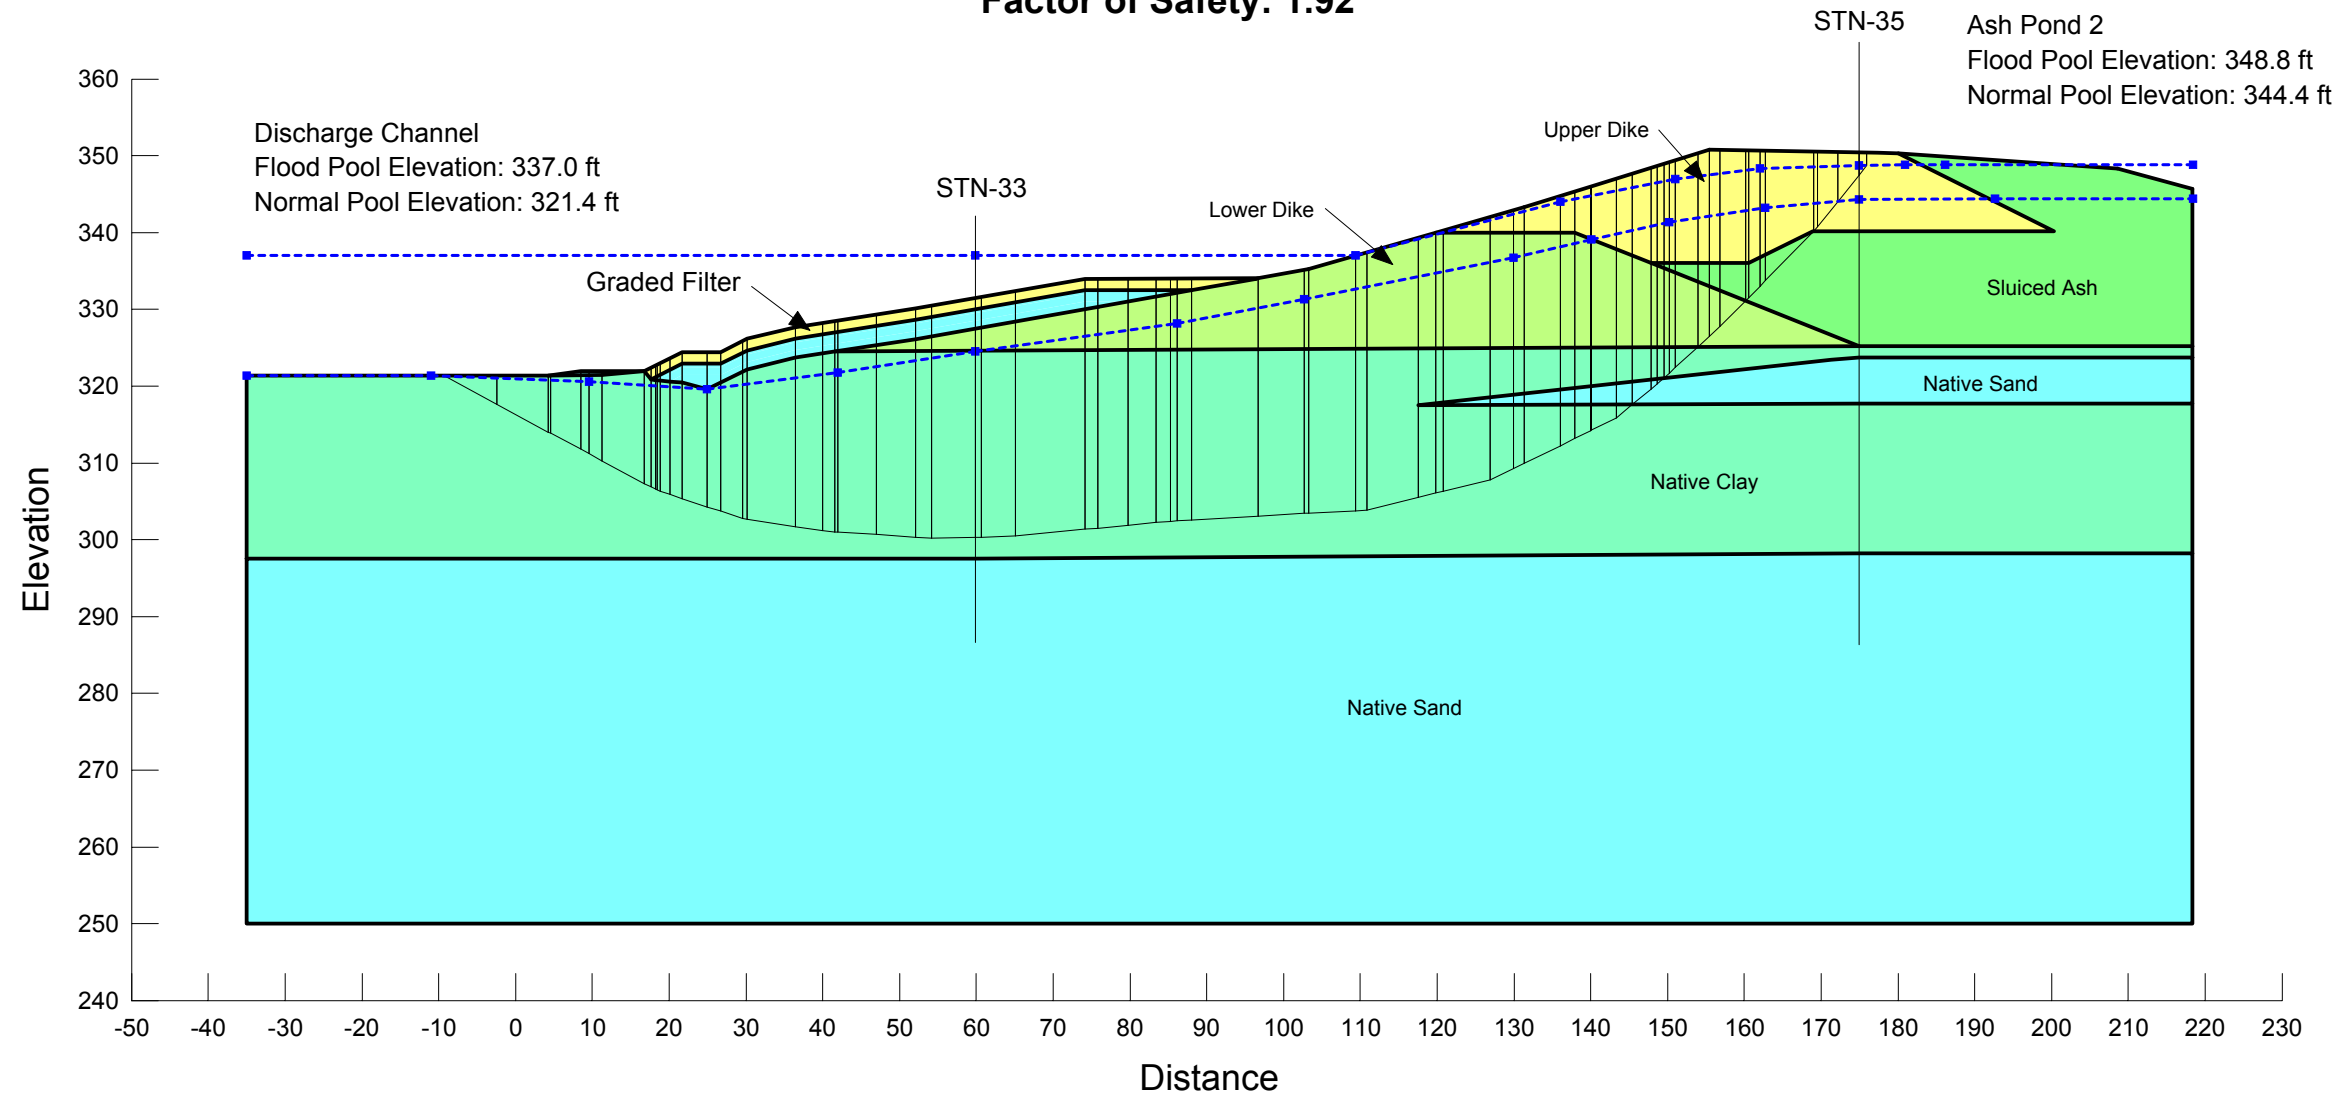
**Tennessee Valley Authority
Shawnee Fossil Plant Ash Pond 2
Paducah, Kentucky
Section N-N'**

Factor of Safety: 1.92
