**RE: Initial Structural Stability Assessment
Bottom Ash Pond
EPA Final Coal Combustion Residuals (CCR) Rule
TVA Cumberland Fossil Plant
Cumberland City, Tennessee**

**Initial Structural Stability
Assessment**

**Cumberland Fossil Plant – Bottom
Ash Pond
Stewart County, Tennessee**

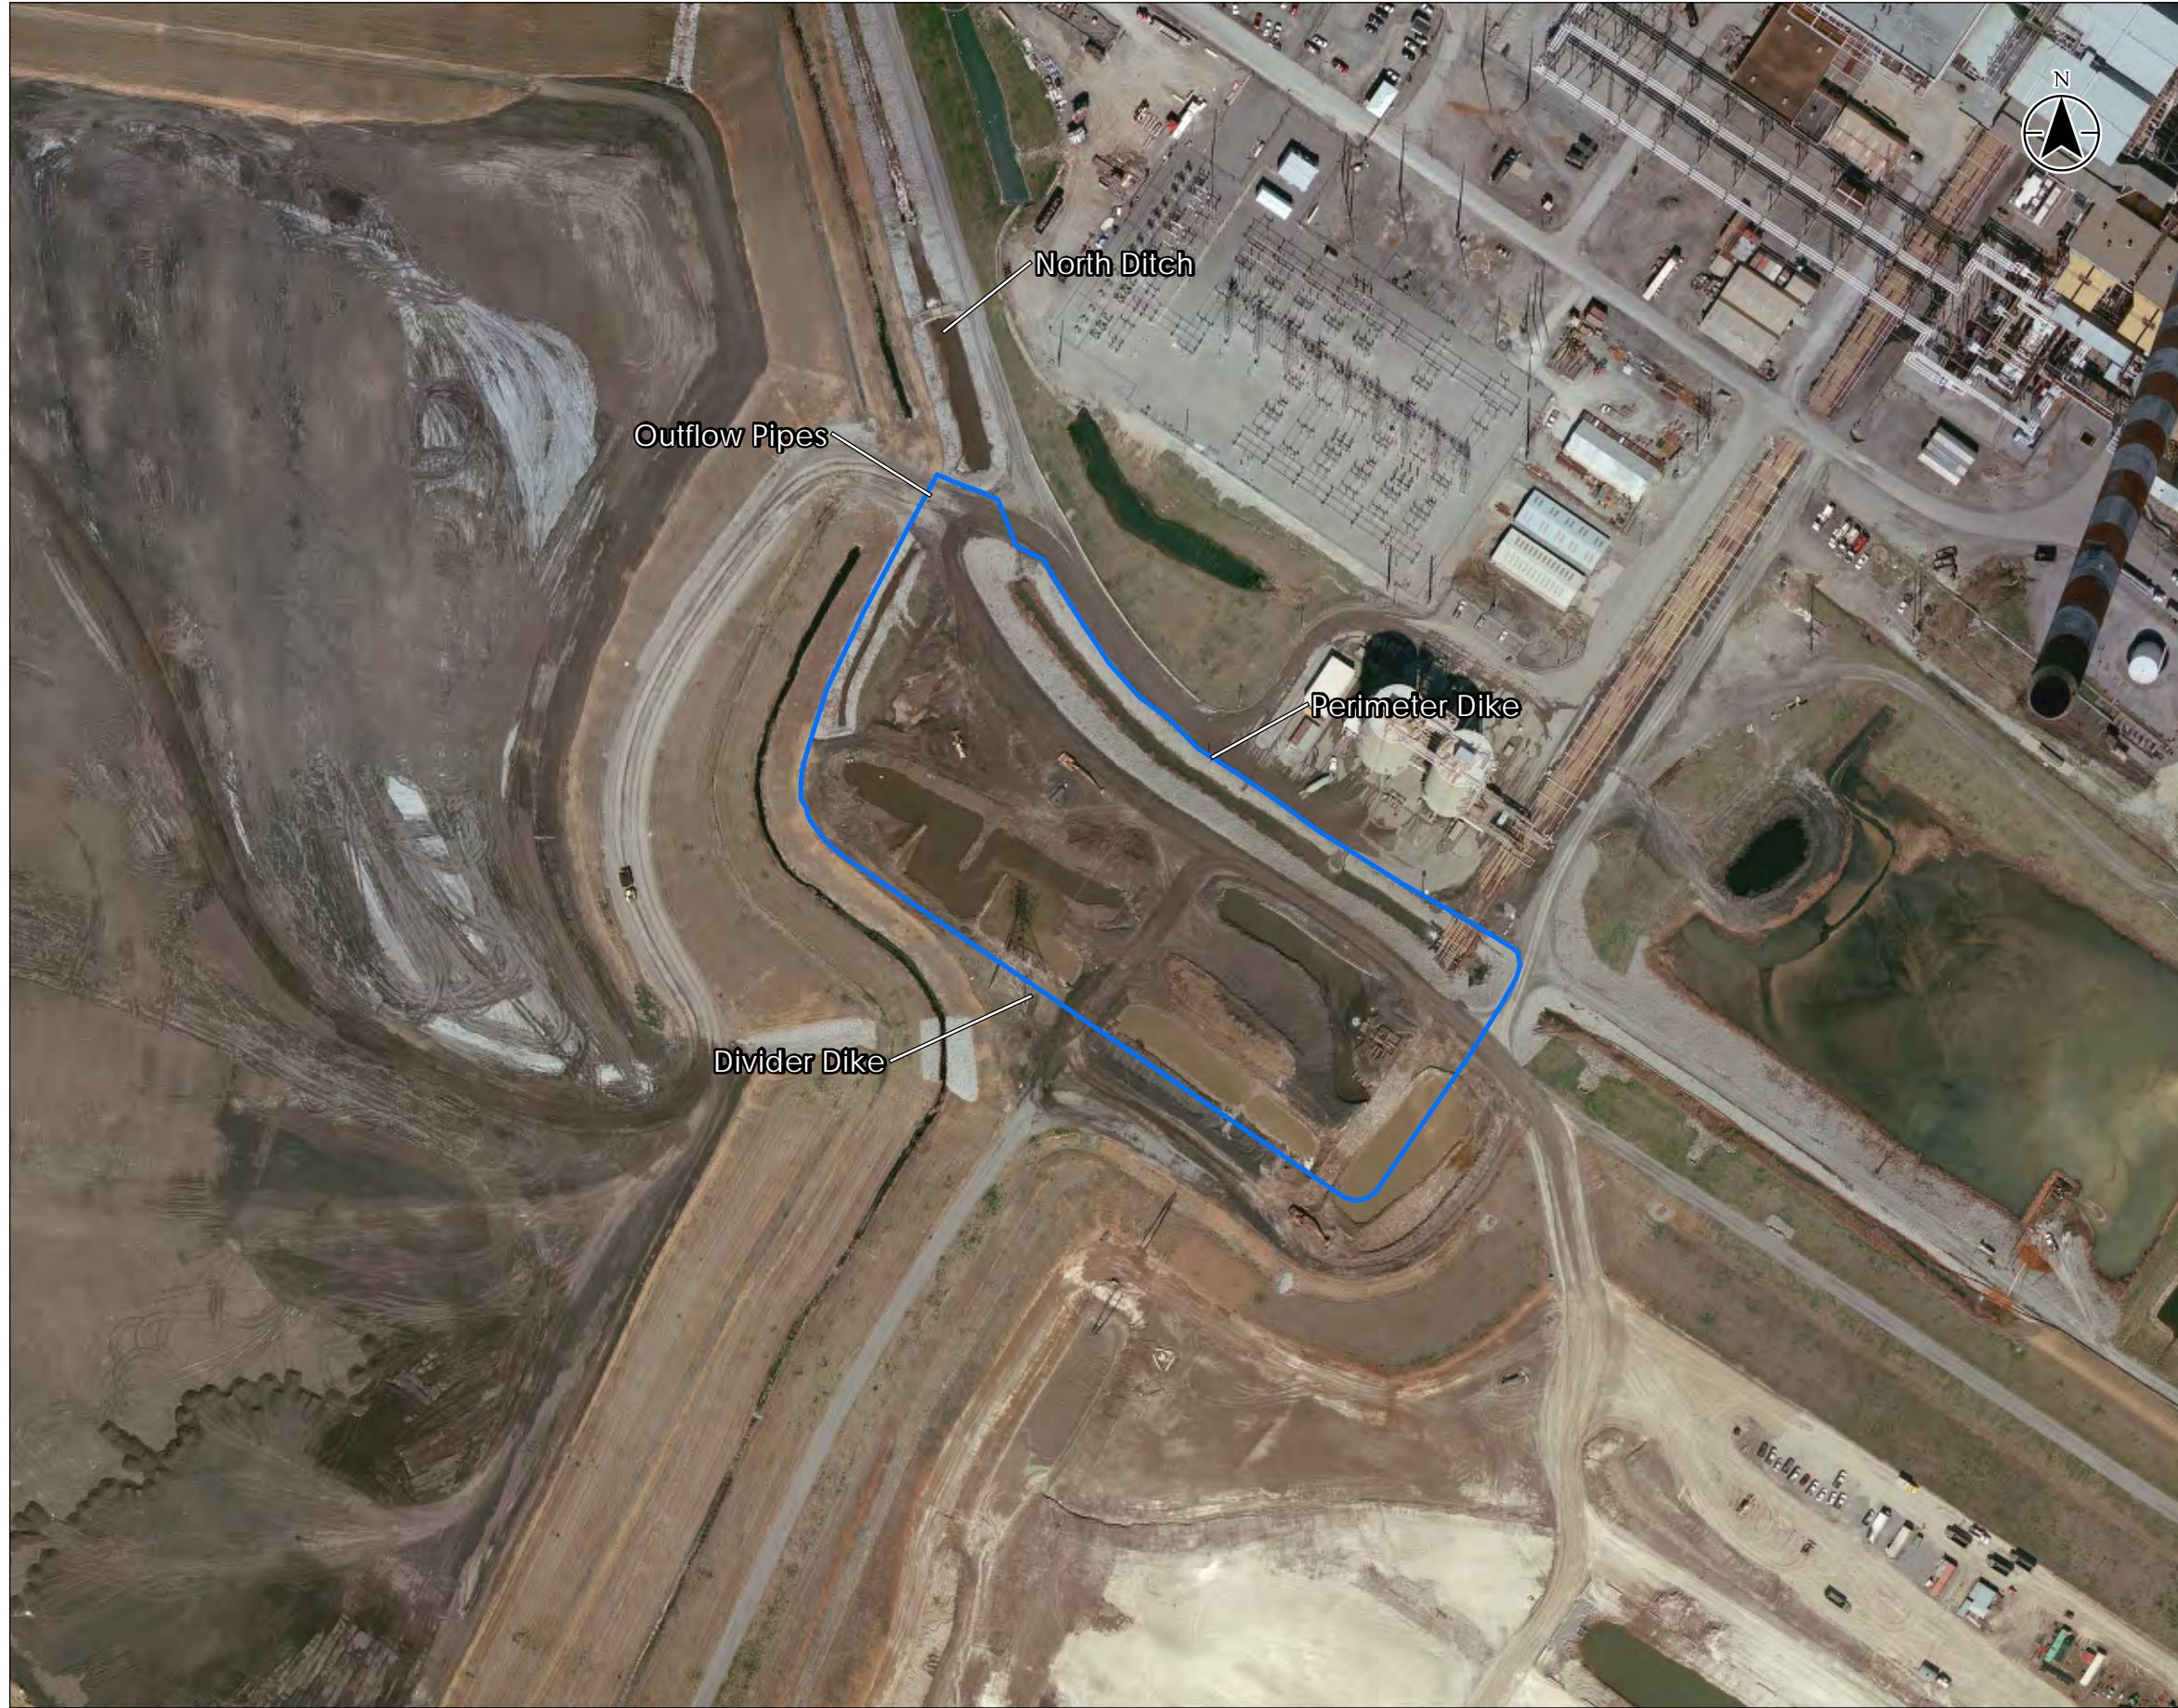
The subsections under §257.73(d) address conditions of appurtenances categorized as embankments, spillways, or hydraulic structures. Sections 2.1 to 2.3 below provide descriptions of the individual unit elements that fall within these appurtenance categories. Figure 1 provides an overview of the Bottom Ash Pond and appurtenances.

Bottom Ash Pond

The Bottom Ash Pond Outflow Pipes consist of two 54-inch-diameter reinforced concrete pipes (RCP) that direct flow from the Bottom Ash Pond to the North Ditch and subsequently the Stilling Pond. The two pipes are located near the northern end of the pond as shown on Figure 1.
