**RE: Unstable Areas Demonstration  
Active Ash Pond 2  
EPA Final Coal Combustion Residuals (CCR) Rule  
TVA Johnsonville Fossil Plant  
New Johnsonville, Tennessee**

## **Unstable Areas Demonstration**

Johnsonville Fossil Plant  
Active Ash Pond 2  
New Johnsonville, Tennessee

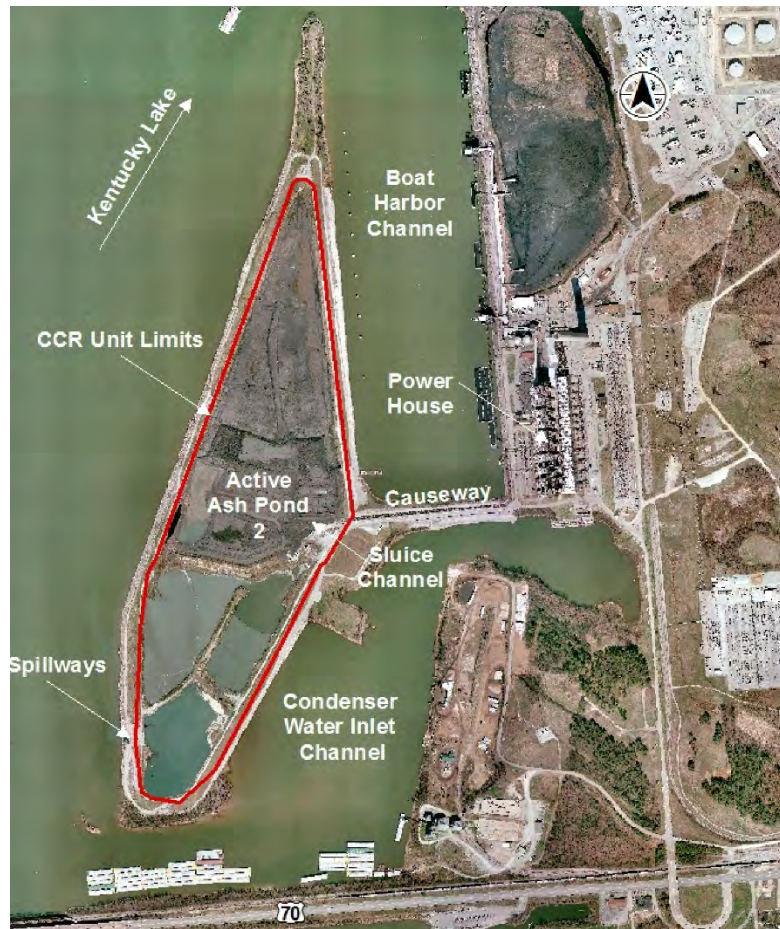
Figure 1: Site Vicinity Map

Referring to **Figure 1**, the Unit is centered approximately 2,000 feet west from the plant's powerhouse. It was created by placing fill and then building an approximate two-mile-long perimeter dike, on an area within the former Tennessee River floodplain (now inundated by Kentucky Lake), to enclose approximately 90 acres. The perimeter dike varies from 25 to 35 feet in height.

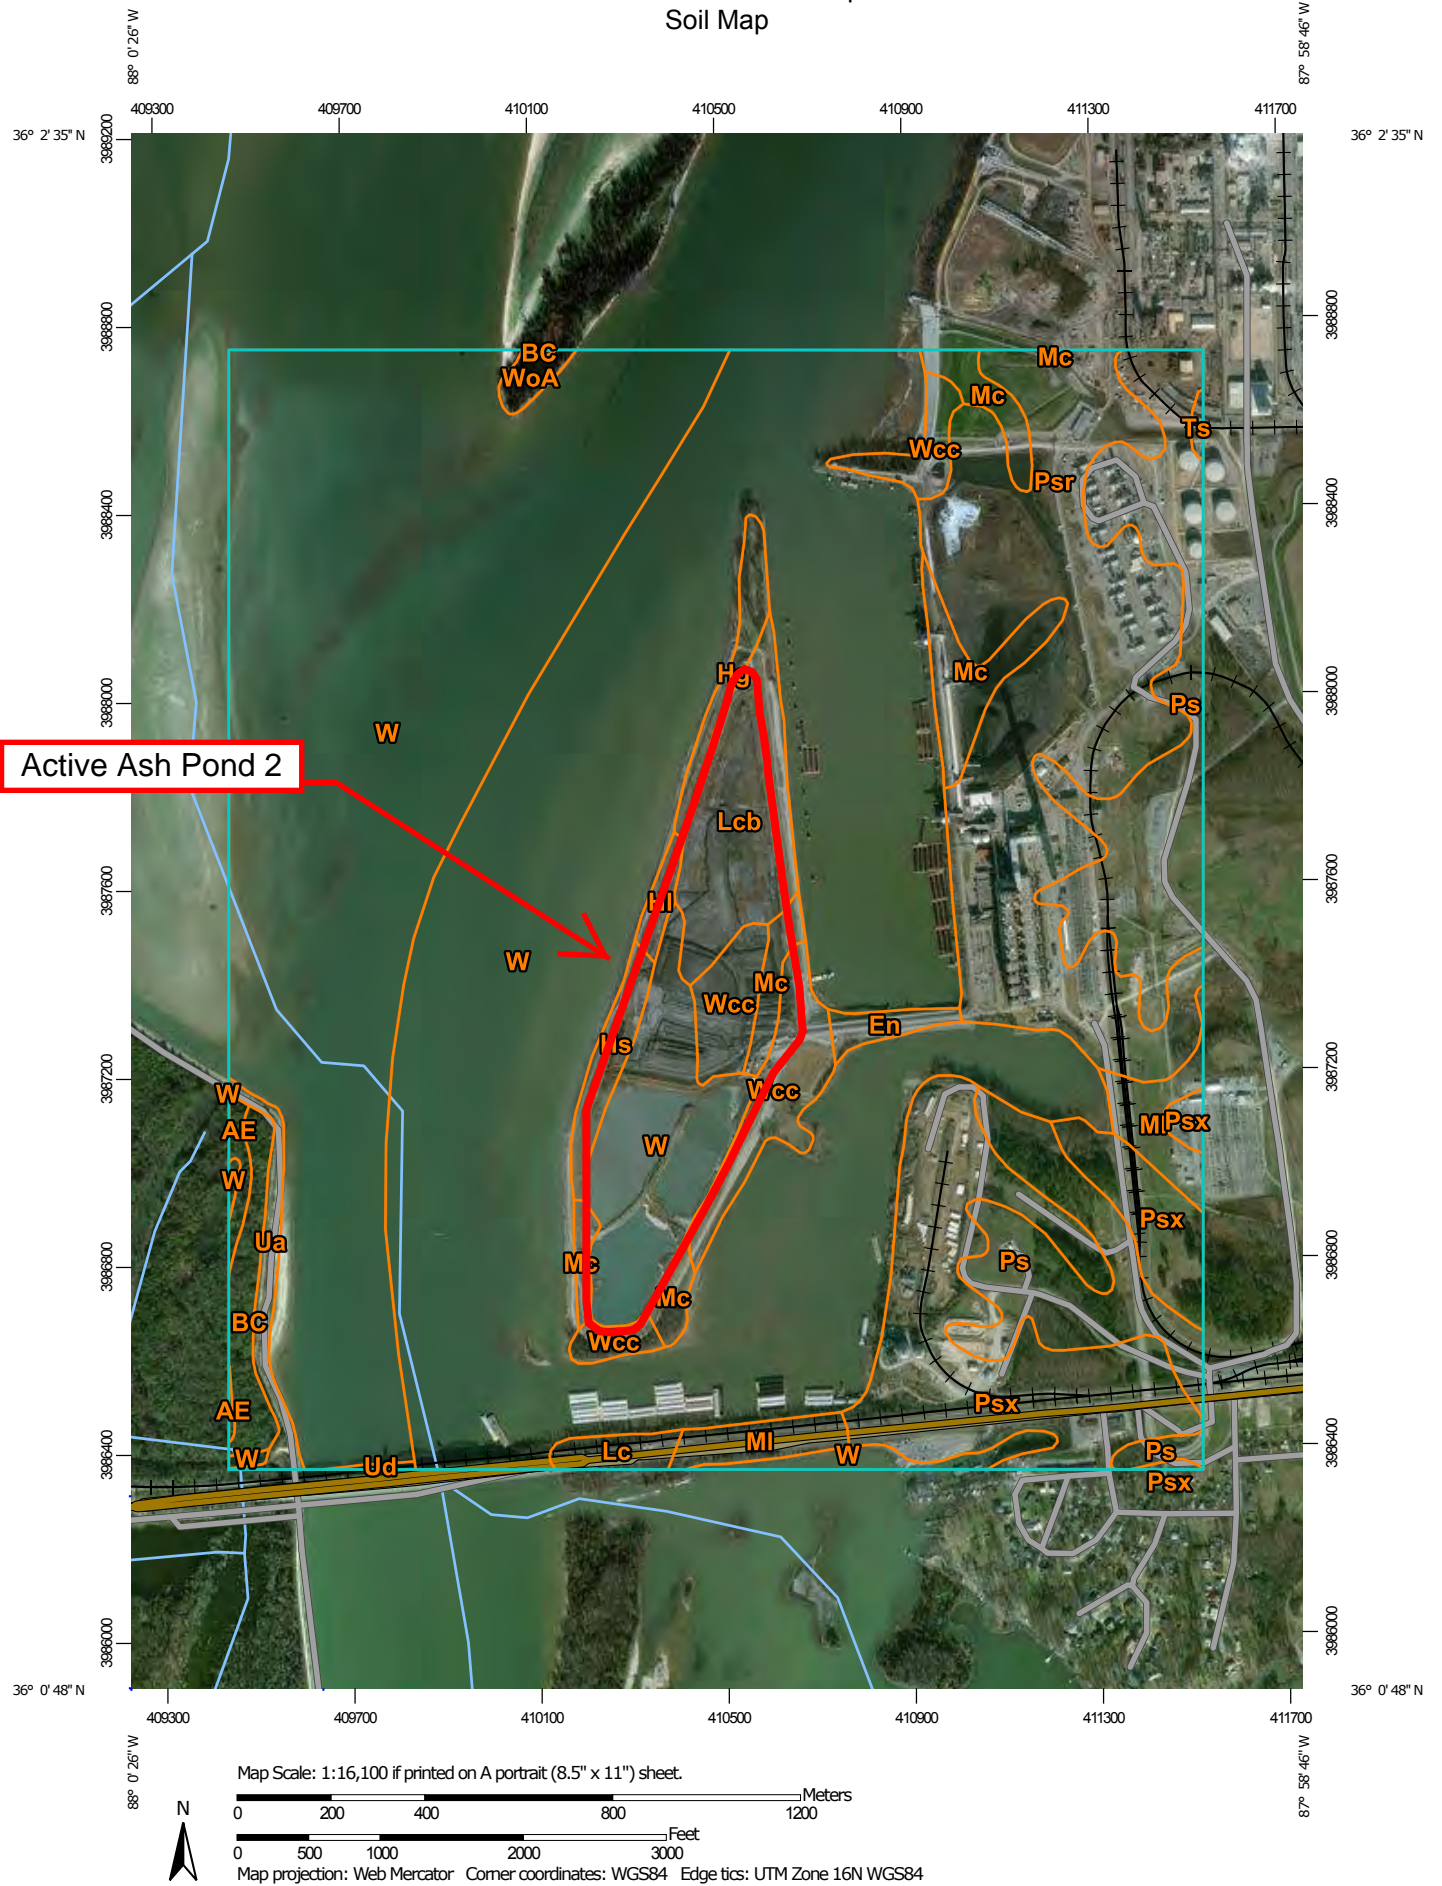
# Custom Soil Resource Report Soil Map

Active Ash Pond 2

The U.S. Department of Agriculture's Natural Resources Conservation Service (NRCS) maintains an online web soil survey tool that provides available data on local soils information for a user-specified Area of Interest. Appendix A includes the Web Soil Survey completed for the JOF site.
