**Engineer's Certification of Unstable Area Demonstration  
Gypsum Disposal Area, Gypsum Disposal Area Stilling Pond 1, and Gypsum Disposal Area Stilling  
Pond 2  
EPA Final CCR Rule  
TVA Paradise Fossil Plant  
Drakesboro, Kentucky**

**TENNESSEE VALLEY AUTHORITY – PARADISE FOSSIL PLANT  
GYPSUM DISPOSAL AREA, GYPSUM DISPOSAL AREA STILLING POND 1, AND  
GYPSUM DISPOSAL AREA STILLING POND 2  
DRAKESBORO, KENTUCKY**

**ENGINEER'S CERTIFICATE OF  
UNSTABLE AREA DEMONSTRATION  
(40 CFR §257.64)  
FOR COAL COMBUSTION RESIDUALS (CCR)  
EXISTING SURFACE IMPOUNDMENTS**

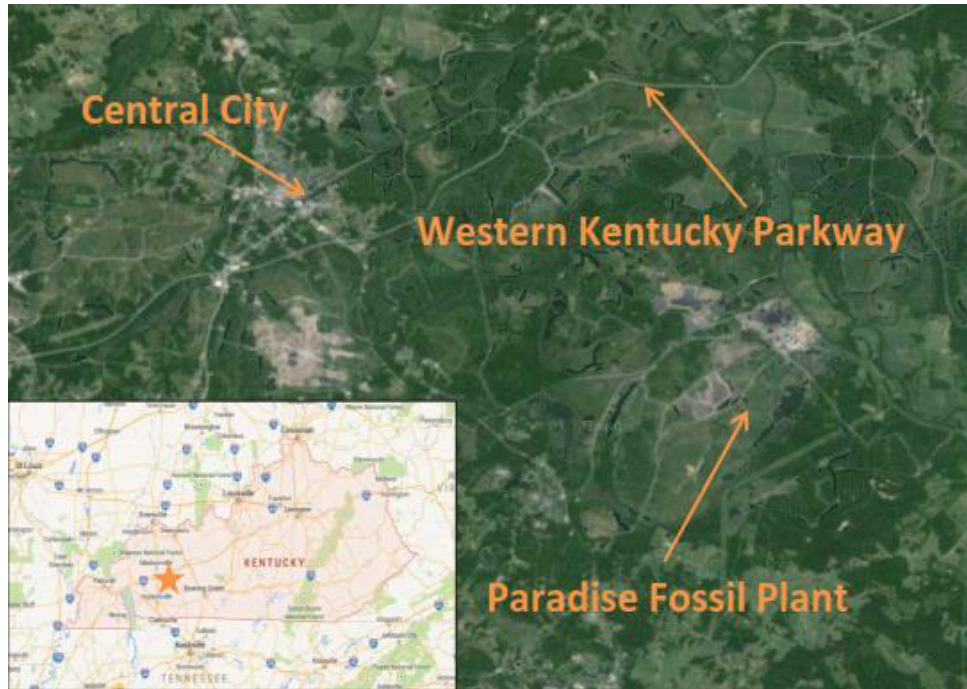
Figure 1: PAF Aerial View

PAF is located in Drakesboro, Kentucky along the west bank of the Green River and State Route 176. The plant features three units, constructed between 1963 and 1970, and three large natural-draft cooling towers. Units 1 and 2 were retired in 2017. The plant sits inside the eastern border of Muhlenberg County as depicted below in **Figure 1**.

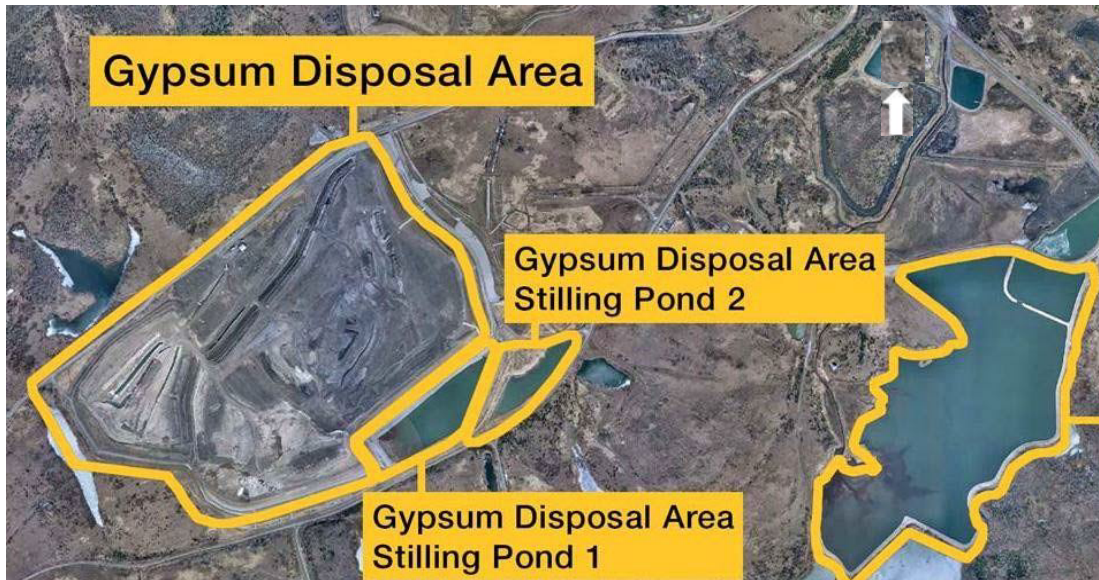
**Figure 2: Site Overview**

The Gypsum Disposal Area is located in the southwest corner of the Paradise Facility and to the west of the plant. The Gypsum Disposal Area is approximately 225 acres in area and partially enclosed by a 1.4 mile long dike with a maximum height of approximately 62 feet. The Gypsum Disposal Area is bordered by hilly and grassy areas on all sides (**Figure 2**). The Gypsum Disposal Area manages process water flows and CCR waste, gypsum and fly ash, during power generation. The Gypsum Disposal Area has two stilling ponds called Stilling Ponds 1 & 2 located at the southeast end of the Gypsum Disposal Area. These ponds receive process water and stormwater drainage from the Gypsum Disposal Area and the surrounding drainage area. Stilling Pond 1 drains to Stilling Pond 2, which discharges to a surface water channel that eventually leads to the Peabody Ash Pond, which is located on the southeast side of the site.
