**Engineer’s Certification of Unstable Area Demonstration
Peabody Ash Pond
EPA Final CCR Rule
TVA Paradise Fossil Plant
Drakesboro, Kentucky**

**TENNESSEE VALLEY AUTHORITY – PARADISE FOSSIL PLANT
PEABODY ASH POND
DRAKESBORO, KENTUCKY**

**ENGINEER'S CERTIFICATE OF
UNSTABLE AREA DEMONSTRATION
(40 CFR §257.64)
FOR COAL COMBUSTION RESIDUALS (CCR)
EXISTING SURFACE IMPOUNDMENT**

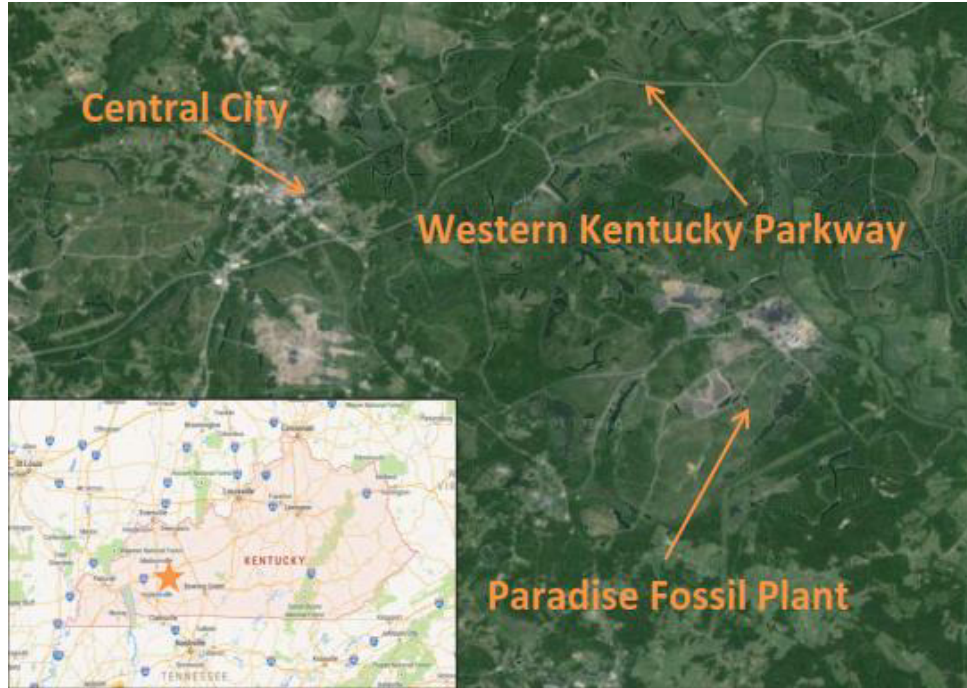
Figure 1: PAF Aerial View

PAF is located in Drakesboro, Kentucky along the west bank of the Green River and State Route 176. The plant sits inside the eastern border of Muhlenberg County as depicted below in **Figure 1**. The plant features three units, constructed between 1963 and 1970, and three large natural-draft cooling towers. Units 1 and 2 were retired in 2017.

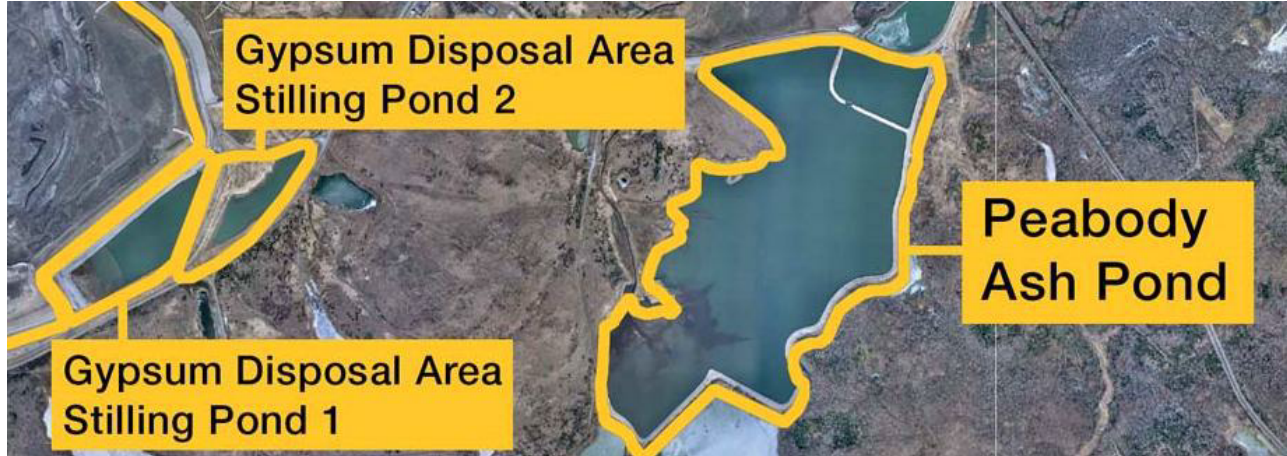
Figure 2. Site Overview

The impoundment has also been known as Jacob's Creek Ash Disposal Area Extension, and the original dikes were at an elevation of 400 feet. Construction documentation of the original dike could not be obtained. The dikes were raised to an elevation of 408 feet in 1997. In addition, a divider dike was built at this time, creating the Peabody Stilling Pond. Construction of the raised dike and Stilling Pond took place between February and September of 1997, with Peabody Ash Pond operations beginning immediately following construction. The original pond was known as the Ash Disposal Area and was later renamed to Peabody Ash Pond. Peabody Ash Pond is bordered by the closed former Jacob's Creek Ash Pond on the north side, Jacob's Creek on the east side, two lagoons on the south side, and hilly and grassy areas to the west (See **Figure 2**).
