**RE: Unstable Areas Demonstration
Ash Pond 2
EPA Final Coal Combustion Residuals (CCR) Rule
TVA Shawnee Fossil Plant
West Paducah, Kentucky**

Unstable Areas Demonstration

Ash Pond 2
Shawnee Fossil Plant
Paducah, Kentucky

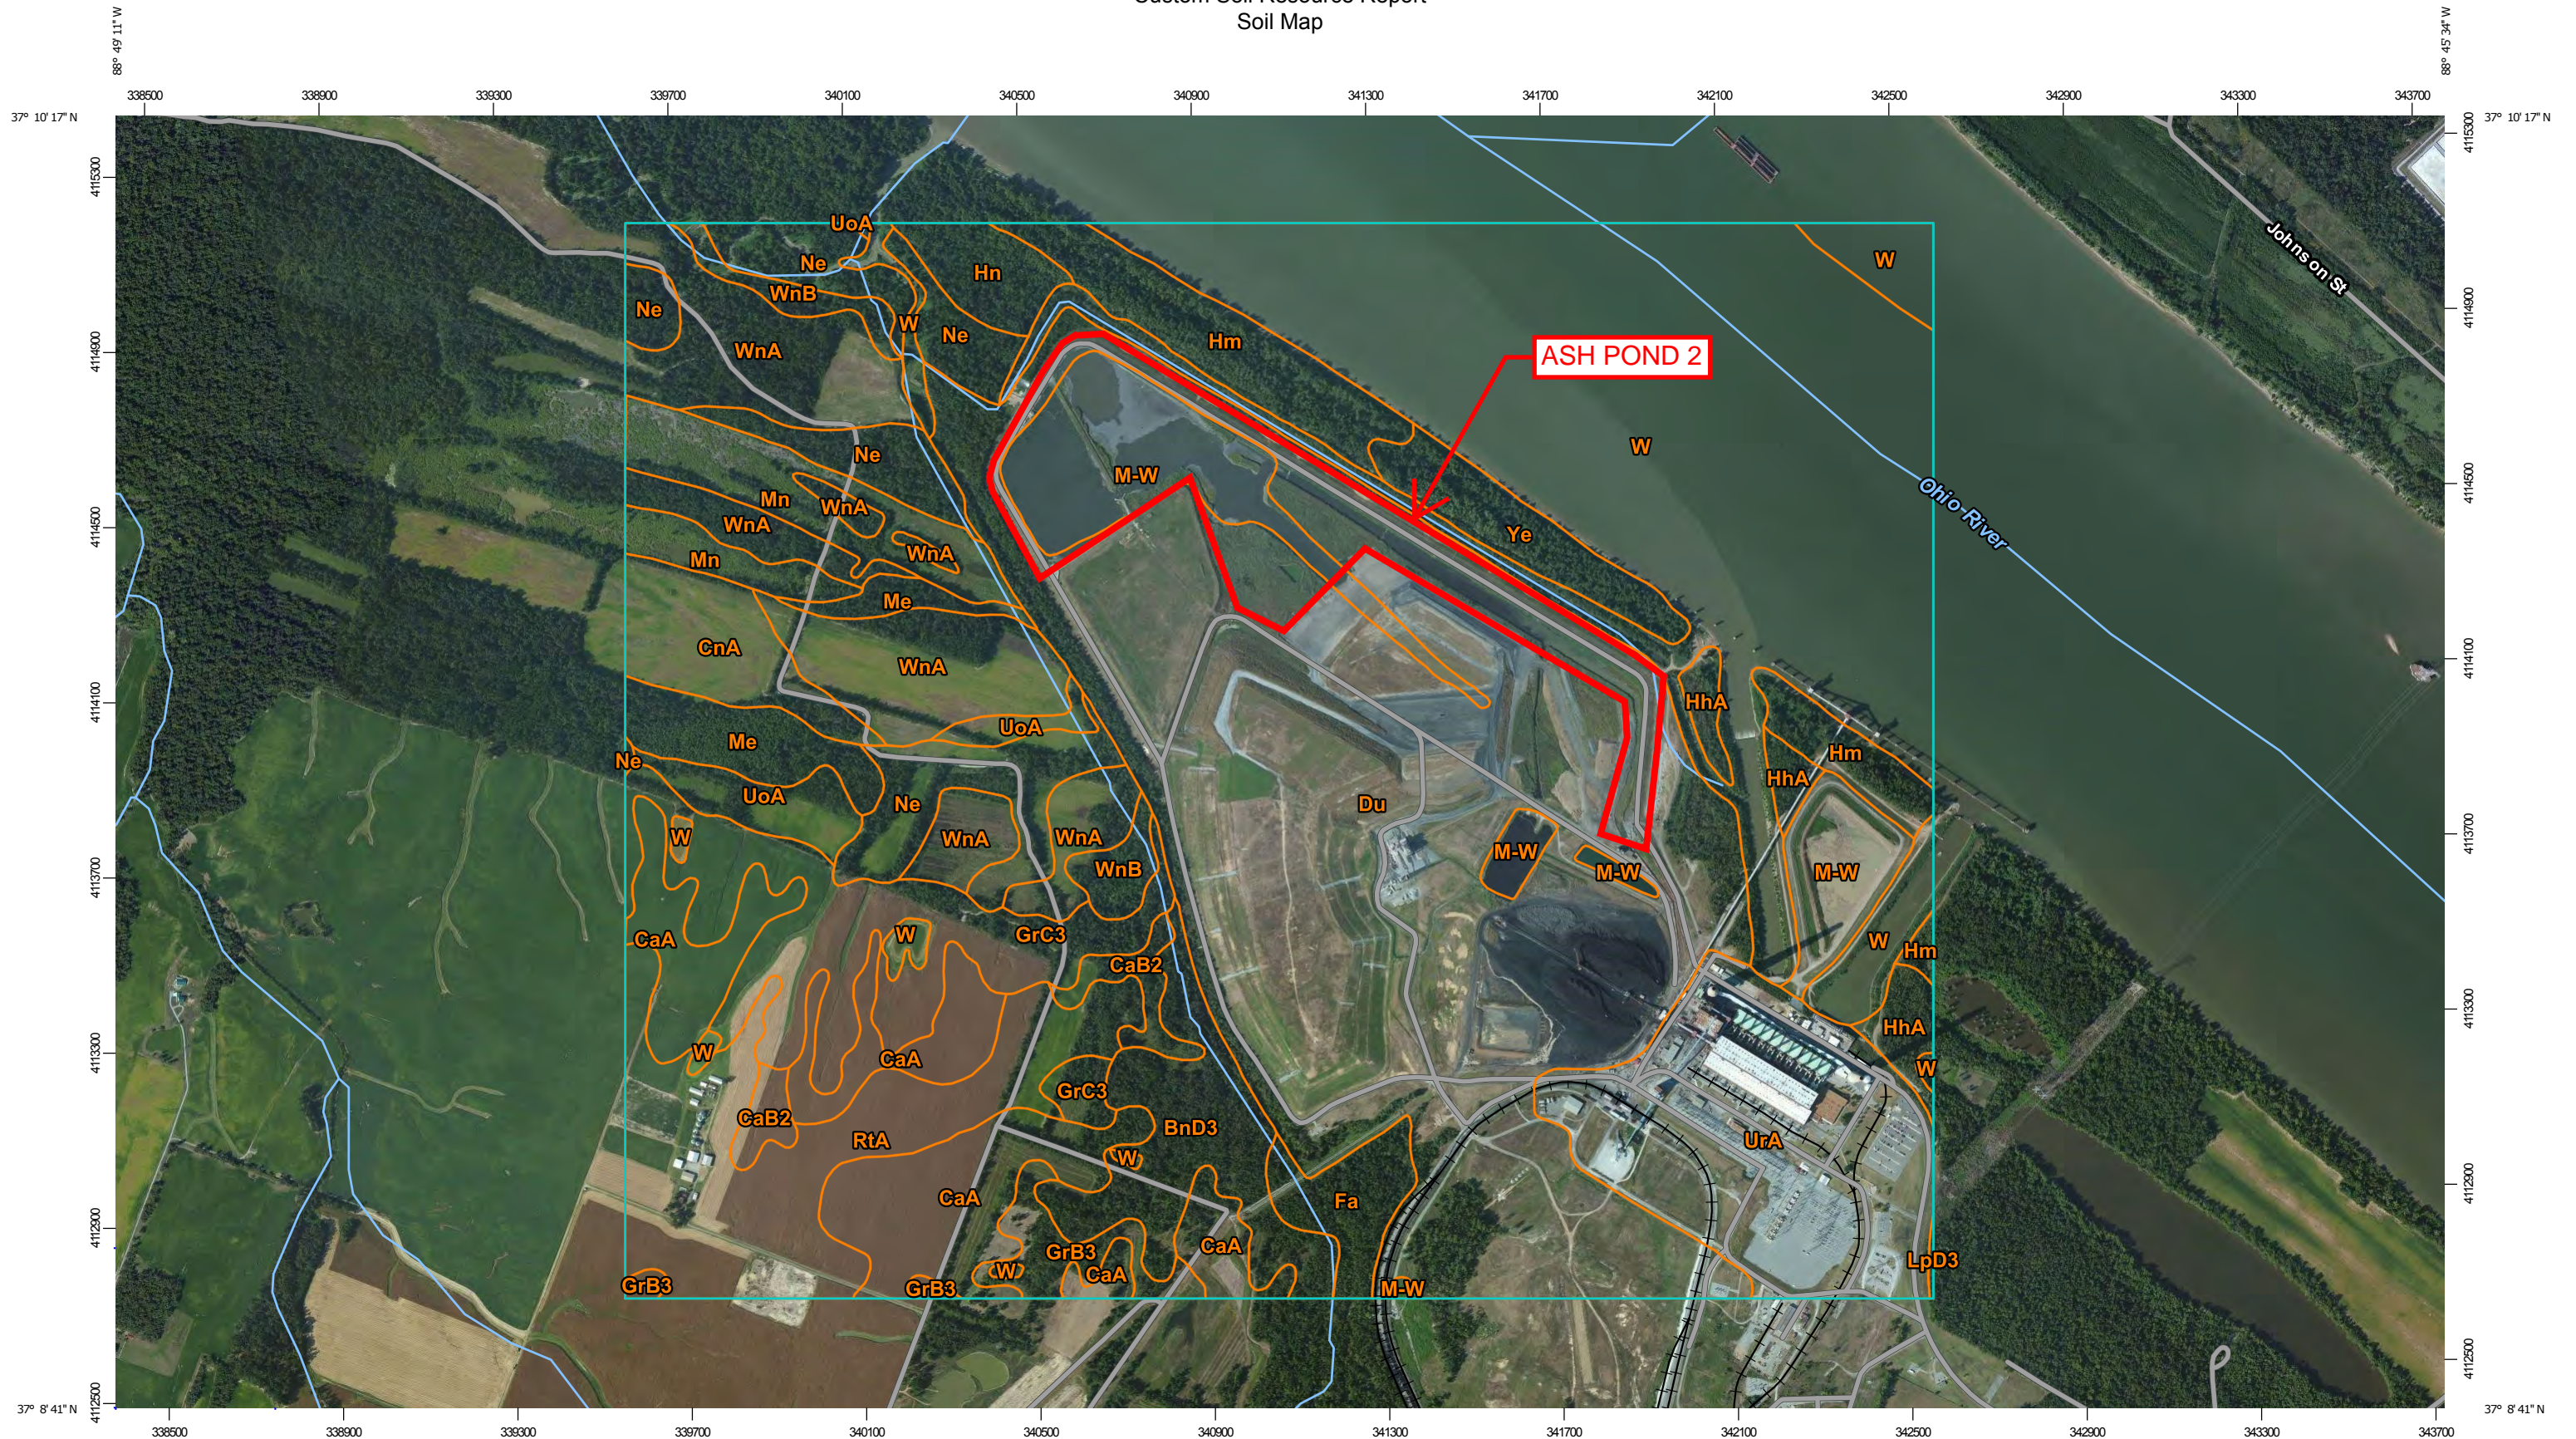
Custom Soil Resource Report
Soil Map

The soil map section includes the soil map for the defined area of interest, a list of soil map units on the map and extent of each map unit, and cartographic symbols displayed on the map. Also presented are various metadata about data used to produce the map, and a description of each soil map unit.

According to available geologic data and soil surveys, Ash Pond 2 is located within the floodplain of the Ohio River within the Calloway-Henry soils association (United States Department of Agriculture Soil Conservation Service, 1976). Typically, the soils are silt loam over loamy clay and silt loams. The loess and Quaternary alluvial deposits primarily classify as CL and ML and associated dual symbols, and beneath those deposits are Plio-Pleistocene sands and gravels with varying silt content that primarily classify as SP, SM, GW, GM, and associated USCS dual symbols (FMSM, 2006).
