**RE: Periodic Structural Stability Assessment
 East Ash Disposal Area
 EPA CCR Rule
 TVA Allen Fossil Plant
 Memphis, Tennessee**

INITIAL STRUCTURAL STABILITY ASSESSMENT

Initial Structural Stability Assessment

TENNESSEE VALLEY AUTHORITY (TVA)
ALLEN FOSSIL PLANT – EAST ASH DISPOSAL AREA
PIPE INSPECTION REPORT

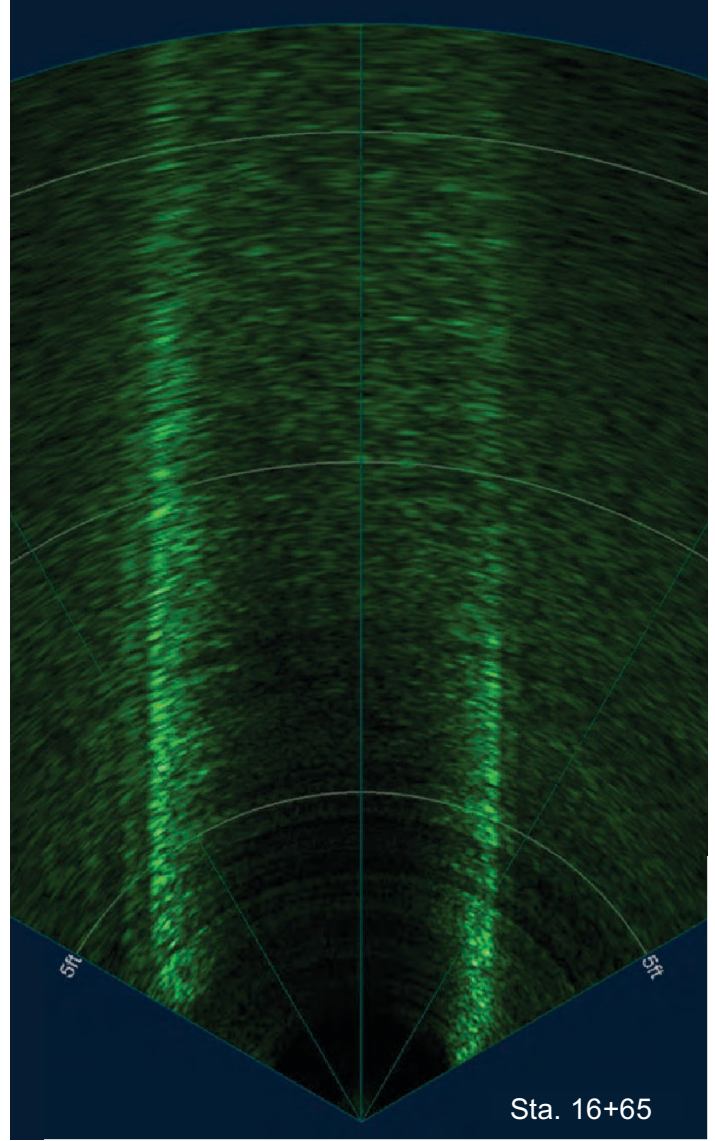
Image 2 – Shows a typical sonar image in a clear pipe. The sonar is positioned at the springline of the pipeline. (-6" debris at invert).
