**RE: Initial Structural Stability Assessment
Active Ash Pond 2
EPA Final Coal Combustion Residuals (CCR) Rule
TVA Johnsonville Fossil Plant
New Johnsonville, Tennessee**

Initial Structural Stability Assessment

Johnsonville Fossil Plant – Active
Ash Pond 2
New Johnsonville, Tennessee

October 12, 2016
Revision 0

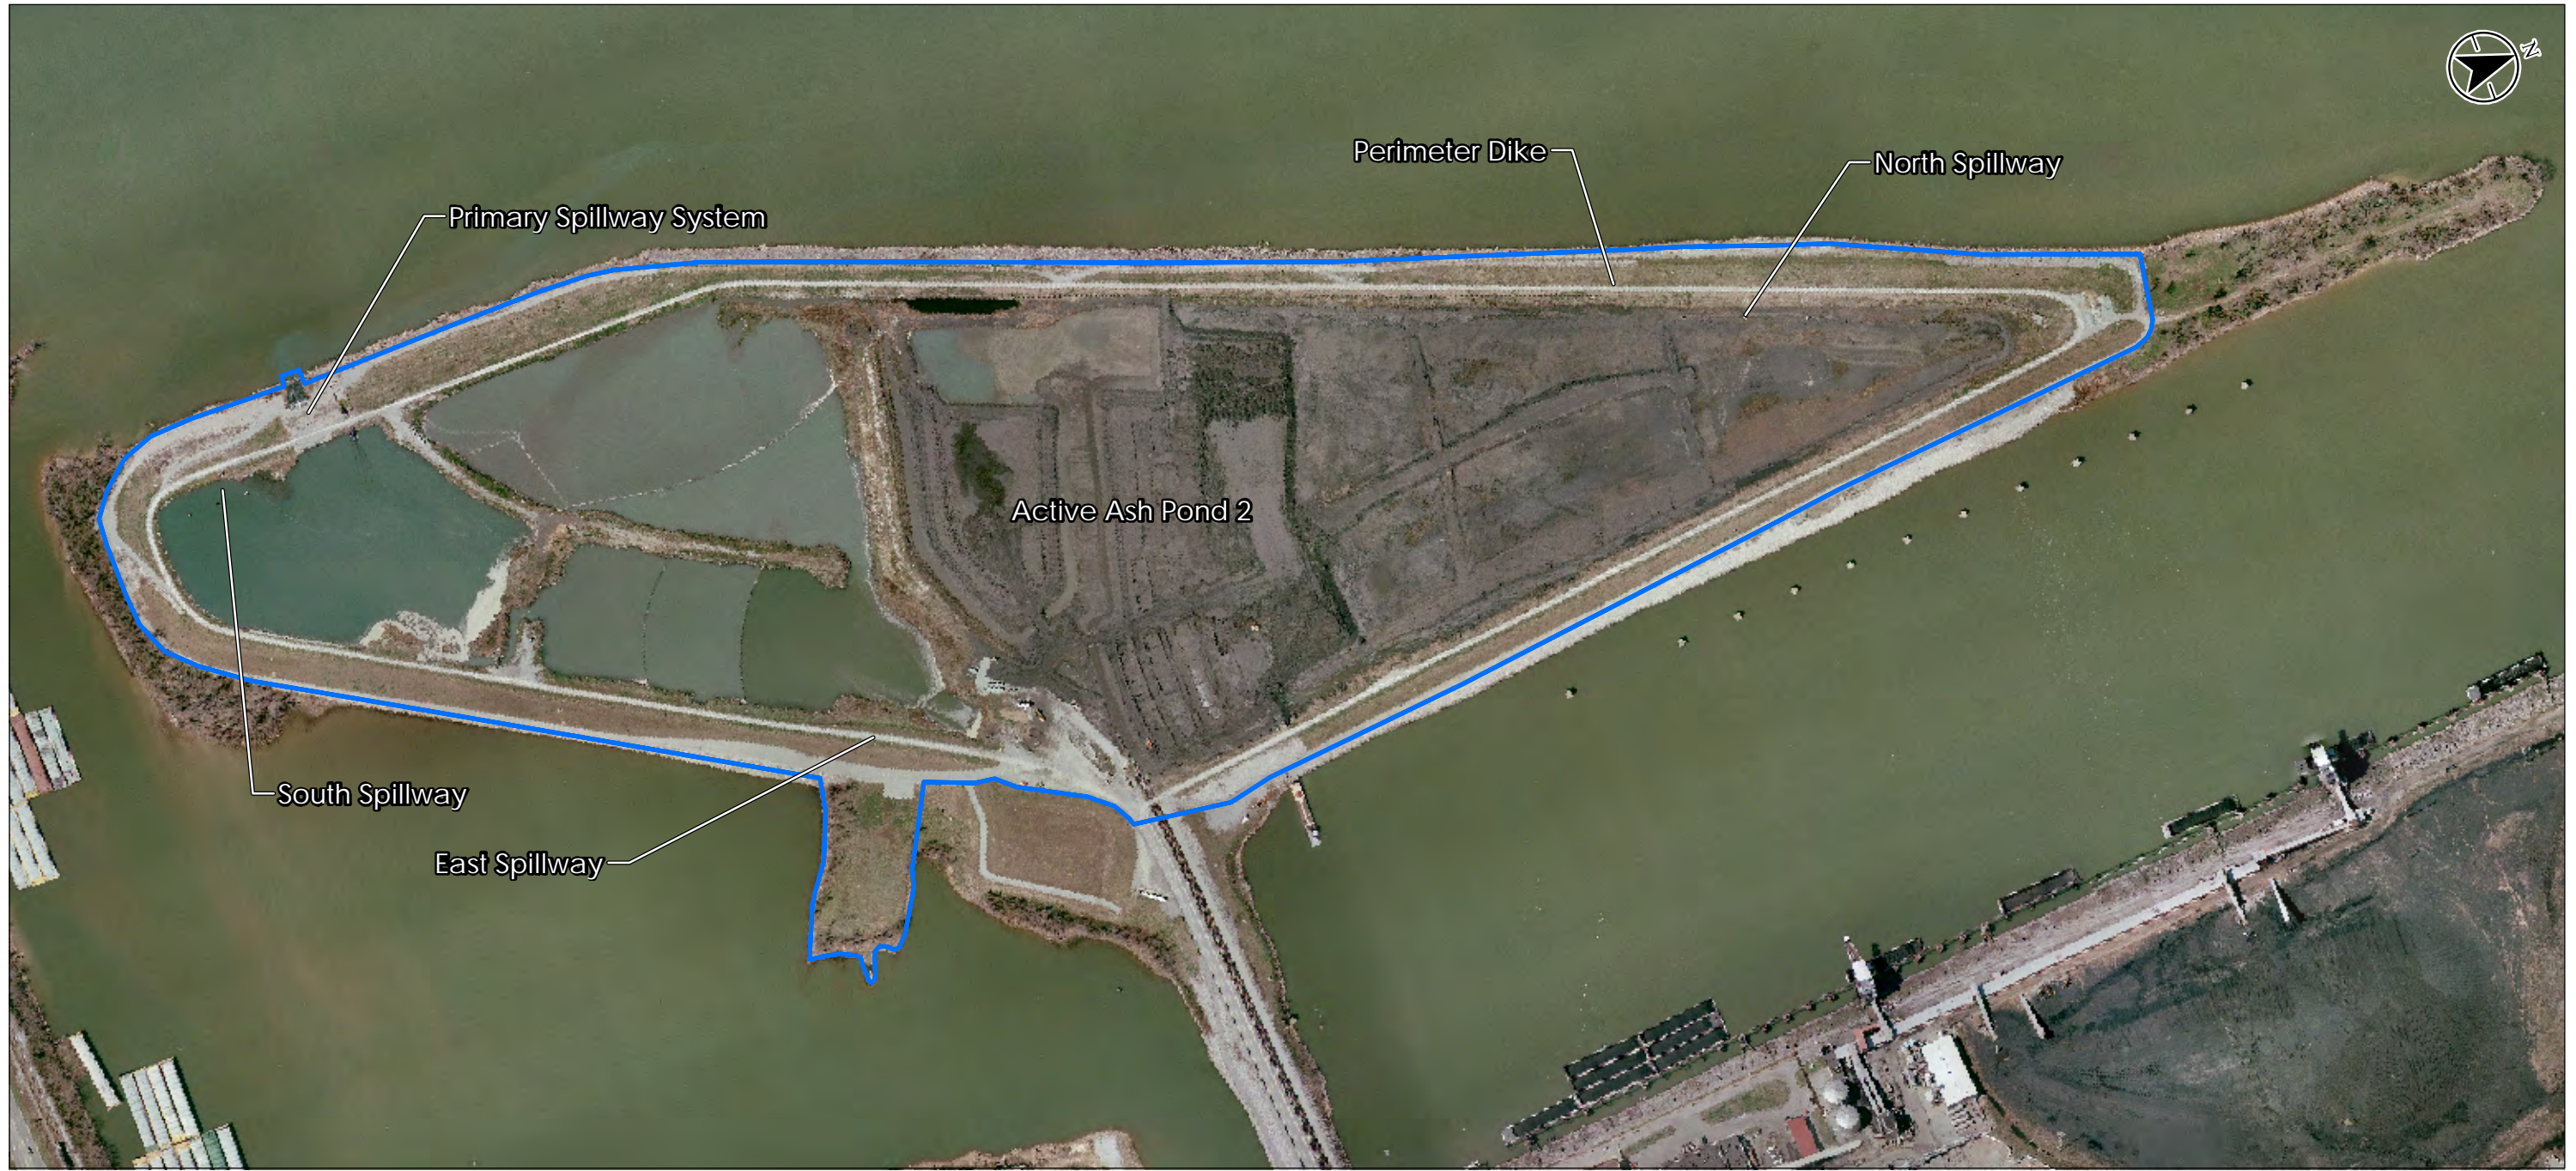
**Figure 2 JOF Active Ash Pond 2 – Plan View of Cross Sections
(Stantec, 2010a)**

The three sets of spillways were located on the northwest dike (North Spillways), southwest dike (South Spillways), and southeast dike (East Spillways) (see Figure 2 for approximate locations). Each spillway riser structure consists of 48-inch inside diameter (ID) stacked concrete pipe sections above a reinforced concrete base structure. Each outlet pipe consists of a 36-inch ID reinforced concrete pipe placed horizontally in a trench beneath the perimeter dike to discharge into Kentucky Lake (South and North Spillways) or into the plant Condenser Water Inlet Channel (East Spillways). As documented in a Construction Certification Report (Stantec, 2011a), TVA permanently ceased operation and closed the North, South, and East Spillways in 2011, as described further in Section 8.1.

Slope stability analyses were available from the Stantec (2010a). Fourteen cross sections from Active Ash Pond 2 were developed based on geotechnical boring locations as shown in Figure 2. Nine representative cross sections were selected for analyses (A-A', B-B', C-C', C1-C1', D-D', E-E', F-F', I-I', K-K', and M-M'). These representative sections were analyzed under static, long-
