**RE: Initial Structural Stability Assessment  
Stilling Pond  
EPA Final Coal Combustion Residuals (CCR) Rule  
TVA Kingston Fossil Plant  
Roane County, Tennessee**

## **Initial Structural Stability Assessment**

Kingston Fossil Plant – Stilling Pond  
Roane County, Tennessee

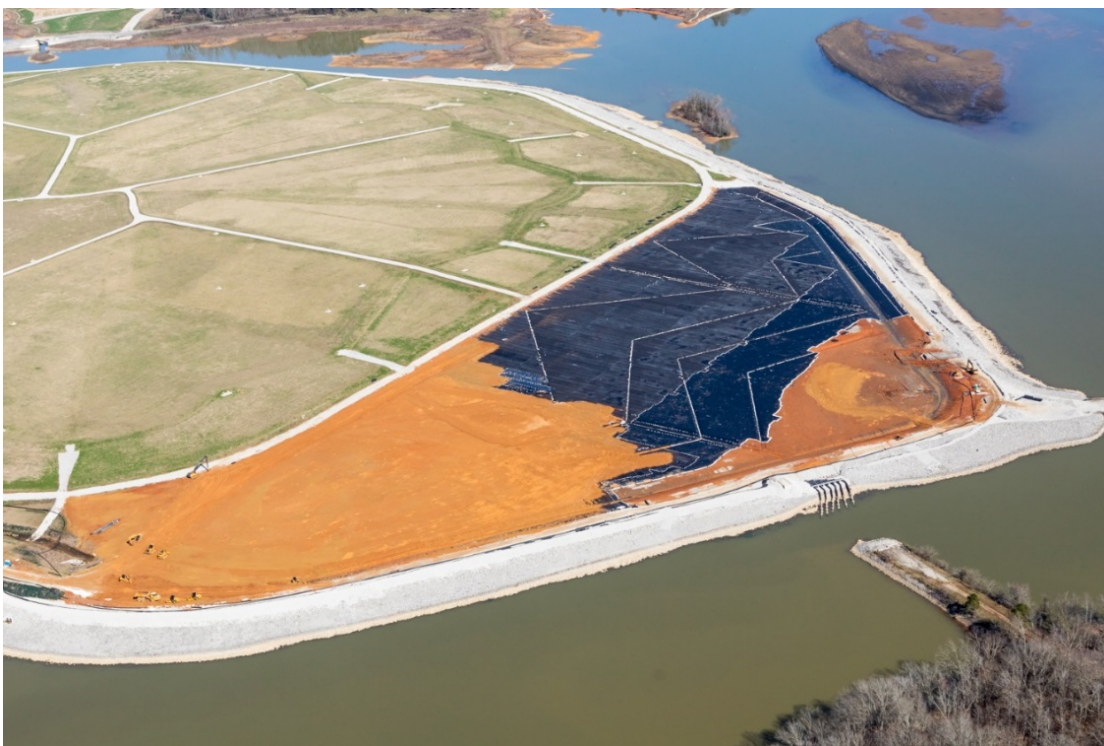
**Figure 1 Aerial Photograph of KIF Stilling Pond Closure (February 27, 2018)**

The subsections under §257.73(d) set forth criteria for the periodic structural stability assessment of the appurtenances. Sections 2.1 to 2.3 below provide descriptions of the individual unit elements that fall within the appurtenance categories: embankments, spillways, or hydraulic structures. Figure 2 provides an overview of the Stilling Pond.
