TENNESSEE VALLEY AUTHORITY (TVA) – GALLATIN FOSSIL PLANT (GAF) –
COMMISSIONER'S ORDER NUMBER OGC19-0004 – NON-REGISTERED SITE (NRS)
#83-1324 FIELD DEMONSTRATION WORK PLAN REVISION 1.

TVA has revised the NRS Field Demonstration Work Plan in response to comments from TDEC in a letter dated July 20, 2021. Enclosed are both the response to comment matrix and the Revision 1 of the NRS Field Demonstration Work Plan.

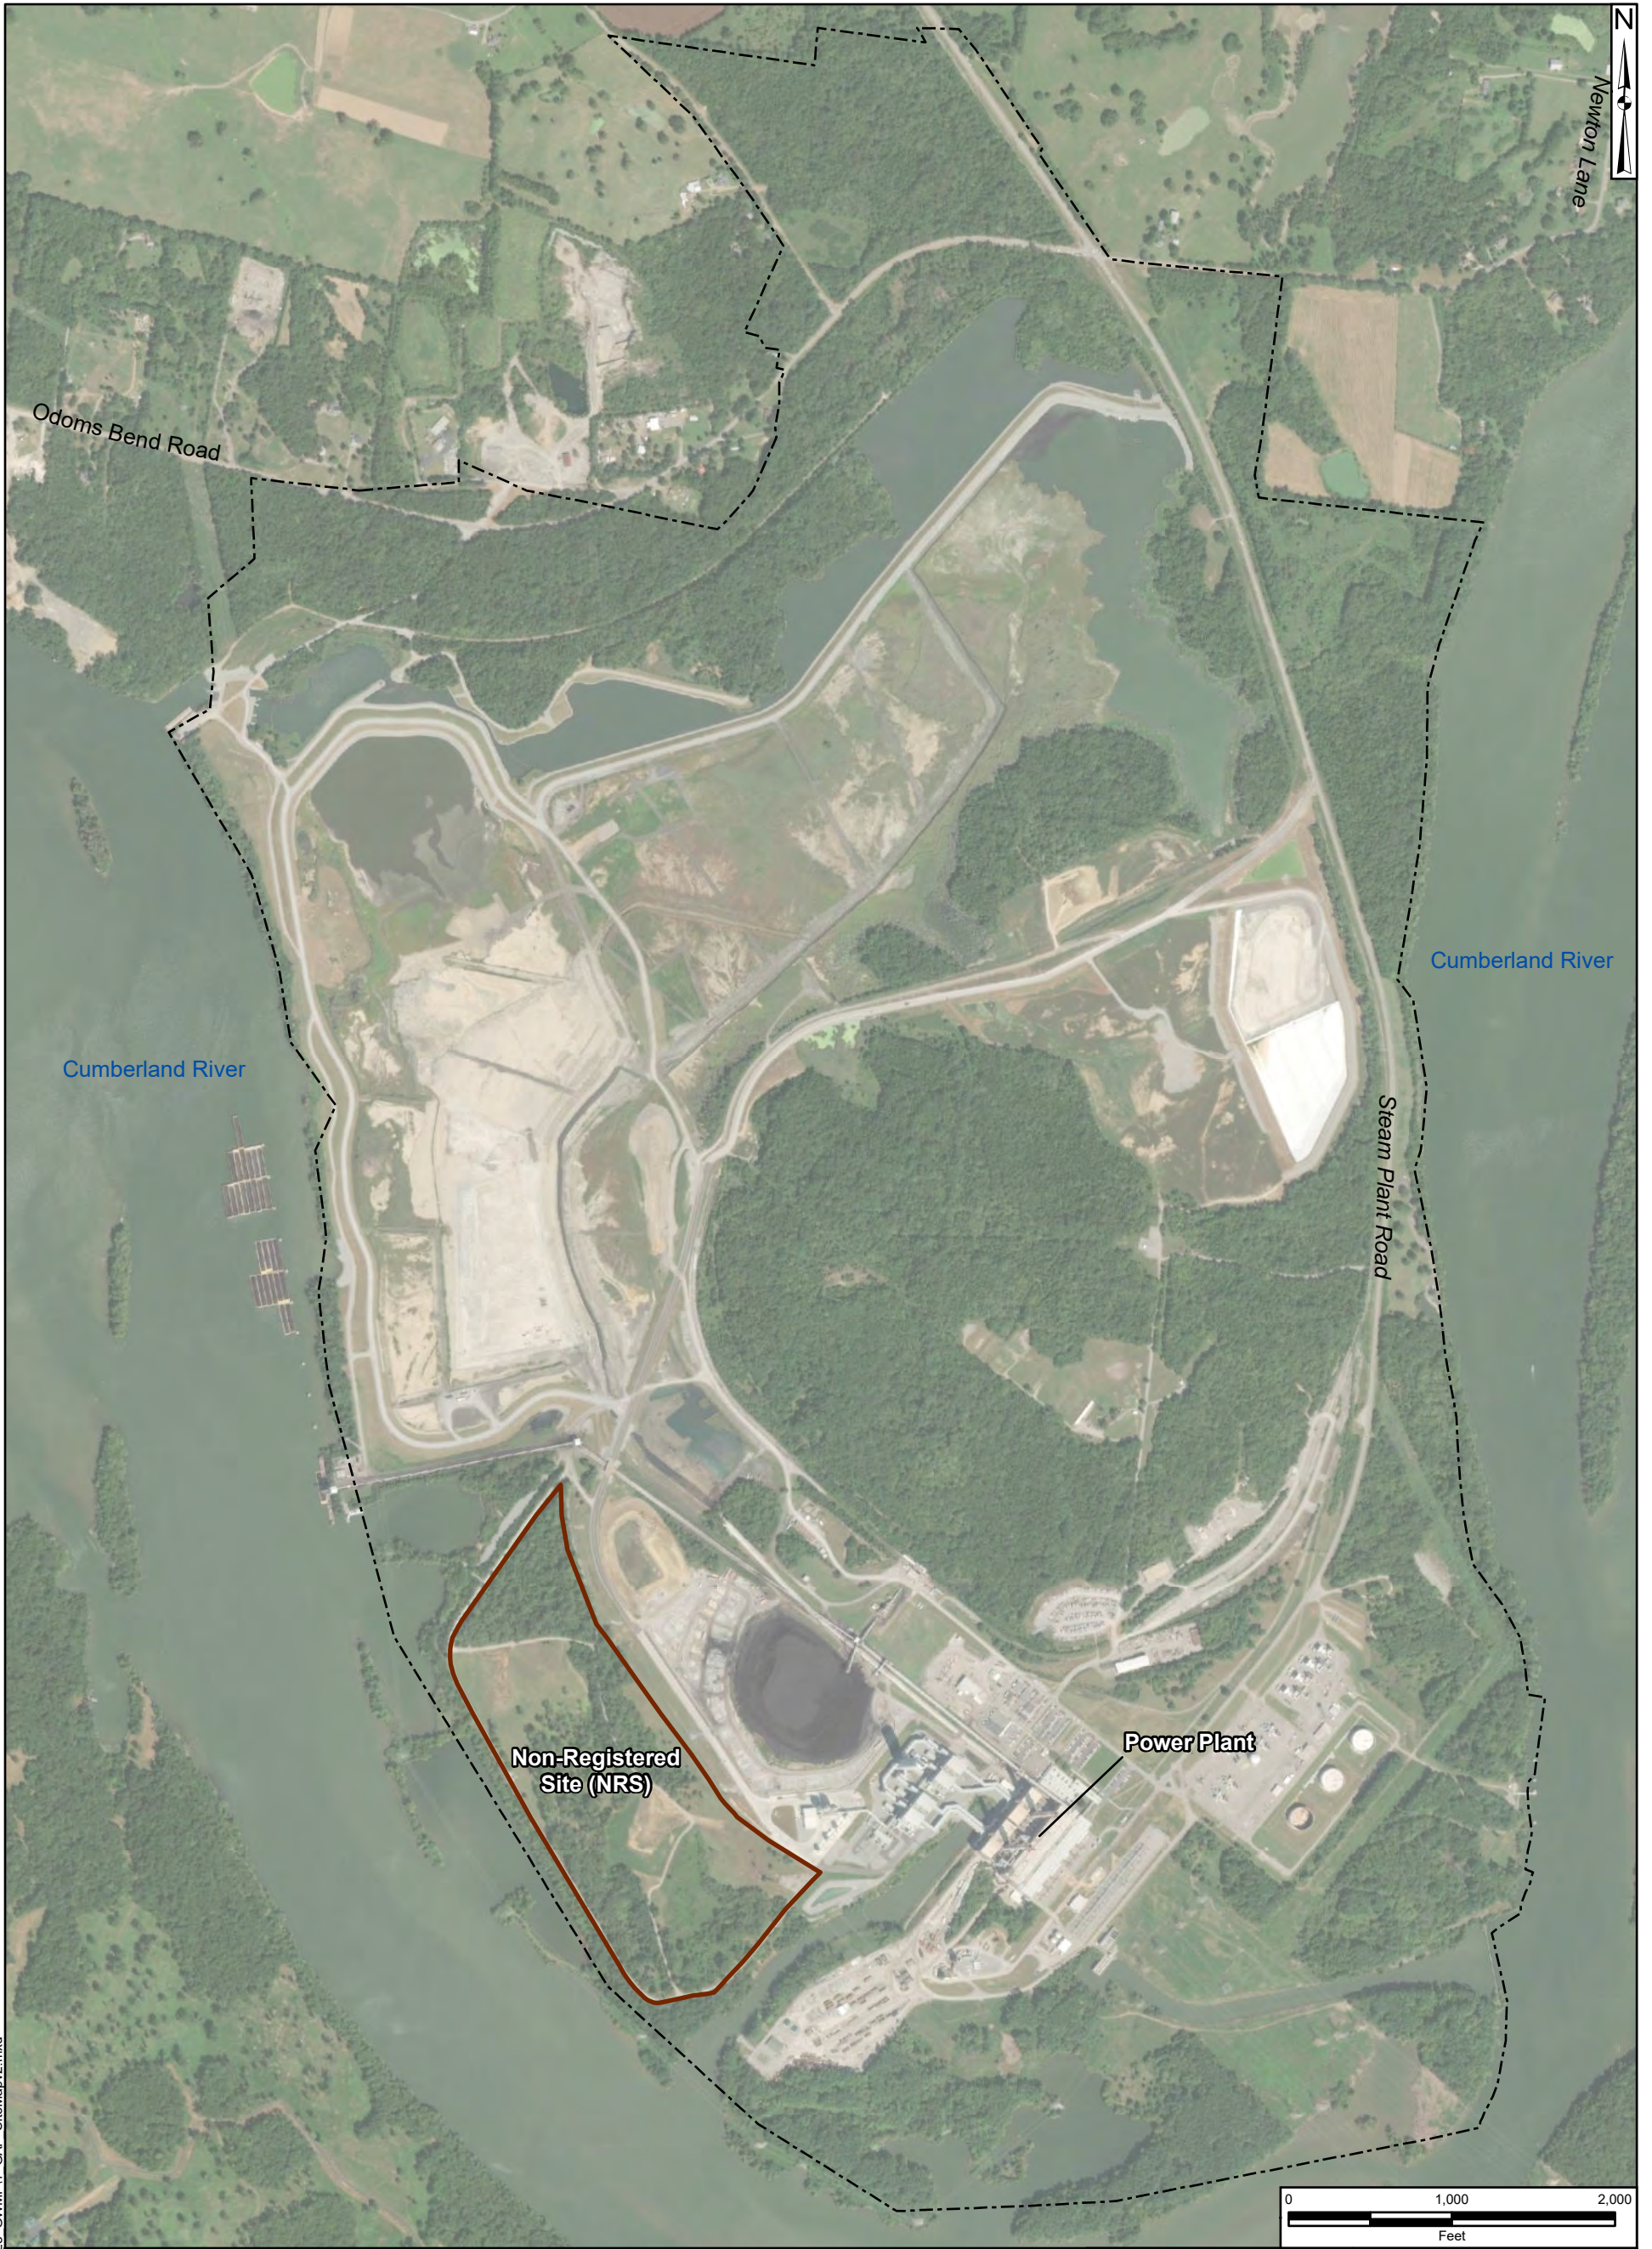
LEGEND
 Non-Registered Site (NRS)
 TVA Gallatin Fossil Plant Property Boundary (Approximate)

The NRS location is depicted in **Figure 1-1**, and a site layout is depicted as **Figure 1-2**. The NRS is an approximately 70-acre, closed surface impoundment historically used for the disposal of coal combustion residuals (CCR) prior to 1970. During groundwater monitoring activities for the NRS, concentrations of beryllium (Be), cadmium (Cd), nickel (Ni), and lithium (Li) (the target metals) were detected in groundwater samples collected from downgradient monitoring wells at concentrations greater than TDEC GWPS (TVA, 2017a).

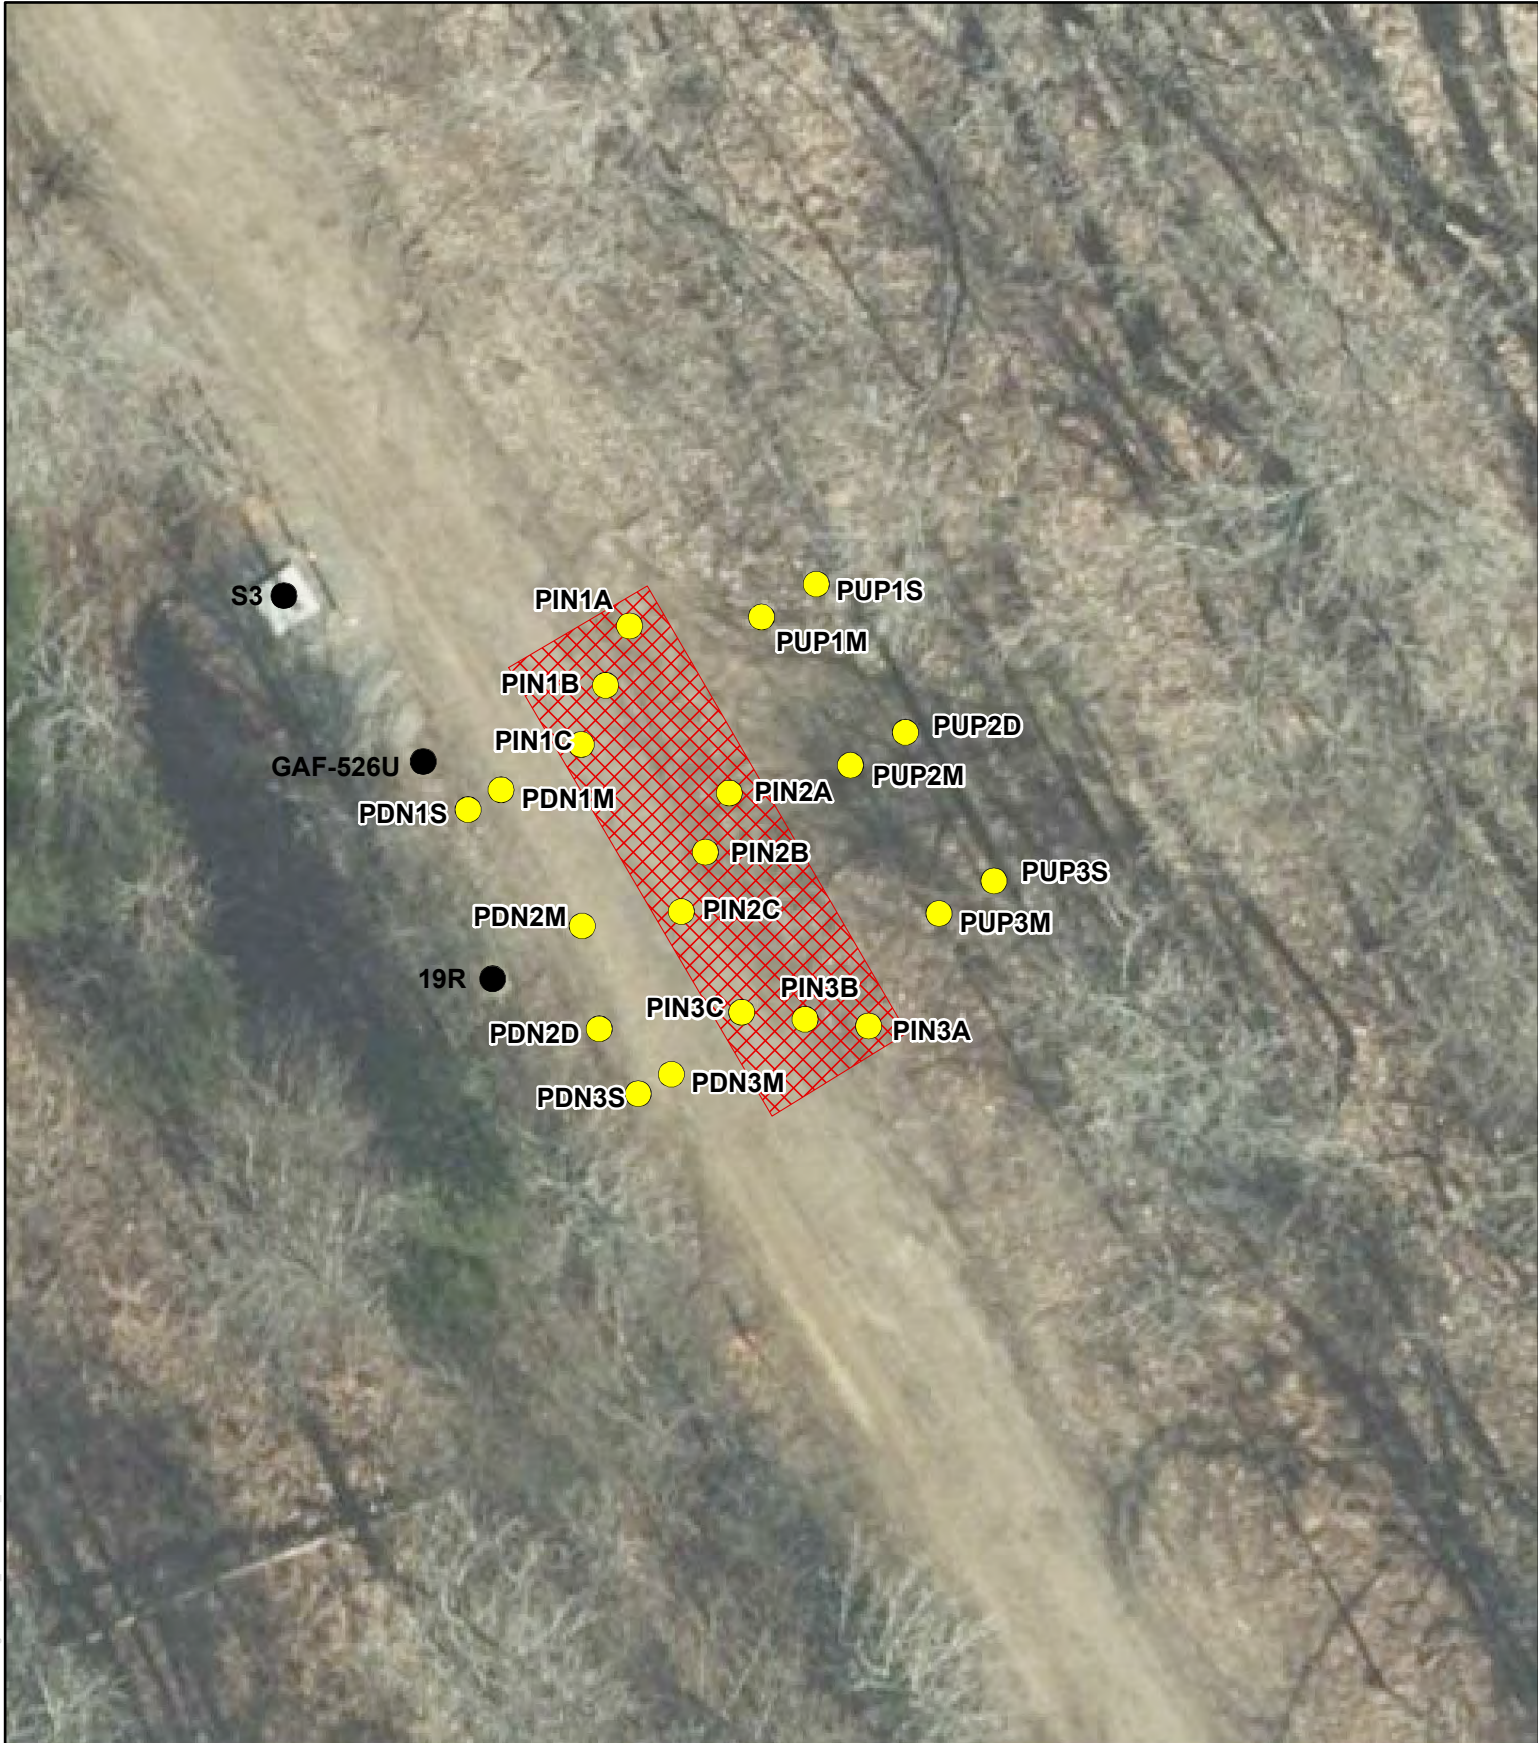
- LEGEND**
- Proposed PRB Monitoring Well
 - Existing Monitoring Well
 - Proposed PRB Wall

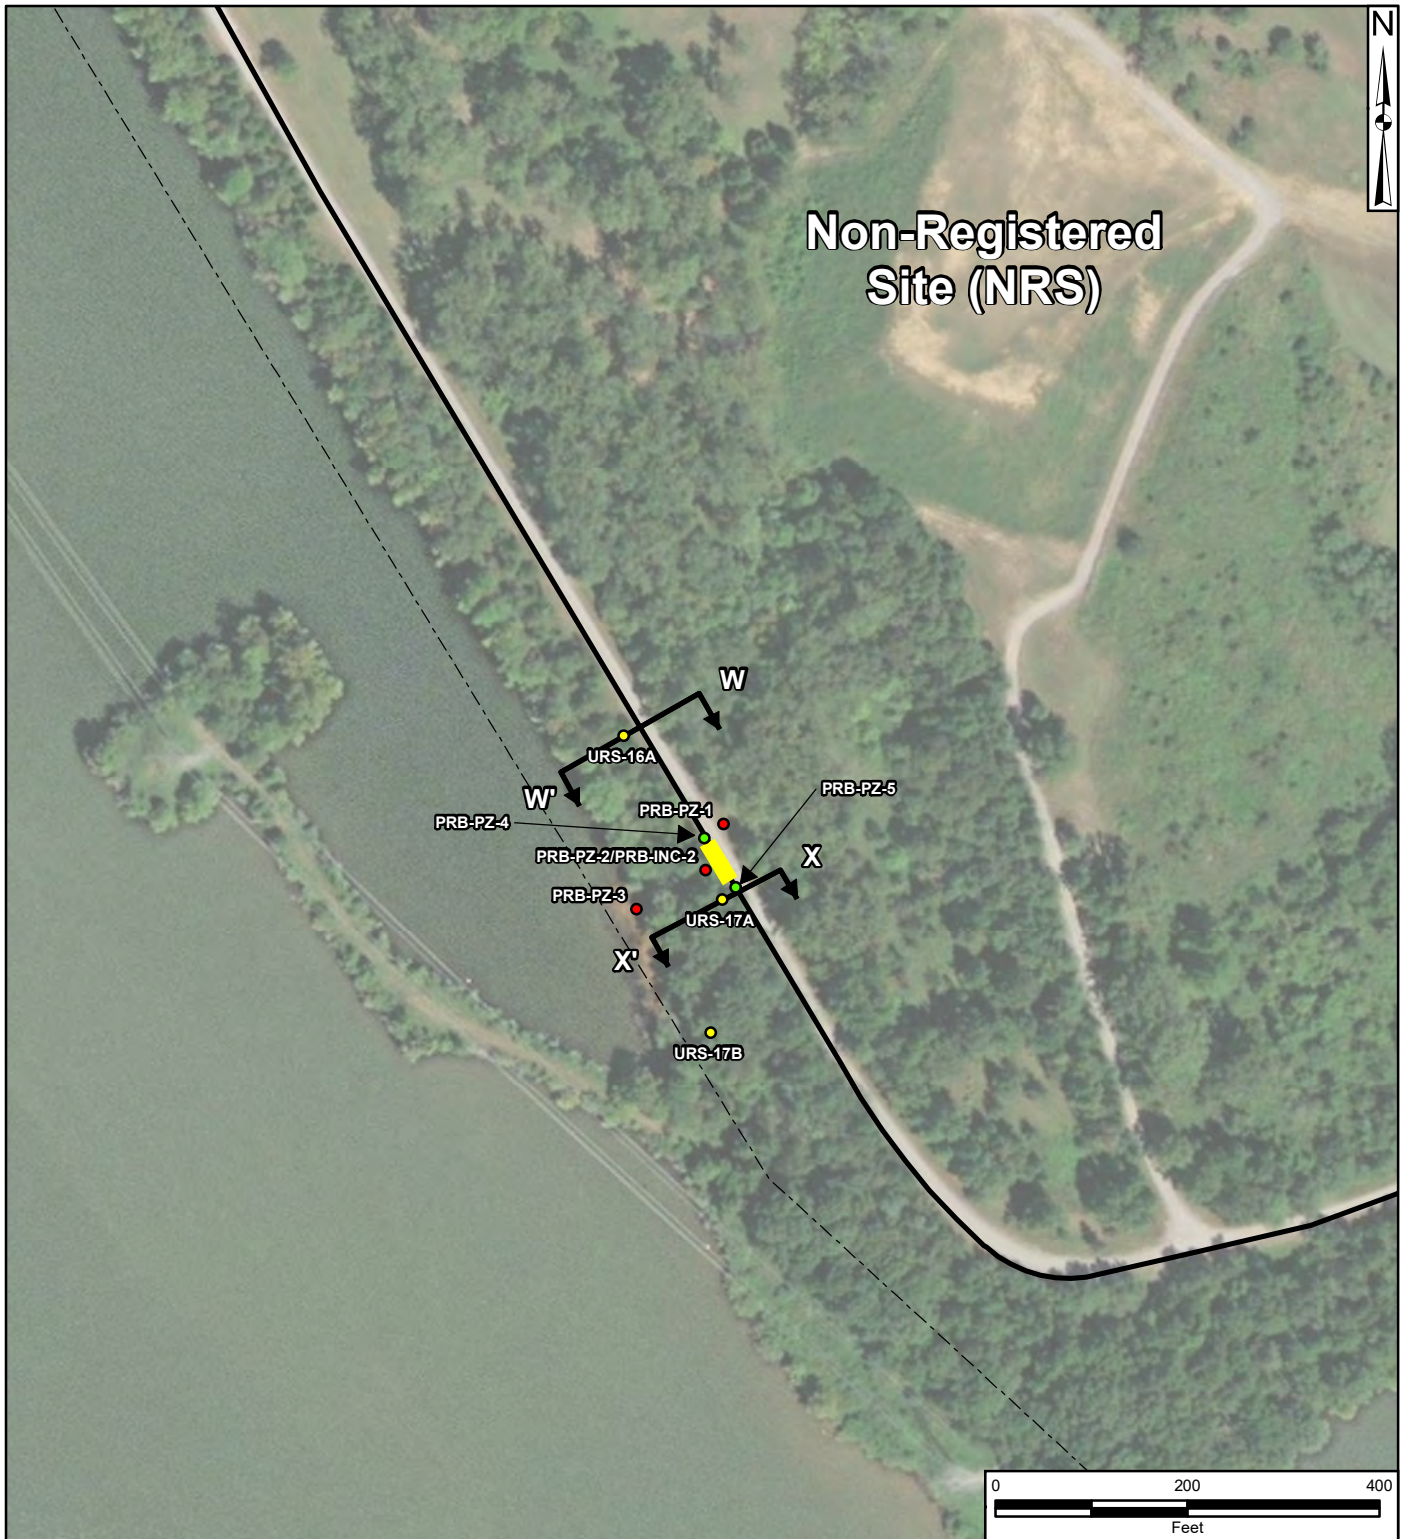
Non-Registered Site (NRS)

- Existing Piezometers
- Proposed Instruments - Slope Stability
- Proposed Instruments - Groundwater
- PRB Wall (Approximate)
- Property Boundary (Approximate)
- NRS Boundary

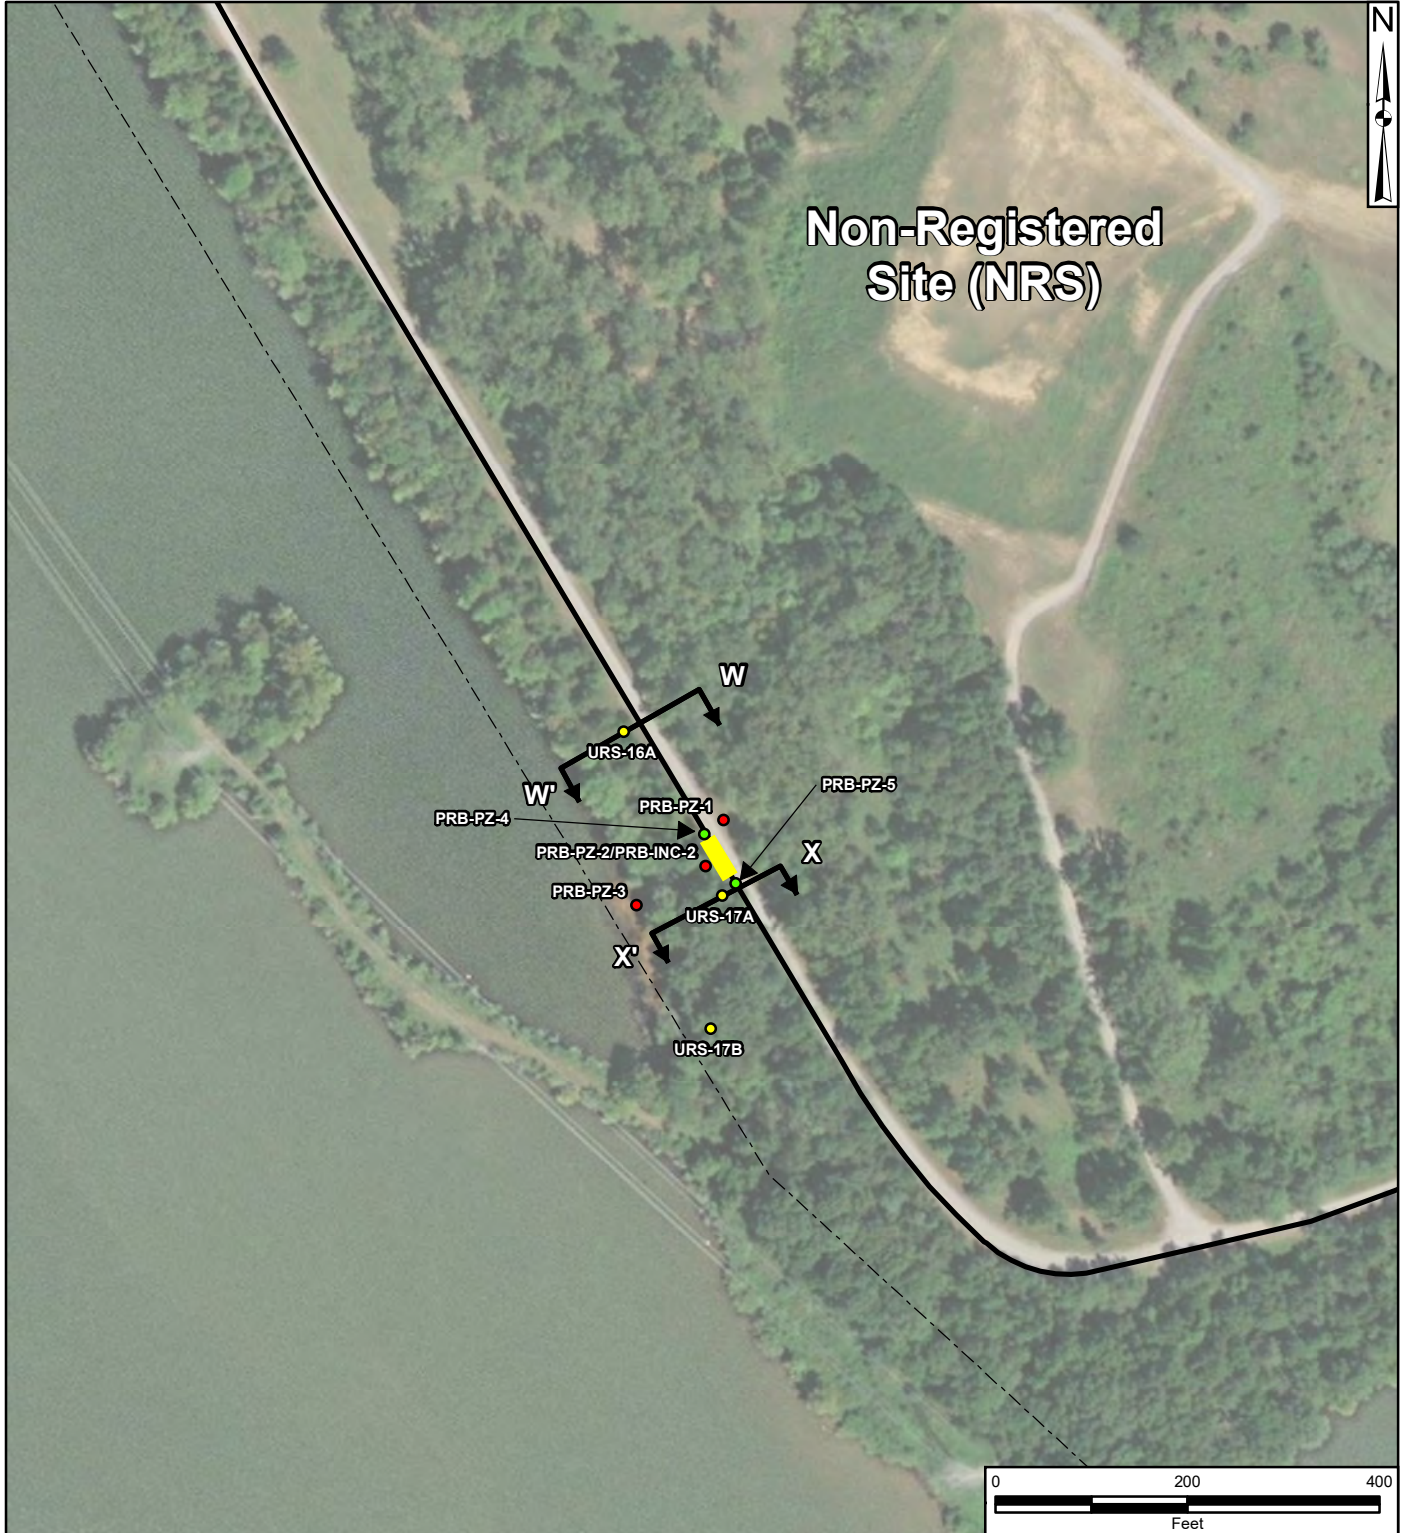
Non-Registered Site (NRS)

- Existing Piezometers
- Proposed Instruments - Slope Stability
- Proposed Instruments - Groundwater
- PRB Wall (Approximate)
- Property Boundary (Approximate)
- NRS Boundary

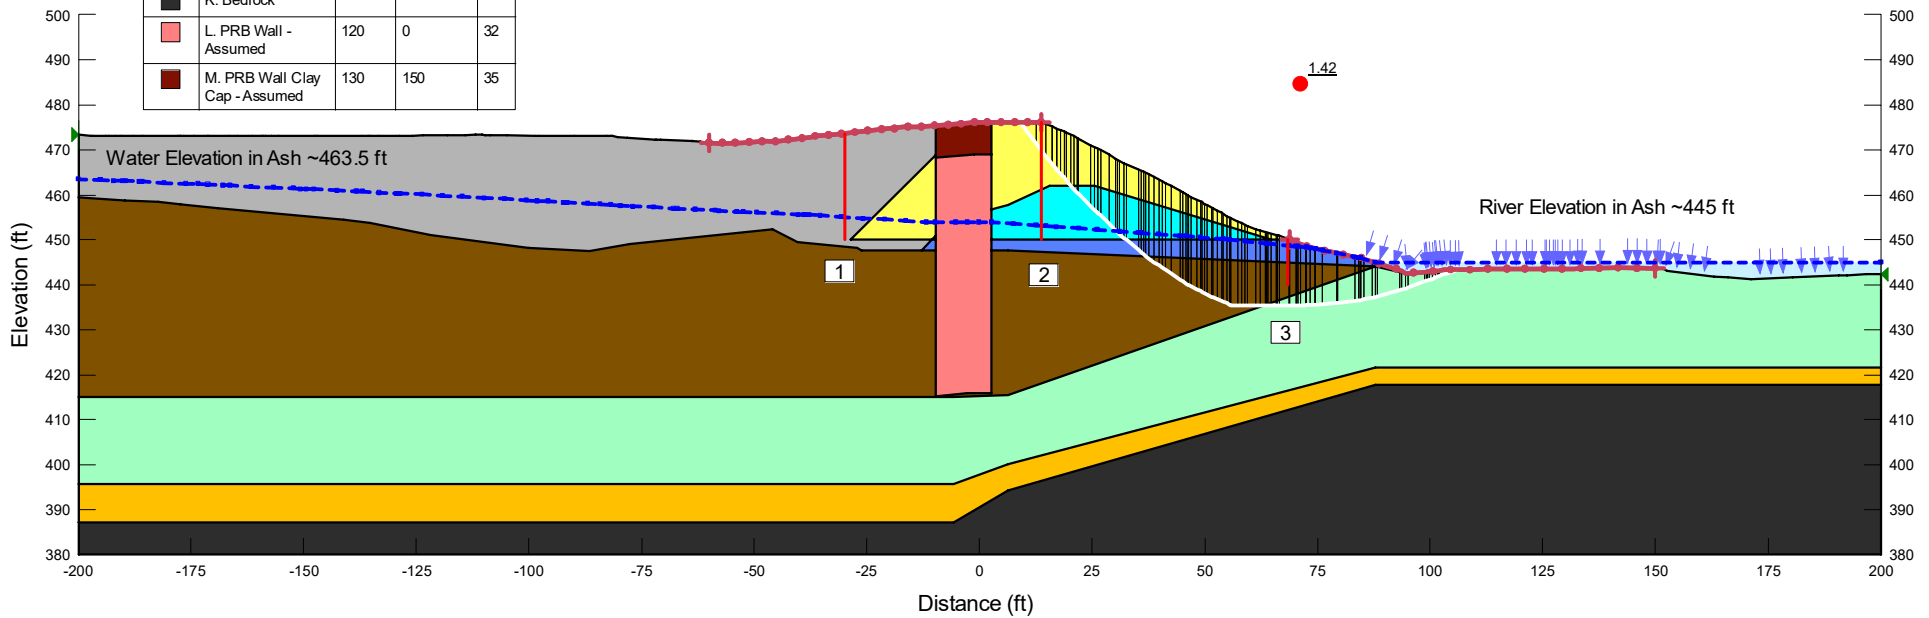
TVA GAF - NRS Permeable Reactive Barrier Wall Section X-X'

Color	Name	Unit Weight (pcf)	Cohesion* (psf)	Phi* (°)
Grey	A. CCR	90	0	42
Yellow	B. Final Raise	132	0	35
Cyan	C. 1958 Raise	132	0	35
Blue	D. Initial Embankment	132	0	35
Brown	F. Lower Alluvium	131	0	35
Light Green	G. Clayey Sand Alluvium	120	0	35
Orange	I. Residuum - North	122	0	34
Black	K. Bedrock			
Pink	L. PRB Wall - Assumed	120	0	32
Dark Red	M. PRB Wall Clay Cap - Assumed	130	150	35

21	Table 1	Summary of Selected Design Strengths	NA	NA	NA	Comment: TDEC recognizes that previous stability analyses were performed as part of the AECOM 2018 assessment so parameter selection may be better explained and justified in that document. TVA Response: Acknowledged. As part of the Stability Assessment (AECOM, 2018) 65 unit weight measurements (ASTM D4254) were performed on the embankment and foundation soils and 82 measurements were performed on CCR. In addition, various strength tests were performed on both the embankment and foundation soils and CCR. These included direct shear (DS) (ASTM D3080), unconsolidated-undrained triaxial compression (UU) (ASTM D2850), isotropically-consolidated undrained triaxial compression (CIU) (ASTM D4767), and static or cyclic direct simple shear (DSS) (ASTM D6528) tests. In total, 16 DS, 29 UU, 21 CIU, and 7 DSS tests were performed on foundation and embankment soils. Ten DS, ten CIU, 12 DSS tests were performed on CCR samples. The unit weights and material strengths used in the analyses presented herein are the same as those presented in the Stability Assessment (AECOM, 2018). The text of Appendix A – Slope Stability Calculation Package Sections 3.4.1 and 3.4.2 has been updated to reflect this testing.

No.	Section Number	Section Title	Page	Paragraph	Line	TDEC Comment dated 7/20/2021 and TVA Response
22	Table 1	Summary of Selected Design Strengths	NA	NA	NA	Comment: <u>CCR</u> : A unit weight of 90 pcf seems low and a phi of 42 seems very high for a material described as a non-plastic silt. TDEC recognizes that CCR is well away from the critical failure surfaces, so assumptions regarding these parameters are unlikely to impact results. TVA Response: See response to comment #21.
23	Table 1	Summary of Selected Design Strengths	NA	NA	NA	Comment: <u>Final Raise</u> : A unit weight of 132 pcf is surprisingly high for a clay soil, particularly one described as a "slightly over consolidated" lean clay. Also, a phi value of 35 is toward the high end of values typically used for the drained strength of clay. It should be noted that a cohesion of zero is likely conservative. As the primary driving force of the critical failure surfaces appear to be the weight of the embankment clay layers, analyzing with a lower unit weight would be expected to increase safety factors. TVA Response: See response to comment #21.
