**RE: Periodic Structural Stability Assessment
 Fly Ash Stilling Pond 2C and Sluice Channel
 EPA CCR Rule
 TVA Bull Run Fossil Plant
 Clinton, Tennessee**

**Initial Structural Stability Assessment
Stilling Pond 2C and Sluice Channel
EPA Final CCR Rule
TVA Bull Run Fossil Plant
Clinton, Tennessee**

**Initial Structural Stability Assessment
40 CFR 257.73(d)(1)
Existing CCR Surface Impoundments
TVA Bull Run Fossil Plant**

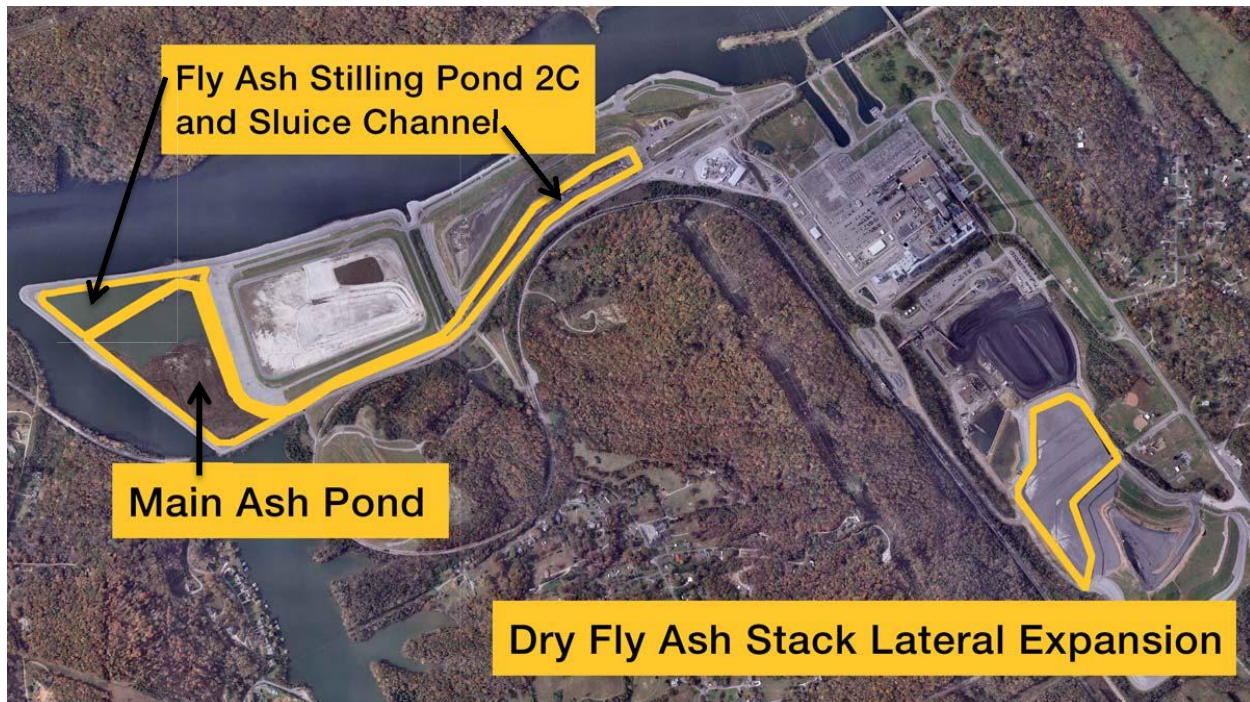
Figure 1: Ash Pond Complex

Fly Ash Stilling Pond 2C and Main Ash Pond meet both criteria. The Sluice Channel is in the process of closure and was an incised CCR unit, so the requirements in §257.73 do not apply. A plan view showing the location of Fly Ash Stilling Pond 2C, Sluice Channel, and Main Ash Pond is shown in **Figure 1**.

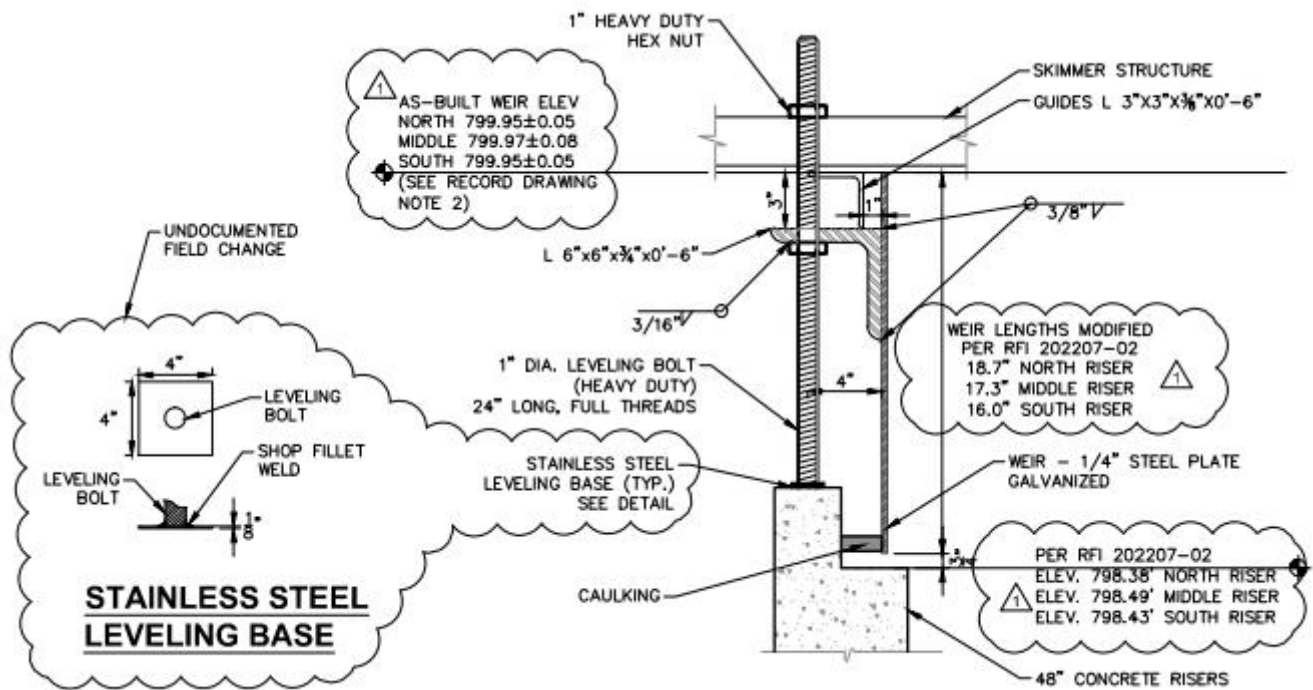
Figure 3: Weir Detail from 10W281-11

Weir ring - 1/4 in stainless steel plate, type 430

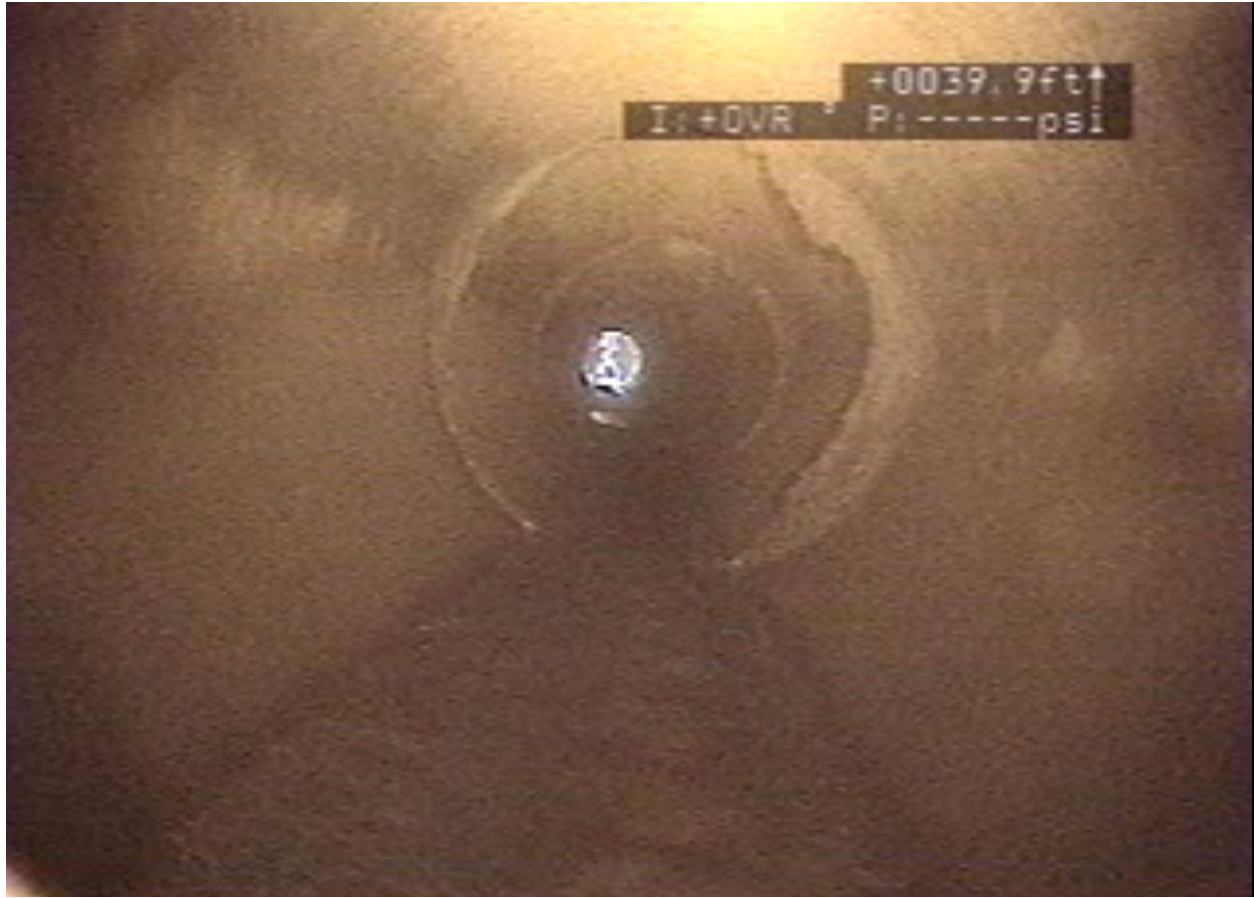
The existing outlet pipes under the perimeter dike between Stilling Pond 2C and the Clinch River have been inspected via camera. The video inspection was completed prior to the spillway modification project completed in 2011. The interior of the outlet pipes were generally in good condition with some minor to moderate deposit encrustation (see **Appendix B** showing an image from the video inspection of the middle outlet pipe). Minimal joint leaking was also noted in the outlet pipes. Evaluation of the video recordings showed a clear pathway for the water flow without any significant obstruction or debris present inside the outlet pipes. Visual inspections of the dikes where pipes pass through do not show any signs of deformation. The pipes have been evaluated for buckling stability for two different limit states: usual loading conditions associated with regularly occurring pool levels and unusual loading conditions associated with the design flood event. All associated calculations, including the structure's geometry and material properties are included in **Appendix A**. The pipes satisfy the stability checks for the limit states considered. Also, in the Stilling Pond Closure Plan (AECOM drawing 10W524-09), the outlet pipes will be slip lined using cured-in-place (CIPP) lining. The liner will seal the pipe joints and add a layer of protection against leakage.

Image 1. Video inspection of outlet pipe from middle riser in Stilling Pond 2C, view looking towards spillway riser showing minor encrustation and minimal leaking.
