**RE: Periodic Structural Stability Assessment
 Main Ash Pond
 EPA CCR Rule
 TVA Bull Run Fossil Plant
 Clinton, Tennessee**

**Initial Structural Stability Assessment
Main Ash Pond
EPA Final CCR Rule
TVA Bull Run Fossil Plant
Clinton, Tennessee**

**Initial Structural Stability Assessment
40 CFR 257.73(d)(1)
Existing CCR Surface Impoundments
TVA Bull Run Fossil Plant**

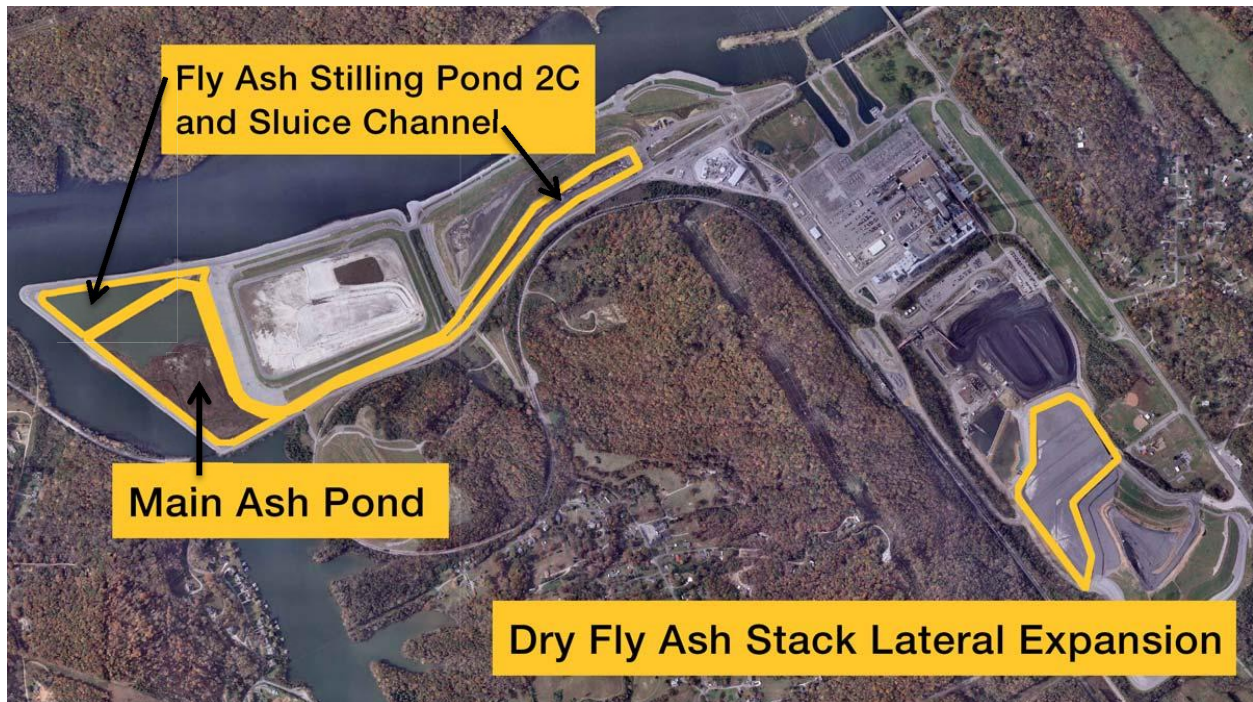
Figure 1: Ash Pond Complex

Fly Ash Stilling Pond 2C and Main Ash Pond meet both criteria. The Sluice Channel is in the process of closure and was an incised CCR unit, so the requirements in §257.73 do not apply. A plan view showing the location of Fly Ash Stilling Pond 2C, Sluice Channel, and Main Ash Pond is shown in **Figure 1**.
