**RE: Unstable Areas Demonstration
Dry Ash Stack
EPA Final Coal Combustion Residuals (CCR) Rule
TVA Cumberland Fossil Plant
Cumberland City, Tennessee**

Unstable Areas Demonstration

Dry Ash Stack
Cumberland Fossil Plant
Stewart County, Tennessee

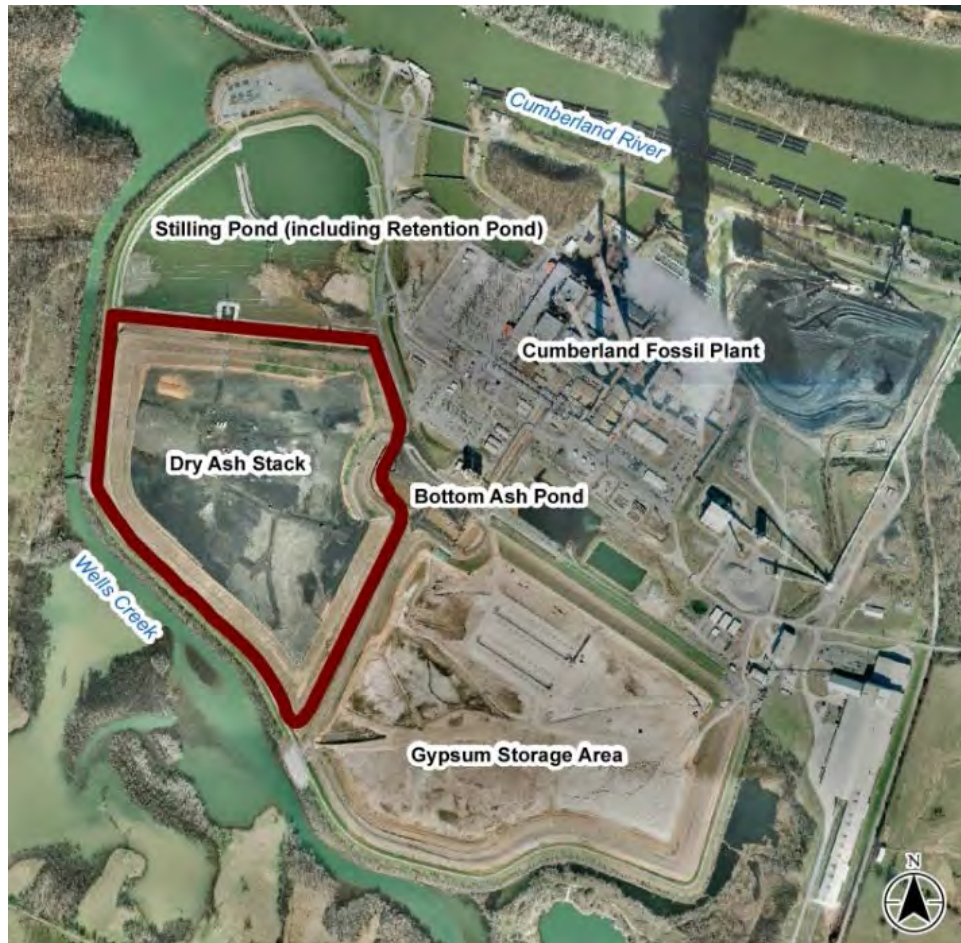
Figure 1. Site Vicinity Map

Referring to Figure 1, the Dry Ash Stack is located northwest of the Gypsum Storage Area, south of the Stilling Pond, and southwest of the powerhouse. TVA has determined that the Dry Ash Stack is a CCR existing landfill and therefore subject to the CCR rule.

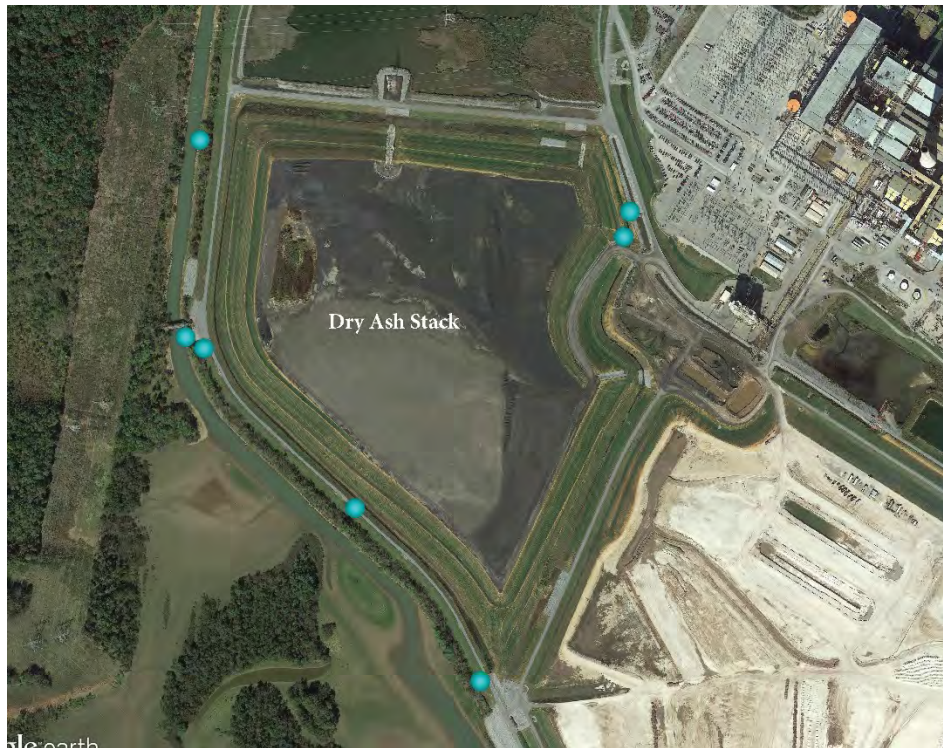
Figure 2. Dry Ash Stack Unit Configuration

Originally, the Dry Ash Stack was a portion of a larger ash disposal area enclosed by an earthfill perimeter dike constructed in 1969. In 1986, approximately 300 feet of the west portion of the divider dike between the Ash Pond and the Dry Ash Stack was constructed. The current Dry Ash Stack is considered to be an existing landfill based on the distinction that it was constructed as a Class II landfill under TDEC permit IDL 81-102-0086 issued in 1996. The permit allowed for portions of the existing surface impoundments to be transitioned to the Gypsum Storage Area and Dry Ash Stack. As part of the Class II landfill permit, in 1996, the current divider dike between the Ash Pond and Dry Ash Stack was constructed (exterior divider dike) to form the current configuration. In 1996, stacking within the Dry Ash Stack began (Stantec Consulting Services Inc., 2010a). Since 1996, TDEC has approved various permit modifications for these CCR units. The CCR Rule became effective in 2015 and does not apply retroactively to the surface impoundments that were transitioned to landfills in compliance with the 1996 TDEC permit. The Dry Ash Stack does not meet the definition of an overfill per the CCR Rule, i.e., "a new CCR landfill constructed over a closed CCR surface impoundment," 40 CFR Part 257.53. A "new CCR landfill" is defined as "a CCR landfill or lateral expansion of a CCR landfill that first receives CCR or commences construction after October 14, 2015," 40 CFR Part 257.53.

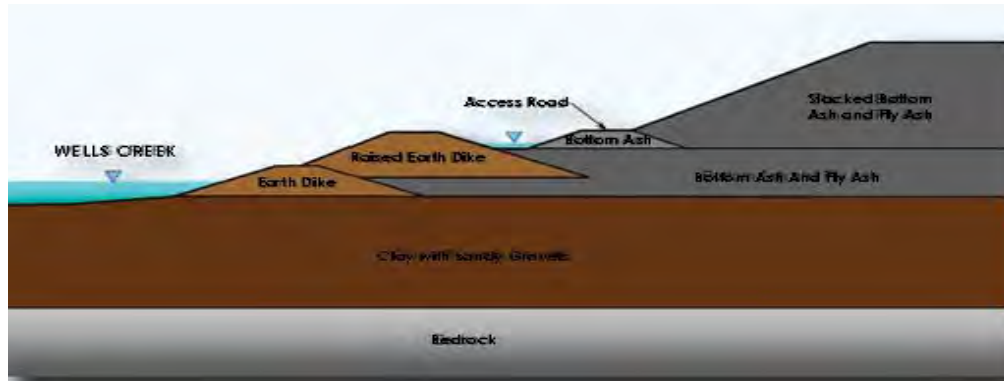
Figure 3. Typical Cross Section

Three Geotechnical Investigations have been conducted of the Dry Ash Stack. These Investigations were conducted and reviewed for concurrence with the potential existence of soft soils and published soil surveys. The foundation soils consist of alluvial clay and sand deposits that vary in thickness from approximately 10 to 35 feet within a portion of the floodplain area on the site. The alluvial clay material was described as lean clay with a silty and/or sandy gradation (Stantec Consulting Services Inc., 2010a). The soil was described as moist to wet, reddish brown to light gray in color and has consistencies that generally range from soft to very stiff.

The alluvial sands were mostly found to be beneath the clay layer and described as silty sand with gravel, gravel with clay, and silt and sand (Stantec Consulting Services Inc., 2010a).

As identified by the "Report of Geotechnical Exploration, Dry Fly Ash Stack and Gypsum Disposal Complex, Cumberland Fossil Plant" (Stantec Consulting Services Inc., 2010a), the Dry Ash Stack perimeter was composed of three dike materials of the original ash pond perimeter. The original perimeter dike, Dike 1, extends from approximate elevation 350 to elevation 380 feet. The material has a textural description of lean clay. The soil was described as moist to wet and red brown to gray brown in color. This soil layer has consistencies that generally range from very soft to very stiff. Dike 2 is the raised dike of the original perimeter dike, built with upstream construction methods located only on the outside perimeter of the Dry Ash Stack. The raised dike has 2 distinct soil horizons of fat and lean clay. The lean clay was field classified as lean clay with gravel and some cobbles with a light brown to brown color. The soil consistency of this layer generally ranges from soft to very stiff. The fat clay has a textural descriptions of fat clay with gravel. The material was described as damp to wet and dark brown to reddish brown in color. The soil consistency of this layer generally ranges from firm to very stiff. The Divider Dike between the Retention Pond and the Dry Ash Stack has a distinct composition of riprap or boulder zones with a reddish brown silty clay matrix. The clay matrix is light brown to reddish or grayish brown and has consistencies ranging from stiff to very stiff. Typically, the clay was field-classified as lean with some fat clay present. (Stantec Consulting Services Inc., 2010a).

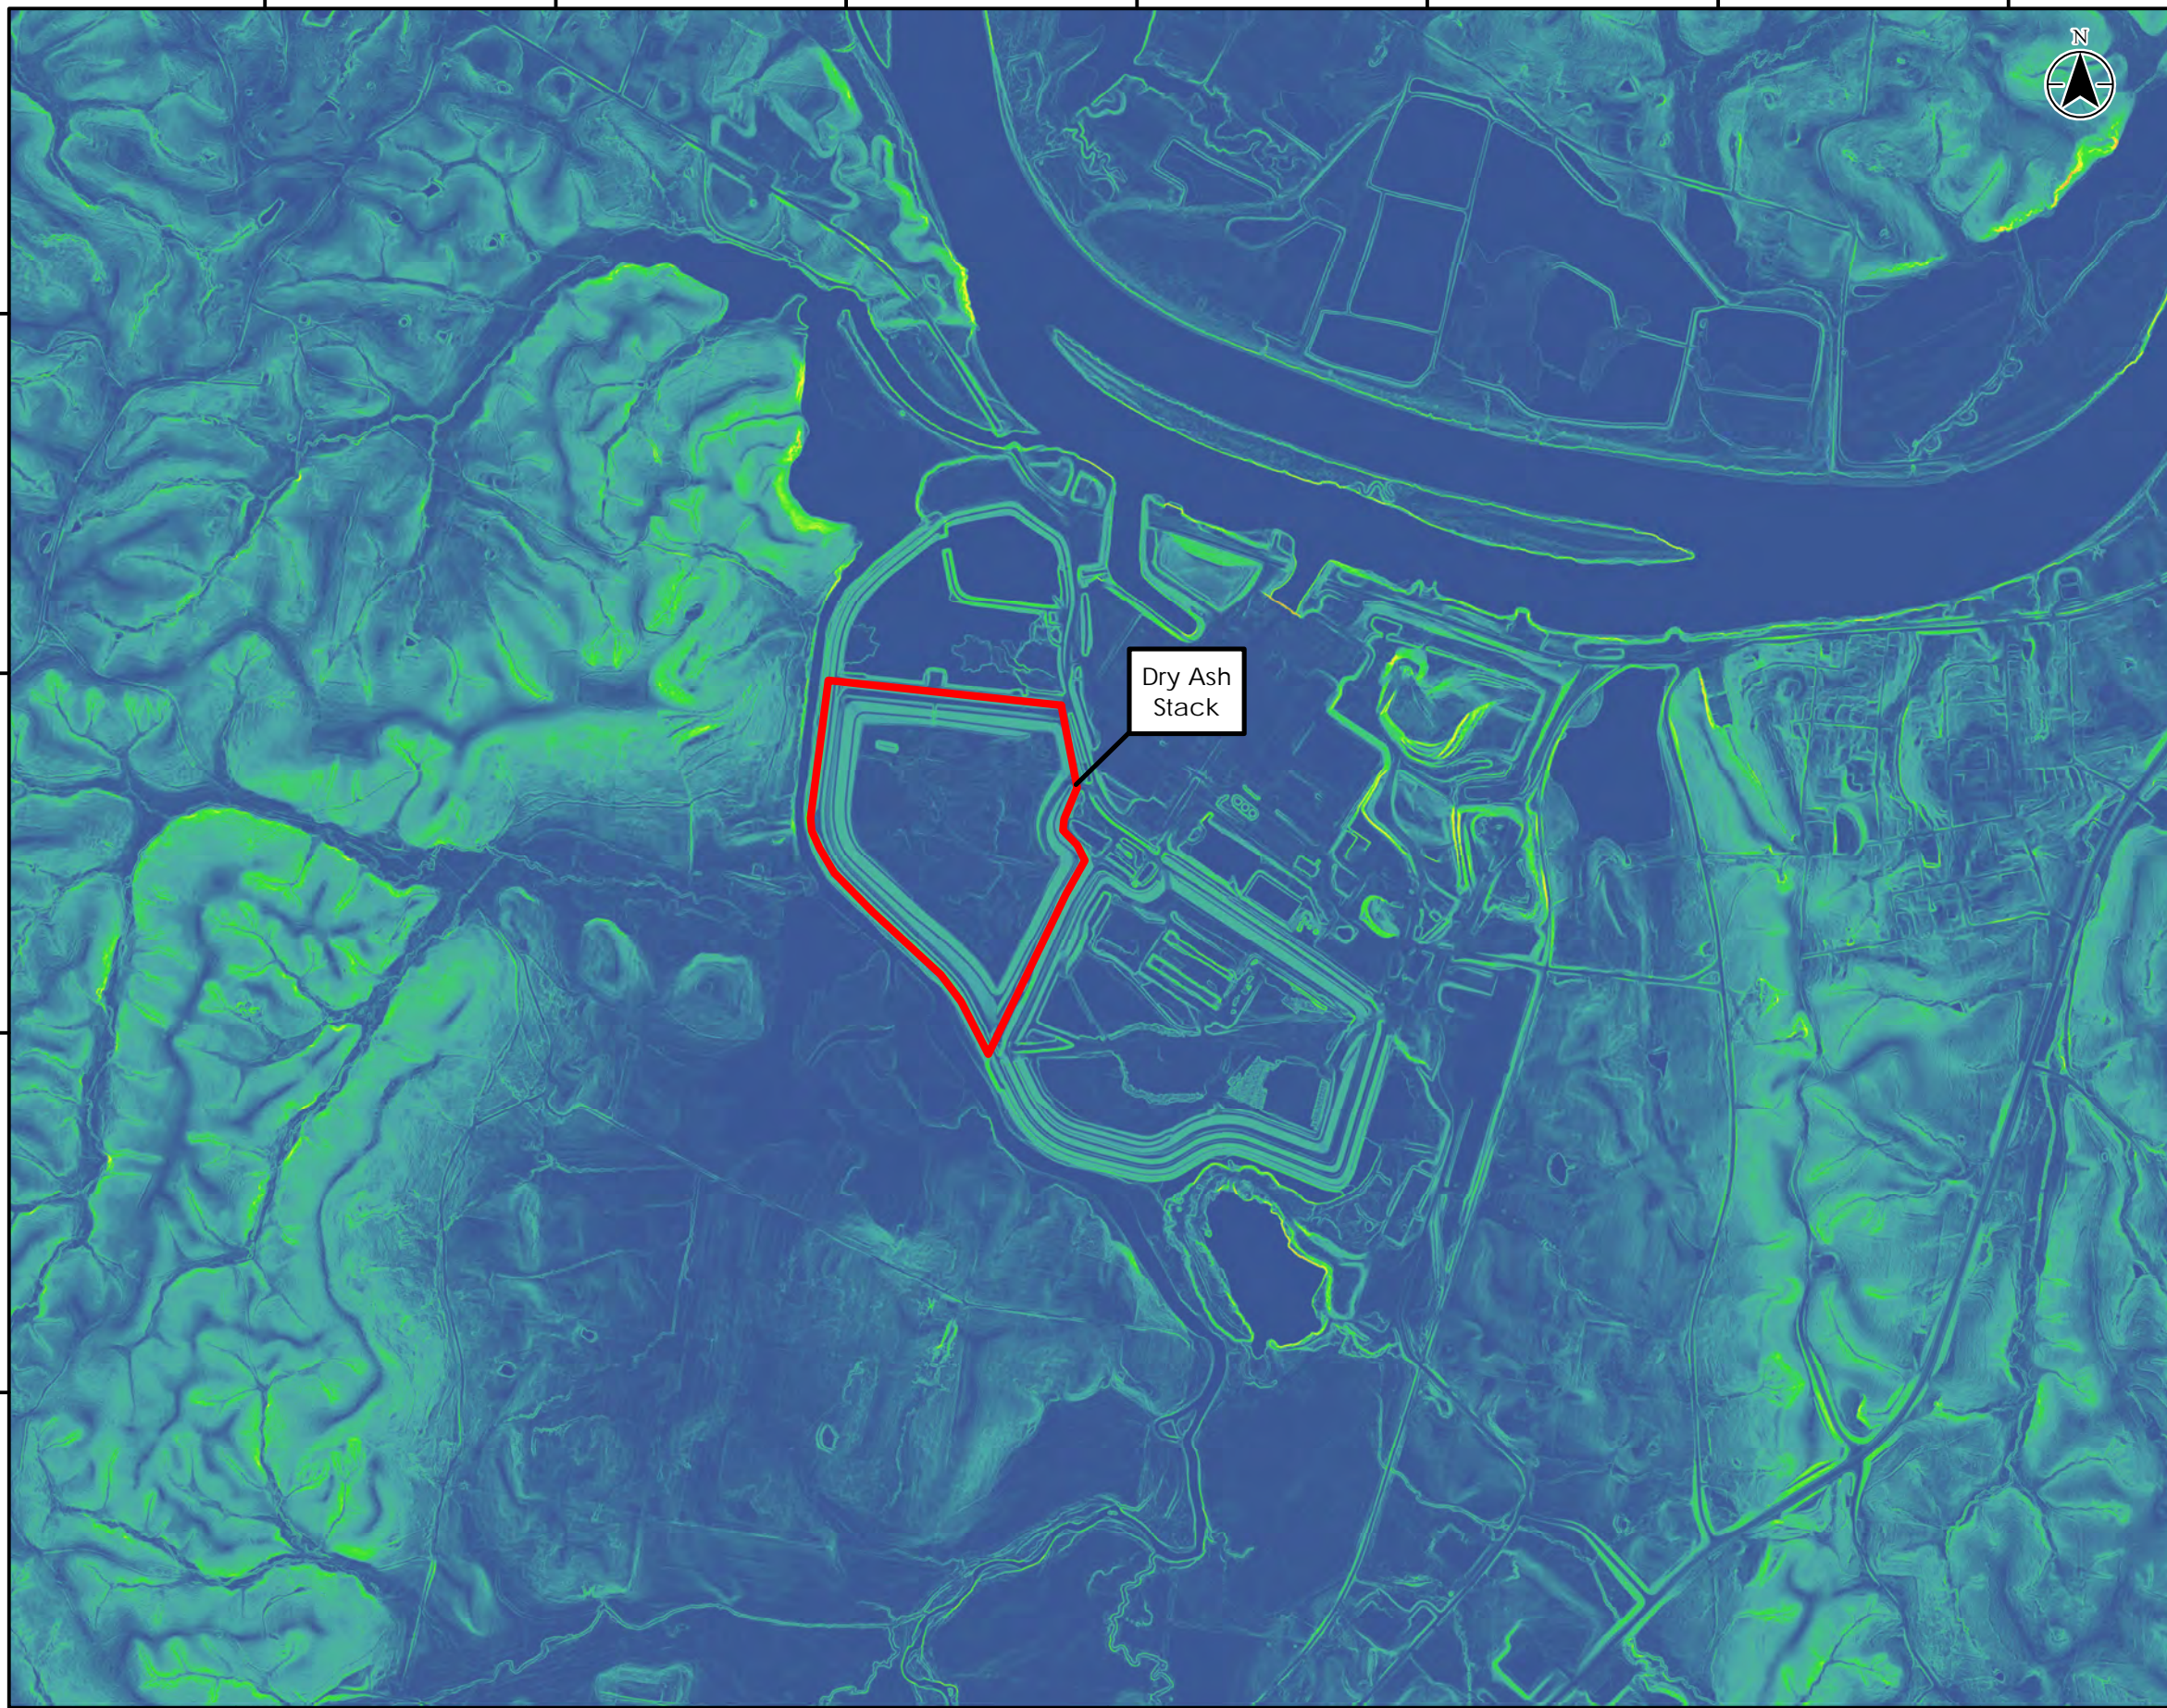
Slope Raster Map

Site
 Cumberland Fossil Plant (CUF)
 Dry Ash Stack

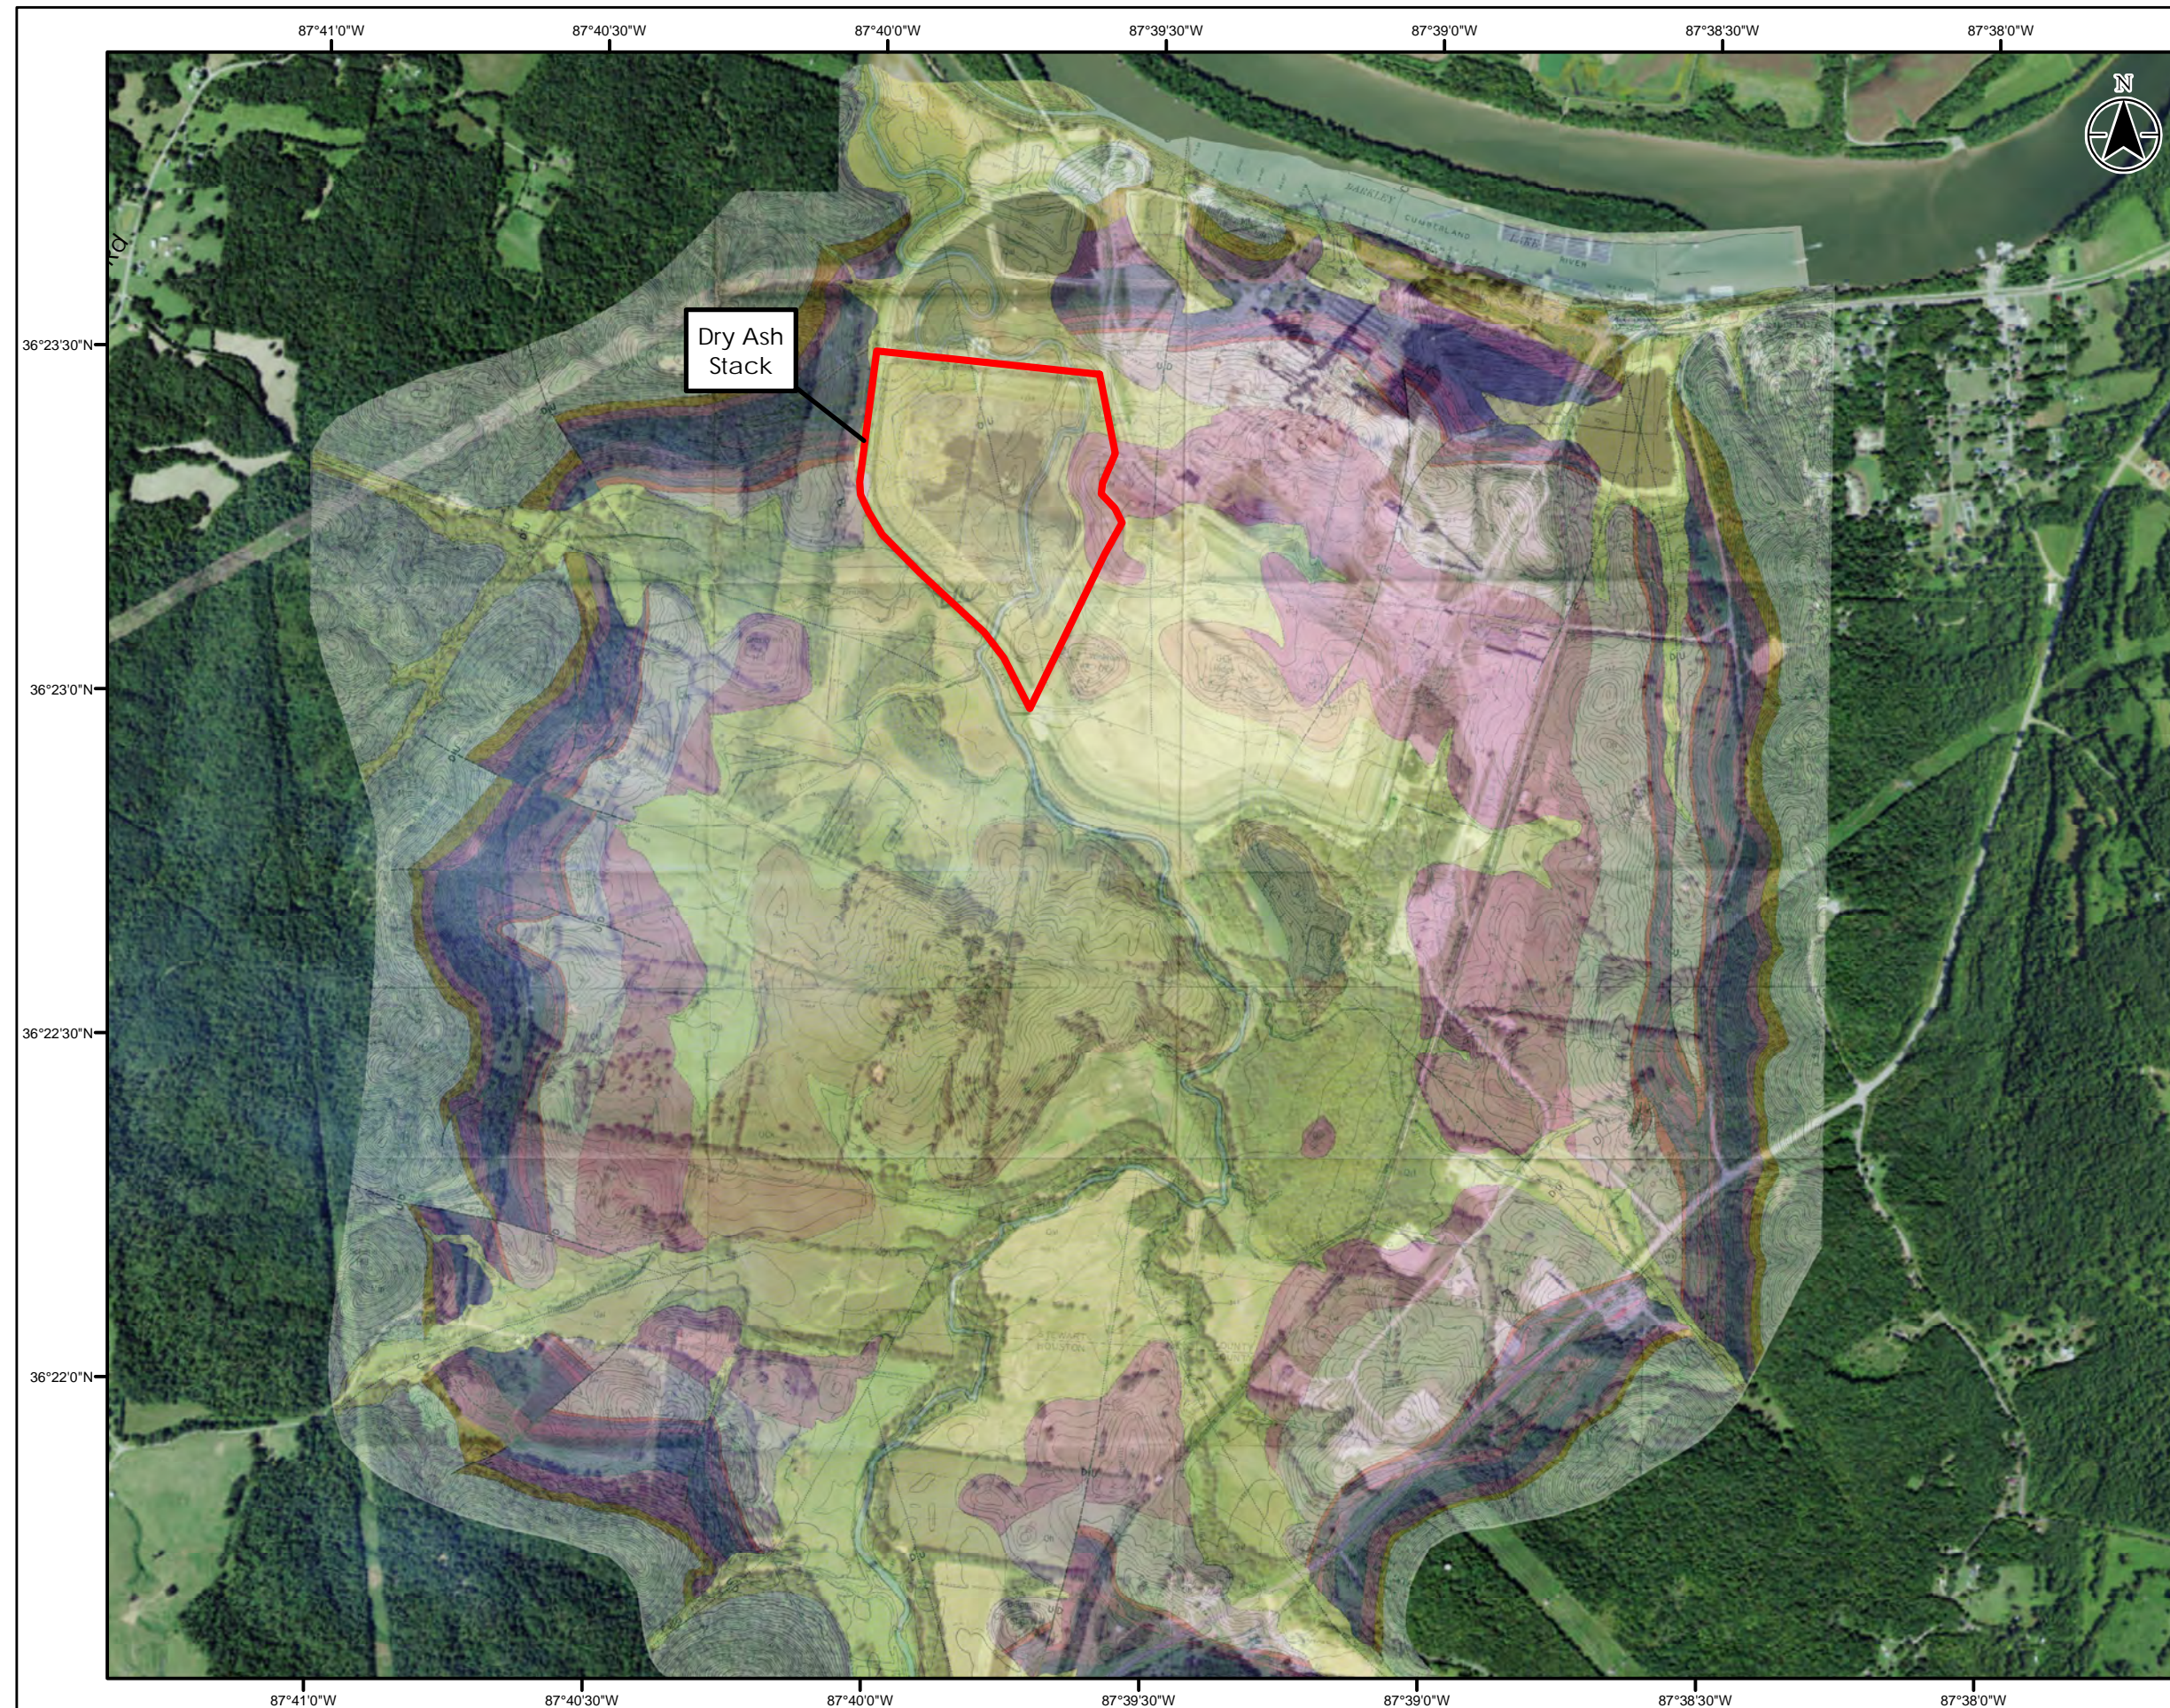
Wells Creek Crater Lithology

Site
 Cumberland Fossil Plant (CUF)
 Dry Ash Stack

- Dry Ash Stack Unit Limits
- Alluvial Deposits (Qal)
- Fort Payne Formation, New Providence Shale, and Chattanooga Shale (Mfp)
- Camden, Harriman, and Ross Formations (Dcr)
- Decatur Limestone (Sd)
- Brownsport Formation (Sbp)
- Dixon Formation (Sdx)
- Lego Limestone and Waldron Shale (Slw)
- Laurel Limestone (Sla)
- Osgood Formation (So)
- Brassfield Limestone (Sbr)
- Fernvale Limestone (Of)
- Hermitage Formation (Oh)
- Stones River Group (Osr)
- Knox Dolomite (OCK)
