**RE:     Periodic Structural Stability Assessment  
        Bottom Ash Pond  
        EPA CCR Rule  
        TVA Cumberland Fossil Plant  
        Stewart County, Tennessee**

**RE: Initial Structural Stability Assessment  
Bottom Ash Pond  
EPA Final Coal Combustion Residuals (CCR) Rule  
TVA Cumberland Fossil Plant  
Cumberland City, Tennessee**

**Initial Structural Stability  
Assessment**

**Cumberland Fossil Plant – Bottom  
Ash Pond  
Stewart County, Tennessee**

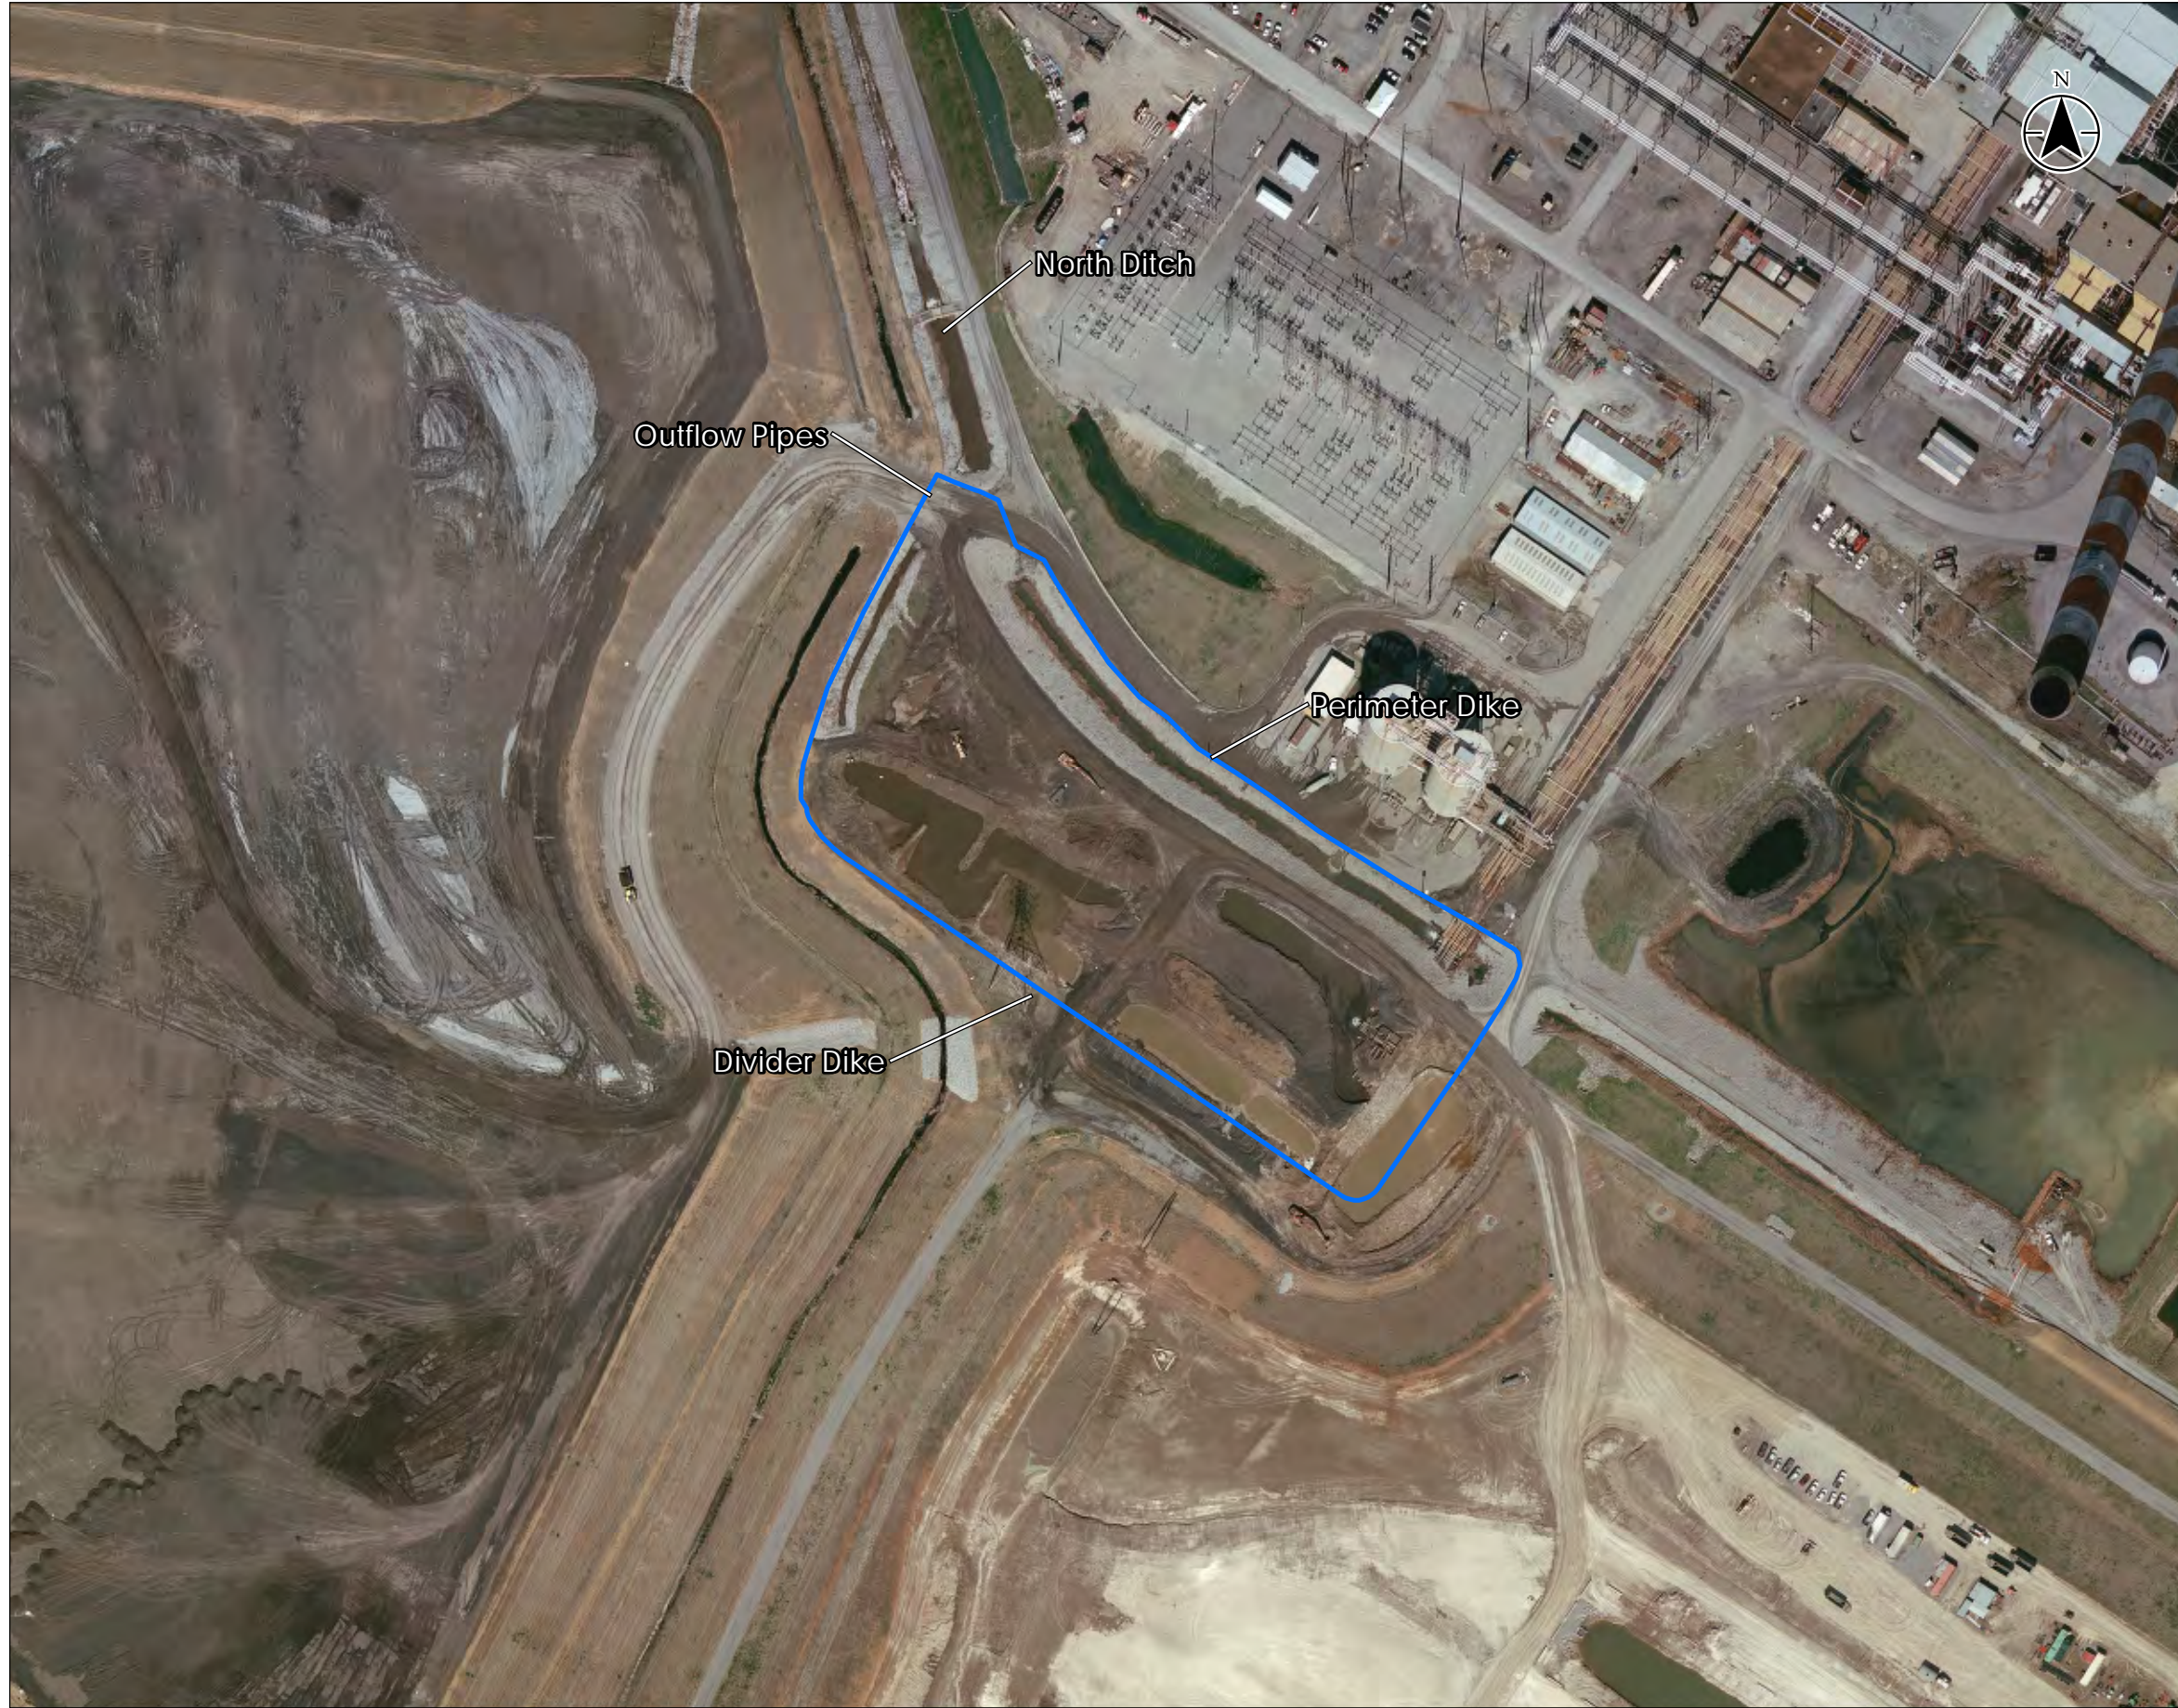
The subsections under §257.73(d) address conditions of appurtenances categorized as embankments, spillways, or hydraulic structures. Sections 2.1 to 2.3 below provide descriptions of the individual unit elements that fall within these appurtenance categories. Figure 1 provides an overview of the Bottom Ash Pond and appurtenances.

Bottom Ash Pond

The Bottom Ash Pond Outflow Pipes consist of two 54-inch-diameter reinforced concrete pipes (RCP) that direct flow from the Bottom Ash Pond to the North Ditch and subsequently the Stilling Pond. The two pipes are located near the northern end of the pond as shown on Figure 1.
