**RE: Unstable Areas Demonstration
Consolidated Waste Dry Stack
EPA Final Coal Combustion Residuals (CCR) Rule
TVA Shawnee Fossil Plant
West Paducah, Kentucky**

**Unstable Areas Demonstration
– SHF Consolidated Waste Dry
Stack**

Consolidated Waste Dry Stack
Shawnee Fossil Plant
Paducah, McCracken County,
Kentucky

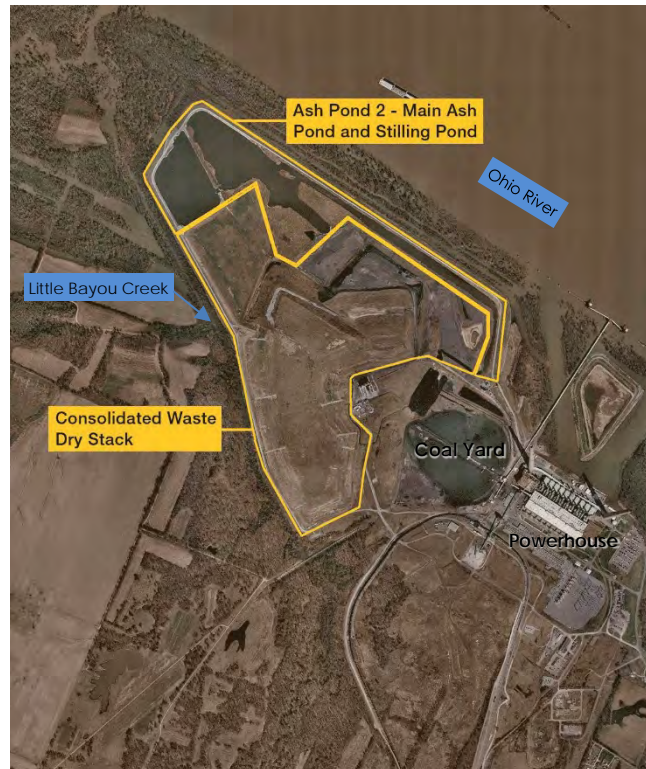
Figure 1: Site Vicinity Map

SHF is a coal-fired, electric-generating plant. The plant is located in McCracken County, Kentucky, along the south shore of the Ohio River near river mile 946 and just east of the confluence of Little Bayou Creek with the Ohio River.

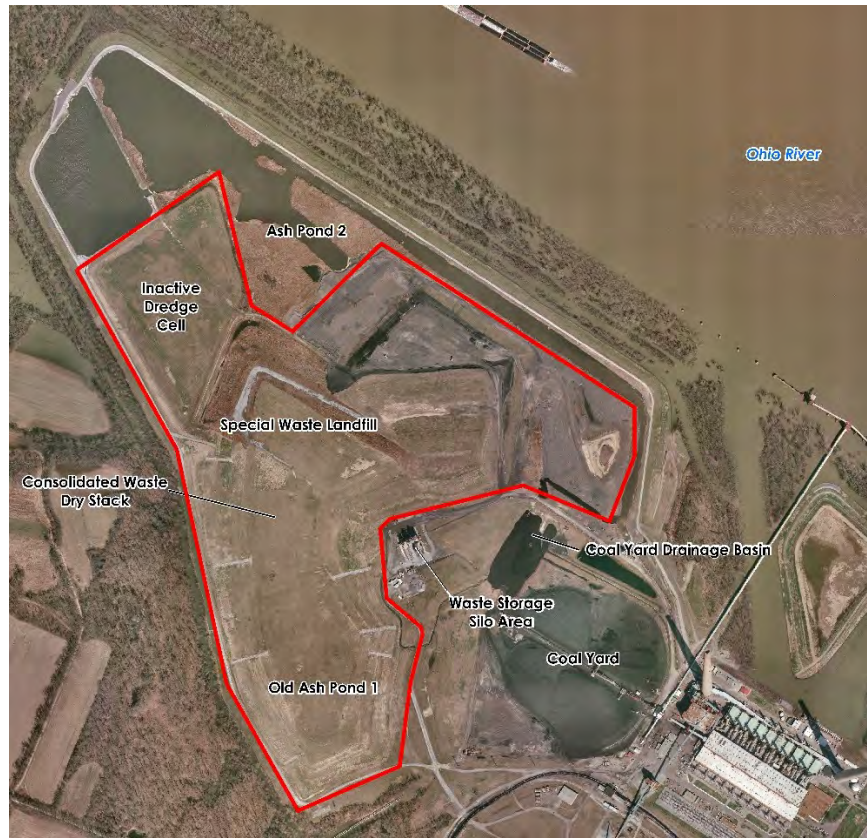
Figure 2: Consolidated Waste Dry Stack Unit Configuration

The Consolidated Waste Dry Stack (CWDS) is located to the west of the powerhouse. The original limits of the landfill are south of Ash Pond 2 with the current permitted expansion into Ash Pond 2. Current disposal activity is to the north within the horizontal stack expansion area designed in 2006. This current stacking plan consists of expanding the stack to the north over Ash Pond 2.

The original portions of the stack are covered and are approximately 110 acres in area and about 100 feet in height. The unit is considered an active CCR landfill unit and currently receives dry fly ash from the plant and dredged bottom ash from Ash Pond 2.

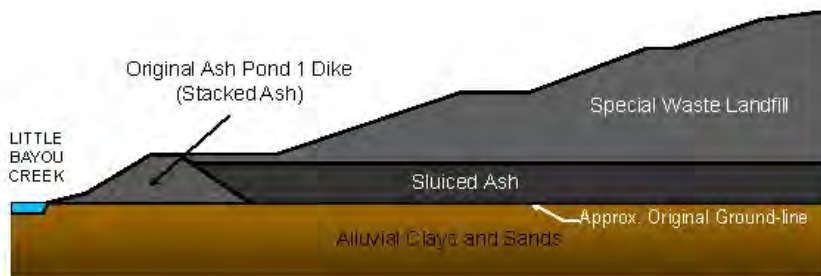
Figure 3: Typical Cross Section

The CWDS is located over the original Ash Pond 1 disposal area. Dry ash was used to build the interior dike of Ash Pond 1 sometime between 1951 and 1956 with a dike raising reported in 1967. Ash Pond 1 contained sluiced ash ranging in thickness from 20 to 30 feet. The CWDS placement began in 1984 with the original portions of the stack fully built-out and covered along the south portion in the late 1990s (Stantec Consulting Services Inc., 2010a). The soil borings from the 2010 geotechnical exploration reveal alluvial material directly below the dike system. It should be noted that there were no construction record drawings, construction inspection reports, or quality control test results contained in the archived materials related to the original construction of Ash Pond 1 (Stantec Consulting Services Inc., 2016b).

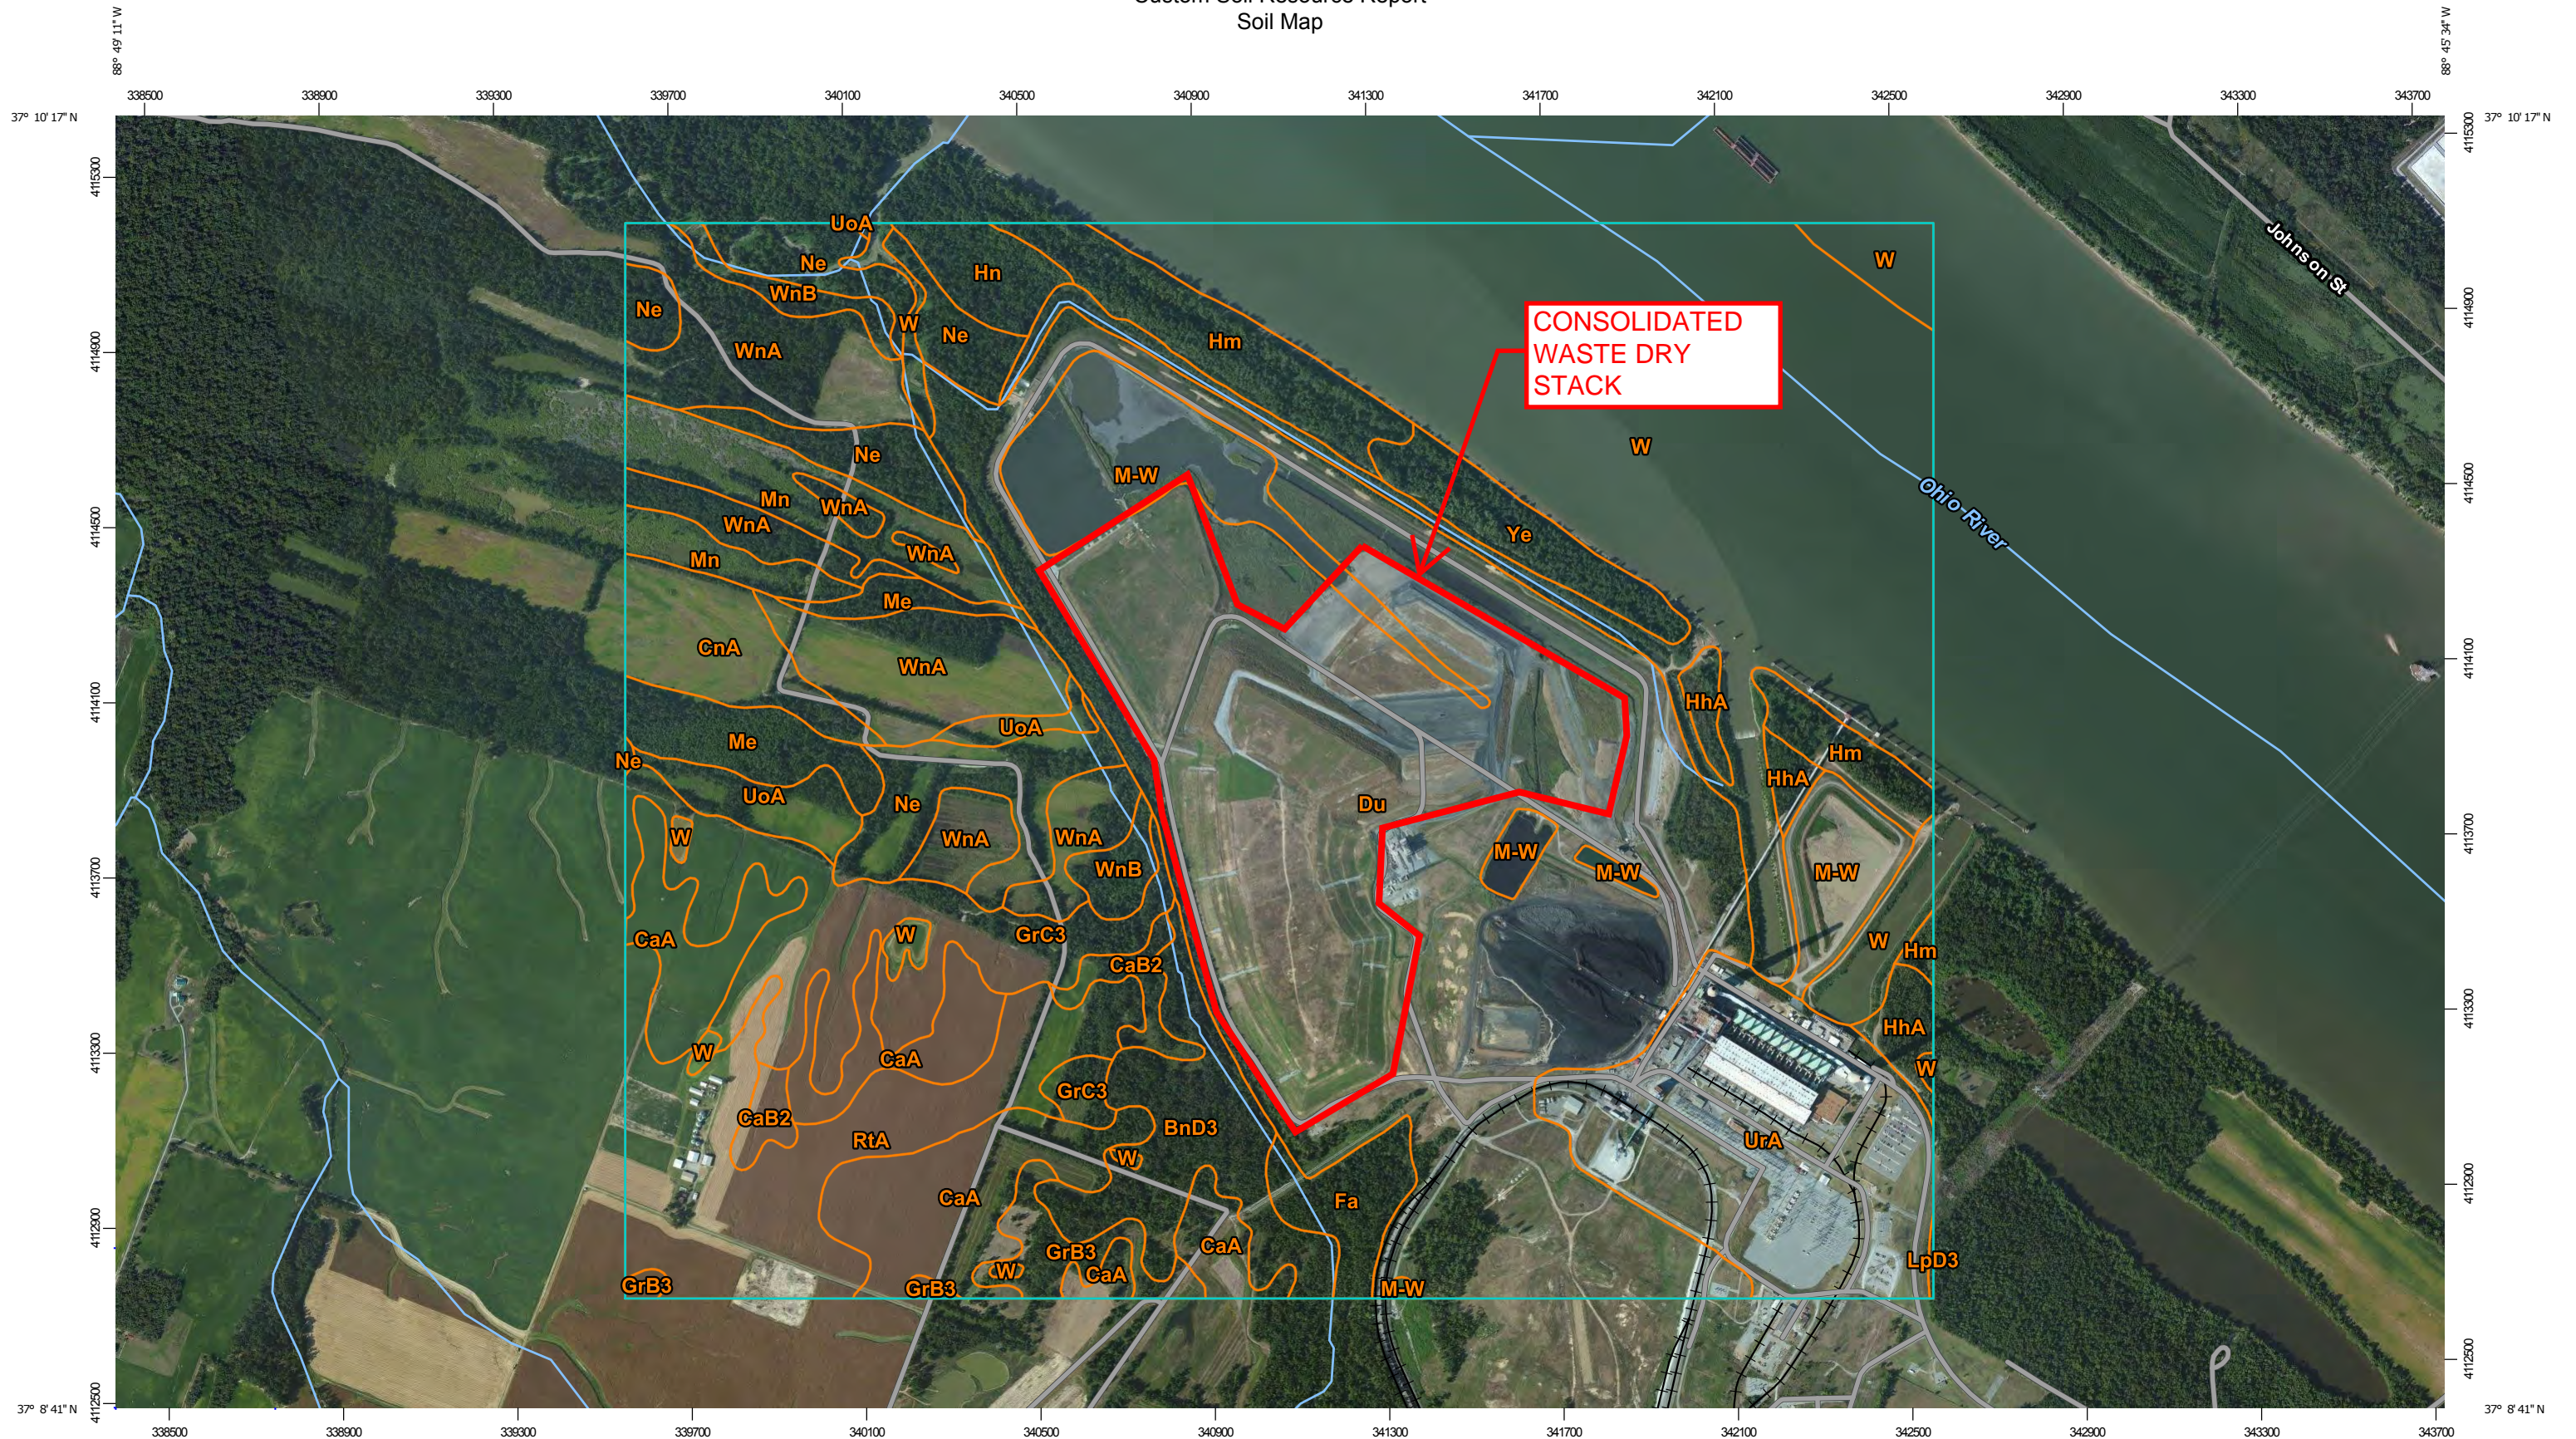
Custom Soil Resource Report
Soil Map

The soil map section includes the soil map for the defined area of interest, a list of soil map units on the map and extent of each map unit, and cartographic symbols displayed on the map. Also presented are various metadata about data used to produce the map, and a description of each soil map unit.

According to available geologic data and soil surveys, the CWDS is located within the floodplain of the Ohio River within the Calloway-Henry soils association (United States Department of Agriculture Soil Conservation Service, 1976). Typically, the soils are silt loam over loamy clay and silt loams. The loess and Quaternary alluvial deposits primarily classify as CL and ML and associated dual symbols, and beneath those deposits are Plio-Pleistocene sands and gravels with varying silt content that primarily classify as SP, SM, GW, GM, and associated USCS dual symbols (FMSM, 2006).
